Ecological site R009XY501OR Low Slope Alluvial Valley Riparian Complex

General information

R009XY501OR: Low slope, Alluvial Valley Riparian Complex

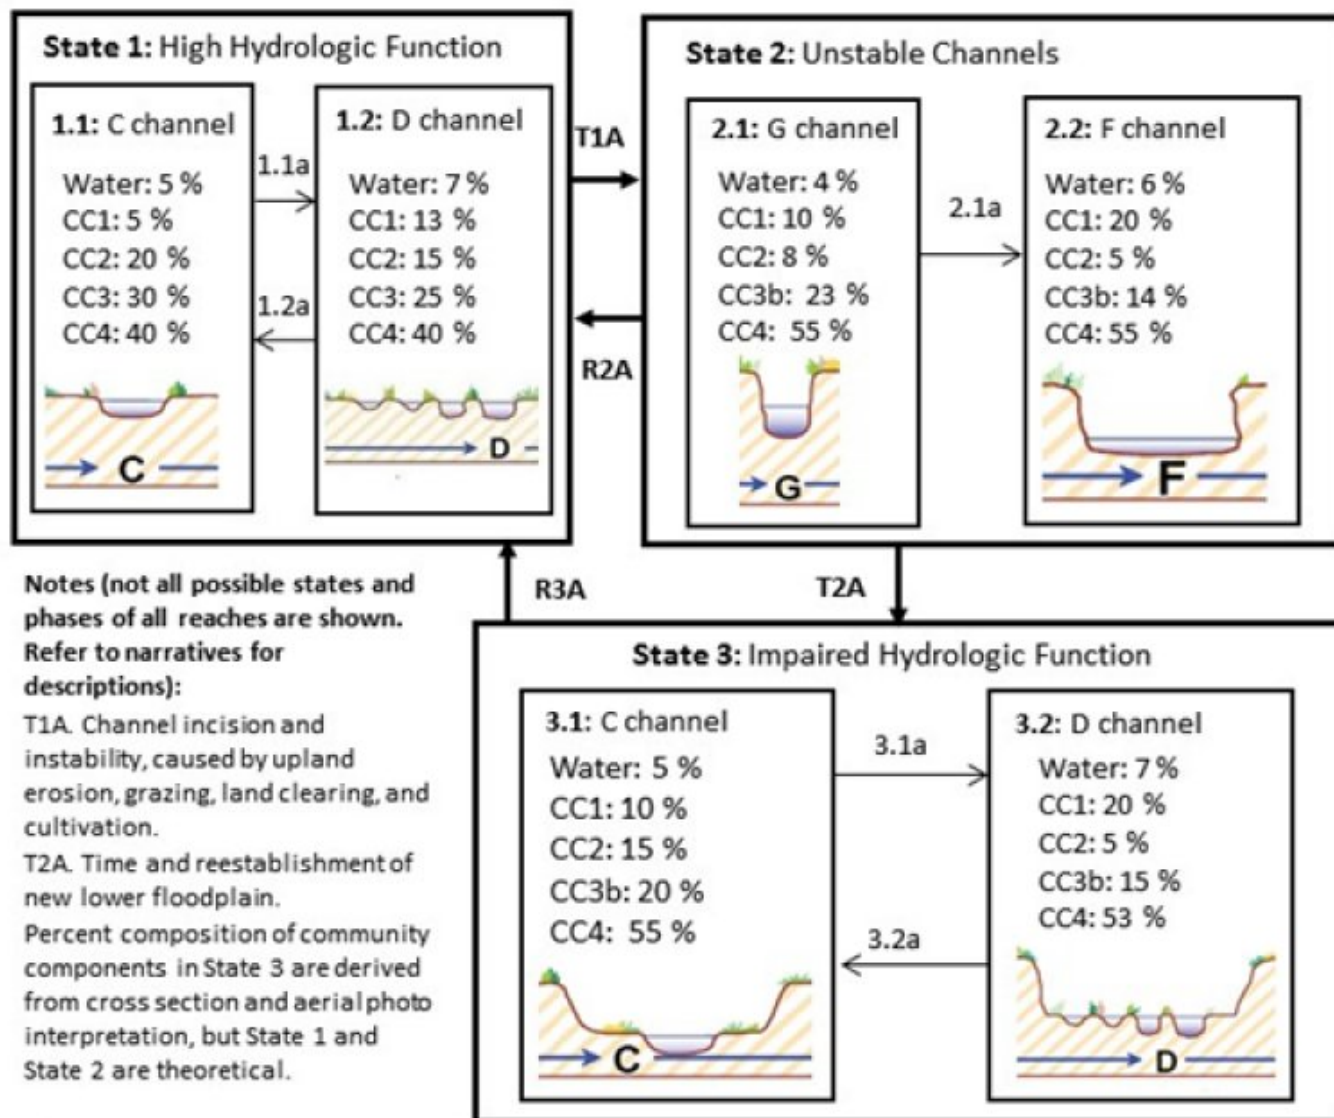
Figure 7. R009XY501OR STM

I.D.	Plant Association	Fluvial Surface/Landform
1	Pioneer forbs, willows	Gravel bar
2	White alder, black cottonwood, Lewis' mock orange	Floodplain, occasionally flooded
3	Black cottonwood, black hawthorn	Floodplain step, rarely flooded
3b	Black hawthorn, black cottonwood, common snowberry	Floodplain step, abandoned, rarely flooded
4	Basin wildrye, black hawthorn, western chokecherry	Stream Terrace, rarely flooded

State 1 High Hydrologic Function

State 2 Unstable Channels

State 3 Impaired Hydrologic Function
