Ecological site R022AX102CA Frigid E-C Meadow System

Major Land Resource Area (MLRA): 022A–Sierra Nevada and Tehachapi Mountains

Ecological site concept

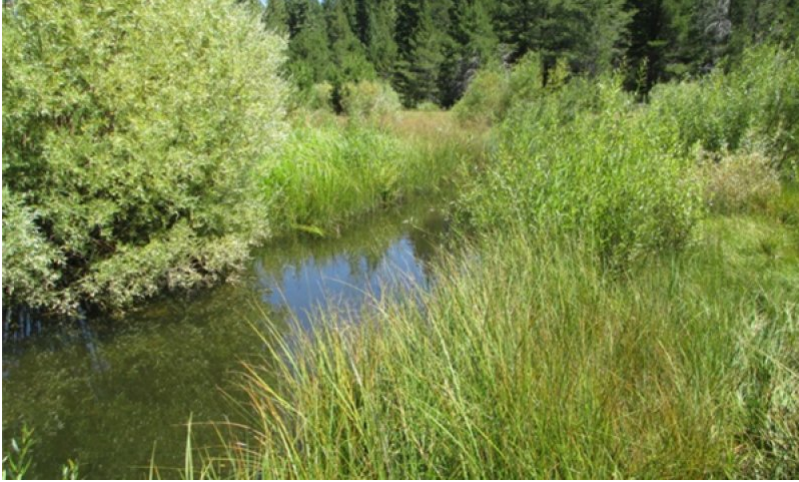
Figure 7. E channel

E type channels typically have thick mats of sedge roots that stabilize channel banks and help maintain a low channel width-to-depth ratio and high stream sinuosity. These small channels frequently flood onto the floodplain leaving fine deposits on the surface. The floodplains have a shallow water table that supports rhizomatous sedges and many obligate wetland species.

This phase is composed of a stable E type channel, with several community components present. There is a wide range of variability in this ecological site, and each area may have a unique plant community or variations in species composition. Only the dominant plant community and associated soil-landforms are described below as representative community components (CC#).

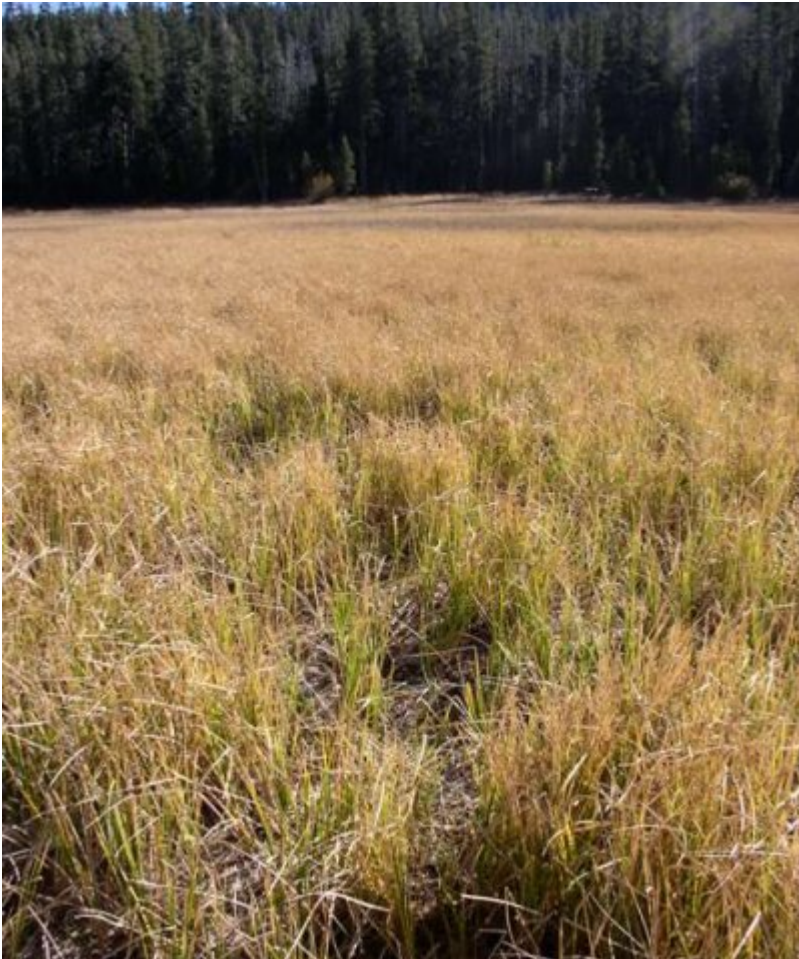
Figure 8. CC1

CC1 Floodplains and depressions: This community is dominated by nearly pure stands of Northwest Territory sedge or blister sedge (*Carex vesicaria*). It occurs in wet depressions that have long durations of ponding, and a water table near the surface for most of the summer. Nebraska sedge, water sedge (*Carex aquatilis*), tufted hairgrass (*Deschampsia cespitosa*) and other species may be present in low amounts.

The Watah (coarse-loamy, mixed, superactive, acid, frigid Histic Humaquepts) soil is of limited extent in this ecological site. The Watah soils develop in the wettest locations, in broad low-lying areas and adjacent to the stream channels on the active floodplain. The Watah soils have 20 to 40 cm of peat or mucky peat, developed primarily from decomposed sedge roots. Below the organic horizons the soil is sandier with gravelly mucky coarse sandy loam and gravelly loamy coarse sand textures. Gleyed soil colors occur below 73 cm. The Watah soils are frequently flooded or ponded for very long durations with up to 15 inches of water. Community component 1 (CC1) is associated with the Watah soils.

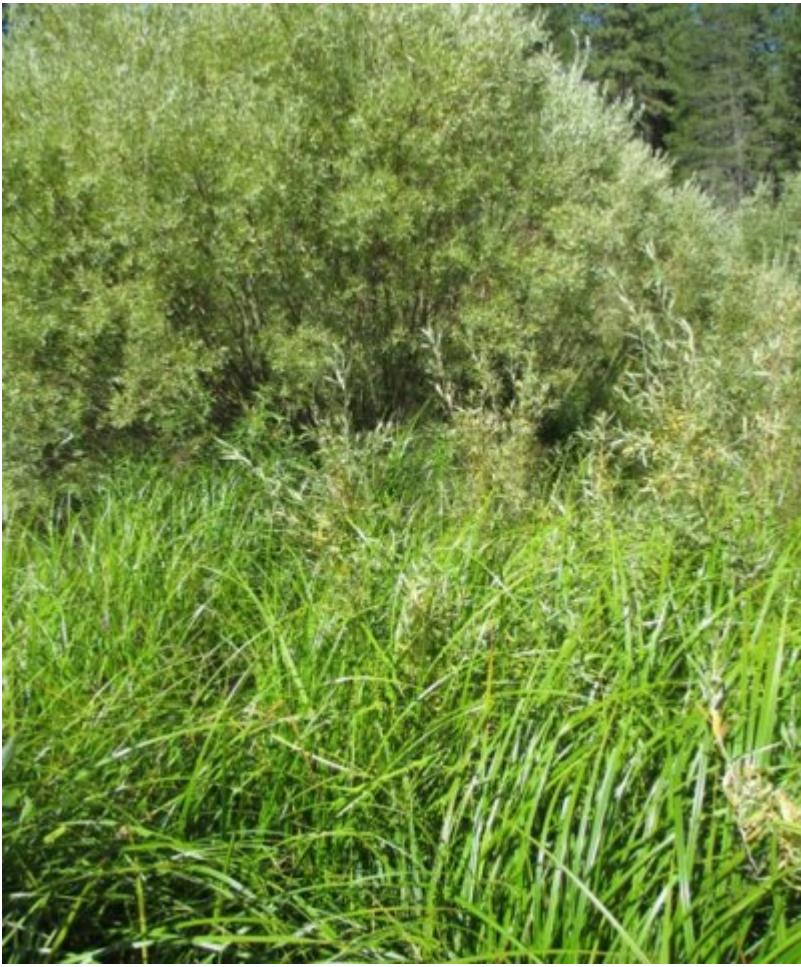
Figure 9. CC2

CC2 Floodplains: This community occurs along the greenline of the channel, and on frequently flooded floodplains. This community has more flood activity than the ponding in CC1. It retains a water table near the surface throughout the summer in the wettest positions, but it is directly affected by fluctuations in the channel water level. Lemmon's willow and Geyer willow are dominant, with shining willow (*Salix lucida*) occasionally present. The understory has high cover and production of grass or grass-like species. Northwest Territory sedge, water sedge, and/or blister sedge are dominant. Nebraska sedge, bentgrass (*Agrostis* sp.), meadow barley (*Hordeum brachyantherum*), Mexican rush (*Juncus mexicanus*), mountain rush (*Juncus arcticus* ssp. littoralis) and panicled bulrush (*Scirpus microcarpus*) are common associates. Forbs are less abundant, but include common yarrow (*Achillea millefolium*), Pacific onion (*Allium validum*), Brewer's bittercress (*Cardamine breweri*), fringed willowherb (*Epilobium ciliatum*), threepetal bedstraw (*Galium trifidum*), largeleaf avens (*Geum macrophyllum*), wild mint (*Mentha arvensis*), seep monkeyflower (*Mimulus guttatus*), moving polemonium (*Polemonium californicum*), knotweed (*Polygonum* sp.), and Oregon checkerbloom (*Sidalcea oregana* ssp. spicata).

The Tahoe, silt loam wet phase (coarse-loamy, mixed, superactive, acid, frigid Cumulic Humaquepts) soil occurs on frequently flooded floodplain steps. The surface texture is mucky silt loam and subsurface textures are mucky silt loam and gravelly coarse sand. The Tahoe, silt loam wet phase component is frequently flooded or ponded for very long durations, with a flooding or ponding depth up to 15 inches deep. CC2 is associated with this soil component.

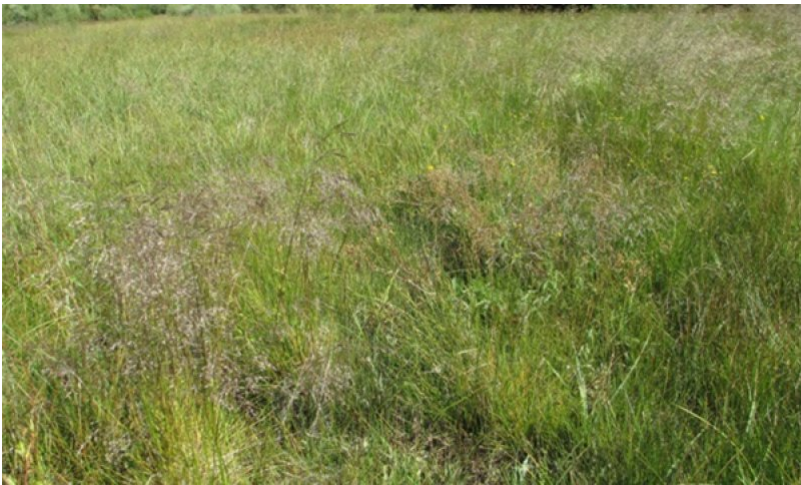
Figure 10. CC3

CC3 Floodplain step, occasionally flooded: This community occurs on occasionally flooded and ponded floodplain steps. The water table may drop below 60 inches during the summer months. Tufted hairgrass and mountain rush are typically dominant with a mix of grass or grass-likes and forbs. Grass and grass-likes include water sedge, slenderbeak sedge (*Carex athrostachya*), Nebraska sedge, Northwest Territory sedge, spikerush (*Eleocharis* sp.), slender wheatgrass (*Elymus trachycaulus*), Mexican rush, pullup muhly (*Muhlenbergia filiformis*) and straightleaf rush (*Juncus orthophyllus*). Common forbs include common yarrow, Chamisso arnica (*Arnica chamissonis*), fringed willowherb (*Epilobium ciliatum*), Virginia strawberry (*Fragaria virginiana*), threepetal bedstraw, largeleaf avens, slender cinquefoil (*Potentilla gracilis*), and Oregon checkerbloom (*Sidalcea oregana* ssp. spicata).

The Tahoe, silt loam phase (coarse-loamy, mixed, superactive, acid, frigid Cumulic Humaquepts) component occurs on occasionally flooded floodplain steps. The surface texture is mucky silt loam and subsurface textures are mucky silt loam and gravelly coarse sand. The Tahoe, silt loam phase component is occasionally flooded or ponded for brief to long durations, with a ponding or flooding depth up to 6 inches deep. CC3 is associated with this soil component.

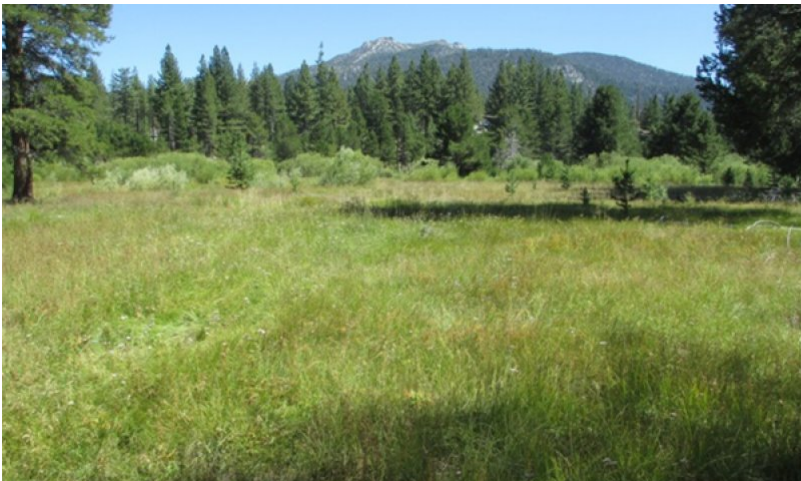
Figure 11. CC4

CC4 Outwash, occasionally flooded: This community occurs on outwash typically on the meadow edge, or raised islands within the meadow. The soils lack the rich organic surface, and indicators of the water table begin at 14 inches. Kentucky bluegrass (*Poa pratensis*), a grass not native to this area, is the most abundant understory species. Other grass and grass-like species include mountain rush, slender wheatgrass, blue wildrye (*Elymus glaucus*) and straightleaf rush. Forb composition is similar to CC3, but forbs are more productive in this community. Common forbs include slender cinquefoil (*Potentilla gracilis*), Virginia strawberry, threepetal bedstraw, groundsmoke (*Gayophytum* sp.), longspur lupine (*Lupinus arbustus*), Rydberg's penstemon (*Penstemon rydbergii*), meadow bistort (*Polygonum bistorta*), garden sorrel (*Rumex acetosa*), longleaf starwort (*Stellaria longifolia*), western mountain aster (*Symphyotrichum spathulatum*), and longstalk clover (*Trifolium longipes*).

The Marla (sandy, mixed, frigid Aquic Dystrocherepts) soils occur on outwash terraces that border this site, and are influenced by the ground water hydrology of the meadow. The surface textures are loamy coarse sand and subsurface textures are loamy coarse sand and clay loam. The Marla soils are associated with CC4.

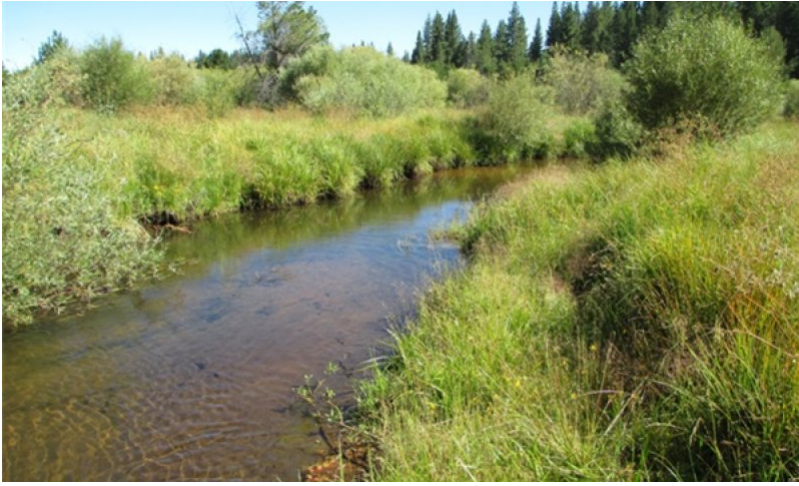
Figure 13. C Channel

The C type channel has similar community components and community composition as described in the E type channel phase, but the channel is wide and shallow. The change in channel morphology may be caused by a beaver activity, logs, root wads, or other channel obstructions, or natural changes in channel gradient or sinuosity.

A C type channel is a slightly entrenched single thread meandering channel with a well defined floodplain. The channel has moderate to high sinuosity with less than 2 percent channel gradient. These channel types generally have a width to depth ratio greater than 12, which means they are wide and shallow. They are often found in broad valleys with well developed alluvial floodplain terraces, and such channels typically flood over bank two years out of three. In an undegraded state, a 50-year flood event should overflow onto the floodplain. C type channels are constantly in the process of transporting and storing sediments from upstream sources or bank erosion. As the particle size of the channel bottom material decreases, the sediment supply generally increases and so does the erosion potential. The channels on this site support gravel (C4) and sand bottom (C5) reaches that have very high erosion potentials, and are very sensitive to disturbance. Vegetation, including willow and sedges, exert a very high controlling influence on C type channel dynamics (Rosgen 1994).

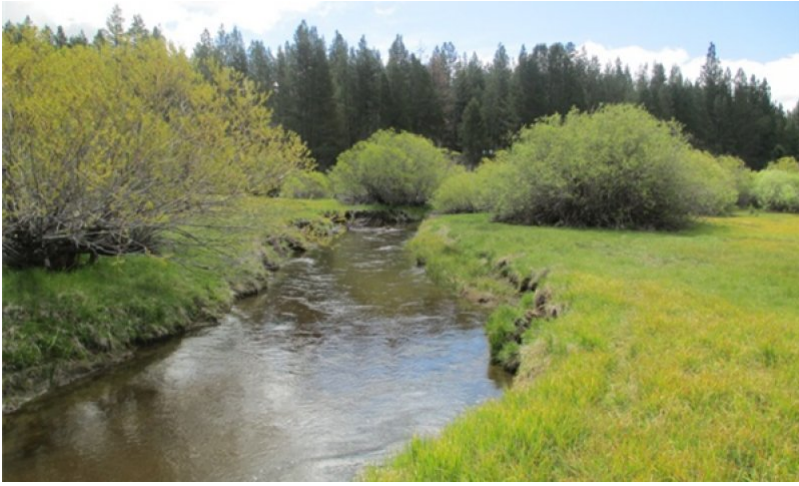
Figure 14. G Channel

This phase is distinguished by a narrow, deeply incised G type channel. Stream banks are nearly vertical, with active slumping and erosion. The water level of the stream has incised 3 to 6 feet from the original elevation, causing the water table to drop throughout the meadow. The community components dependent upon frequent flooding, long durations of ponding and high water tables (CC1 and CC2) decline, and the vegetation shifts to drier upland species. CC1 Floodplains and depressions: Northwest Territory sedge and blister sedge will decline over time if water tables remain below 2 feet throughout the year. Typically this community will persist for some time, since it is in the lowest, wettest positions that may still be close enough to the water table. However as the site dries out, production and cover decline as shorter less robust plants develop. Other grass and grass-likes, less dependent upon a permanent high water table such as Nebraska sedge, Mexican rush, and mountain rush may increase. As bare ground increases, pioneer forbs establish. CC2b Floodplains: This community responds dramatically to channel incision and back erosion. Species dependent upon high water levels, such as Northwest Territory sedge, water sedge, blister sedge, widefruit sedge, and panicked bulrush are nearly eliminated, except in low positions or small lower benches in the channel. Lemmon's willow and Geyer willow persist without a measurable decline. Nebraska sedge is more tolerant of fluctuating water tables, increases after release from grazing, and is often dominant with willows along the incised channels. Forbs and grasses from CC3 and CC4 increase in this former active floodplain. Common yarrow, Chamisso arnica, western mountain aster, tufted hairgrass, Mexican rush, Rhyberg's penstemon, meadow barley, Oregon checkerbloom, slender cinquefoil, Woods rose, mountain rush, Sierra lodgepole pine and Kentucky blue grass may be present in this altered community component. CC3b Floodplain step, occasionally flooded: This community maintains similar species as State 1 CC3, but overall cover and production declines. Tufted hairgrass flowering stalks may be over 3 feet tall in state 1, and 1 to 2 feet tall in this altered phase of CC3b. Mountain rush and forbs increase in dominance. Common yarrow, Chamisso arnica, Virginia strawberry, slender cinquefoil (*Potentilla gracilis*), Rhyberg's penstemon and Oregon checkerbloom (*Sidalcea oregana* ssp. *spicata*) are common. Kentucky bluegrass and Sierra lodgepole pine often increase. CC4 Outwash, occasionally flooded: This community increases into the former floodplains as water tables drop and flood disturbances are reduced. Production of Kentucky blue grass may decline with lower water tables. Sierra lodgepole pine cover may increase from a few scattered trees to a dense forest. Jeffrey pine and white fir (*Abies concolor*) may also establish.

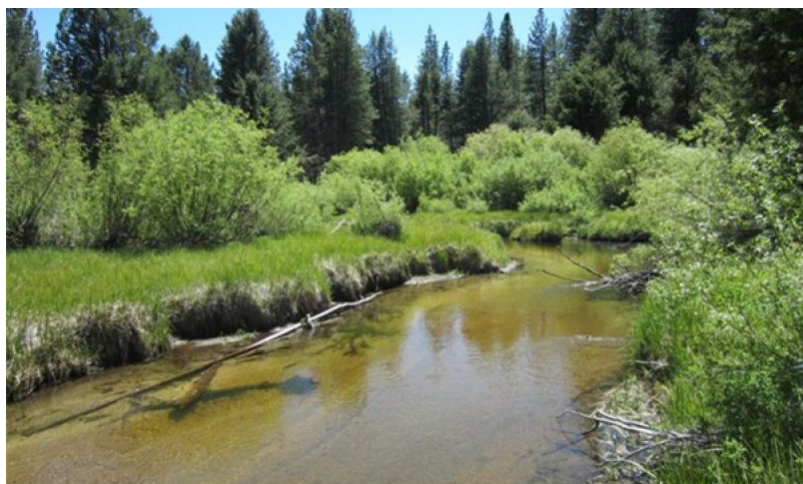
Figure 16. F Channel

The F type channel is wide, shallow and incised, with unstable actively eroding banks. Community components and community composition is similar as describe in the G type channel phase. The wider channel and lack of vegetation on the banks causes an exposed stream with little shade. Silt and sand from actively eroding banks cause a decline in habitat quality for fish and aquatic insects.

This pathway develops as sedimentation and bank erosion continues to widen the channel forming, an F type channel.
