Ecological site R022AX103CA Cryic E Meadow System

R022AX103CA, Cryic E Meadow System

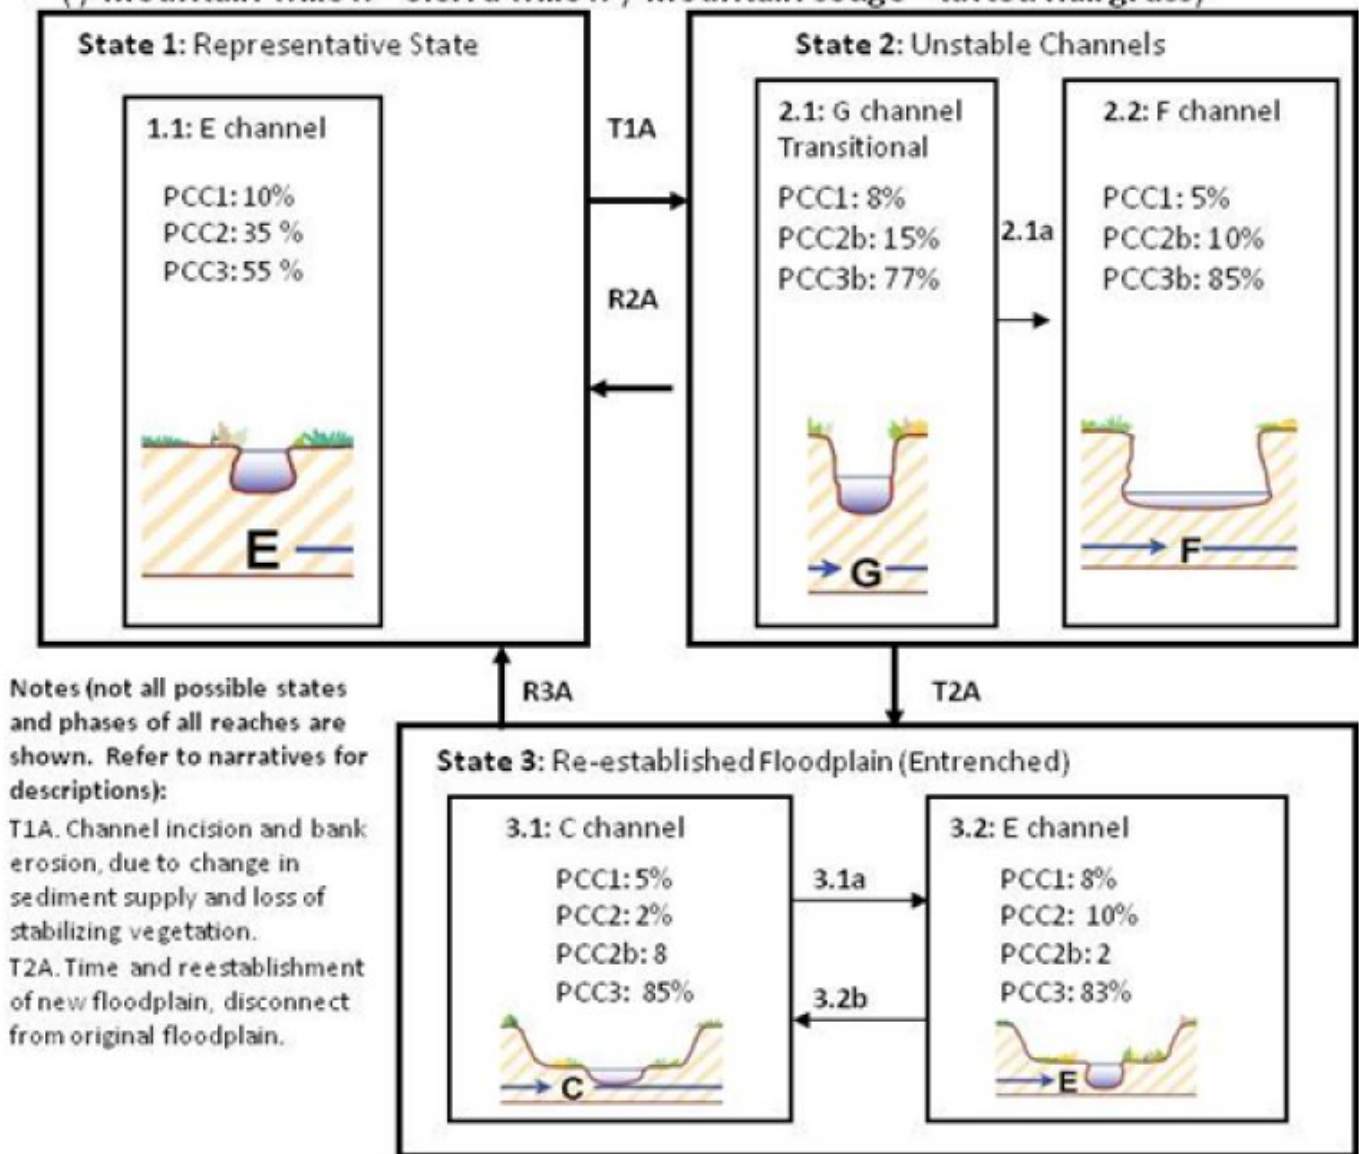
Figure 5. R022AX103CA STM

I.D.	Plant Association	Fluvial Surface/Landform
1	Moss- Sierra willow- mountain willow/ sedges	Discharge slopes
2	Mountain willow- mountain sedge	Floodplain, Greenline
3	Tufted hairgrass- mountain rush	Floodplain step

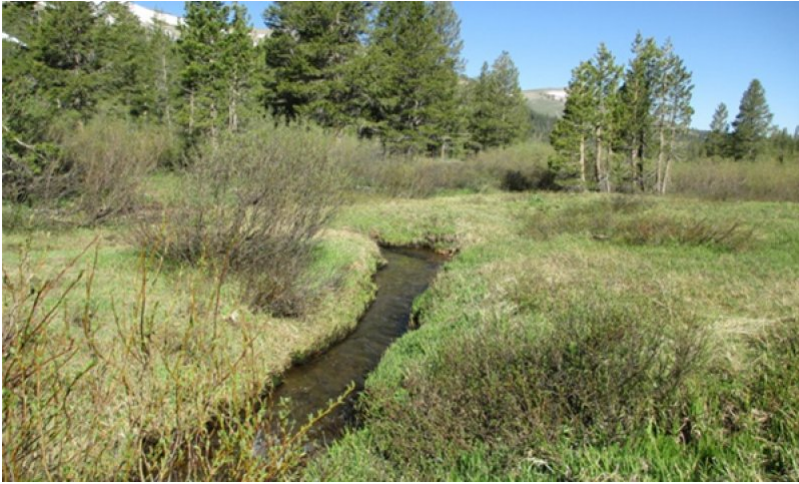
Figure 6. E channel

The E type channel flows through gently sloping alpine meadows. The channel is a small, stable, narrow, deep, meandering stream. These meadows maintain a high water table throughout the summer, and floods reach over the banks, two out of three years, which supports a healthy community of sedges and willows. Several community components are associated with this phase. CC1, Discharge slopes and depressions: This community typically occurs upslope of the main meadow, where subsurface flow seeps to the surface, creating a cool, perennially wet site that typically develops deep histic soil horizons. This component may also develop in depressional basins within the meadow. There are several plant communities that may occur on the discharge slopes. The variation is due in part by past disturbances, and in part by abiotic variation such as aspect. However, the scale required to capture these unique assemblages is beyond the scope of the soil survey. The most common plant communities are fen communities with high cover of mosses (*Sphagnum* and other sp.). Mountain sedge, Northwest Territory sedge (*Carex utriculata*) and spikerush (*Eleocharis* sp.) are dominant. Water sedge (*Carex aquatilis*), blister sedge (*Carex vesicaria*) and lakeshore sedge (*Carex lenticularis*) are present along small rivulets that have surface flow or ponded areas of standing water. Patches of mountain willow and Sierra willow can range from sparse to dense. Forbs typically are only a minor component and include (*Arnica mollis*), alpine shootingstar (*Dodecatheon alpinum*), Sierra shootingstar (*Dodecatheon jeffreyi*), willowherb (*Epilobium* sp.), alpine gentian (*Gentiana newberryi*), tinker's penny (*Hypericum anagalloides*), primrose monkeyflower (*Mimulus primuloides*), tundra aster (*Oreostemma alpigenum* var. *alpigenum*), Parish's yampah (*Perideridia parishii*), longleaf starwort (*Stellaria longifolia*), and western aster (*Symphyotrichum ascendens*). Meadow bistort (*Polygonum bistorta*) and California false hellebore (*Veratrum californicum*) may occasionally be dominant. CC2 Floodplain, frequently flooded: This community develops along the channel and on broad, frequently flooded floodplains. Mountain willow occurs along the stream and in the very wet areas. Sierra willow can be present or absent, and it may occur further from the stream. Other willow species may be present. In cooler or higher elevation sites western moss heather (*Cassiope mertensiana*), purple mountainheath (*Phyllodoce breweri*) and rose meadowsweet (*Spiraea splendens* var. *splendens*) are present. Mountain sedge is the dominant understory sedge, with bentgrass (*Agrostis* sp.), lakeshore sedge, Northwest Territory sedge, tufted hairgrass, slender hairgrass (*Deschampsia elongata*), pullup muhly (*Muhlenbergia filiformis*) and Donner woodrush (*Luzula subcongesta*) are often present. Forb diversity is relatively high. Common forbs include Pacific onion (*Allium validum*), alpine gentian, tinker's penny, bigleaf lupine (*Lupinus polyphyllus*),

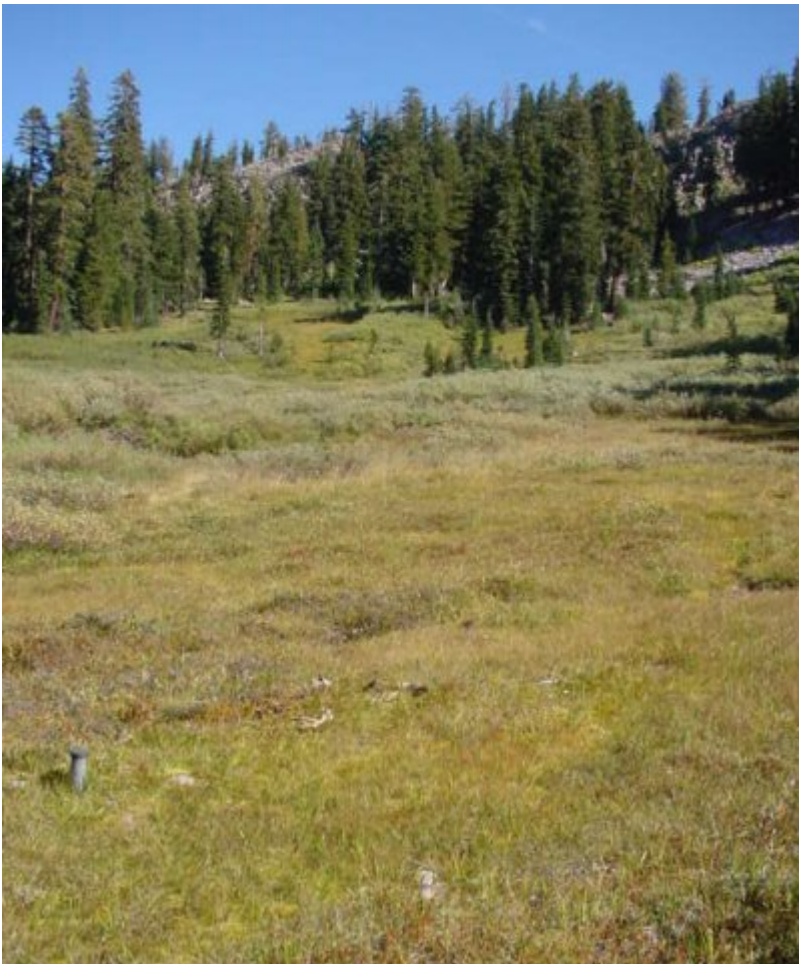
Figure 7. CT1 Discharge Slope

The Hellhole soil occurs in areas with permanent high water tables, which allows deep organic soils to develop from moss fibers. The hellhole soils are Euic, frigid Typic Sphagnofibrists. They are rarely flooded for brief durations, but are frequently ponded (saturated) for long durations. Available water capacity is 21.7 to 25.6 inches in the upper 40 inches of soil (ESIS does not allow AWC greater than 15.99 to be entered). CC1 and CC2 are associated with this component.
