Ecological site R022AX103CA **Cryic E Meadow System**

R022AX103CA, Cryic E Meadow System

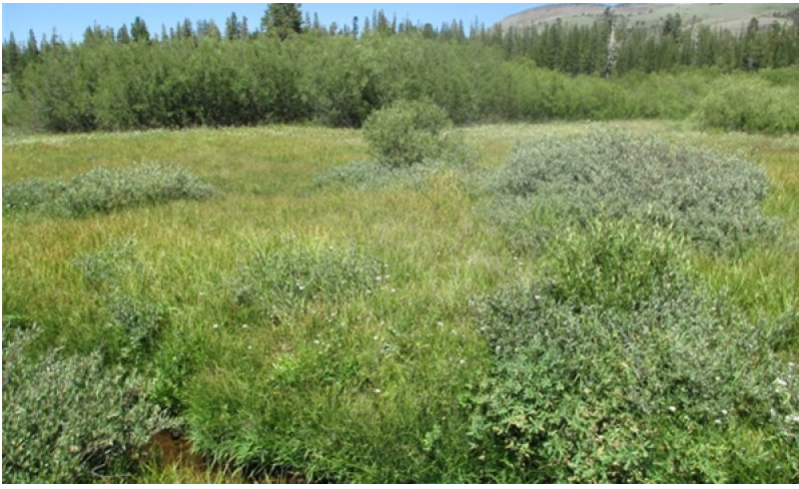
Figure 8. CT2 Floodplains

The Bidart, wet phase occurs on the active floodplains. The Bidart soils have a mucky silt loam surface texture, with silt loam, extremely gravelly coarse sand, fine sandy loam, and sandy loam subsurface textures. These soils exhibit episodic depositional layers. Mottling from water saturation is evident at 3 inches, with gleyed conditions starting at 17 inches. The Bidart soils are coarse-loamy, mixed, superactive, acid Fluvaquentic Cryaquepts. The Bidart wet phase is frequently flooded and ponded for long durations. CC3 is associated with this component.

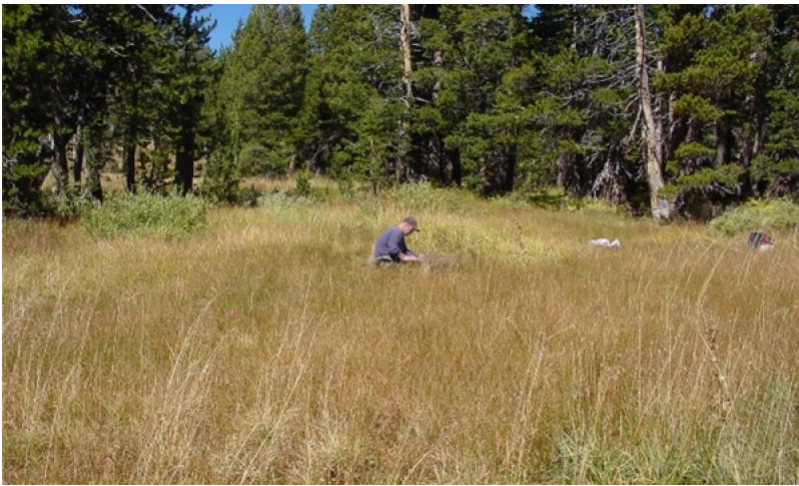
Figure 9. CT3 Floodplain Step

The Bidart silt loam component has the same features as describe for the Bidart wet phase, but it is occasionally flooded and ponded, due to its higher topographic position on the floodplain. CC4 is associated with this component.
