Ecological site R022AX105CA Steep Mountain Drainageways

R022AX105CA, Steep Mountain Drainageway Complex

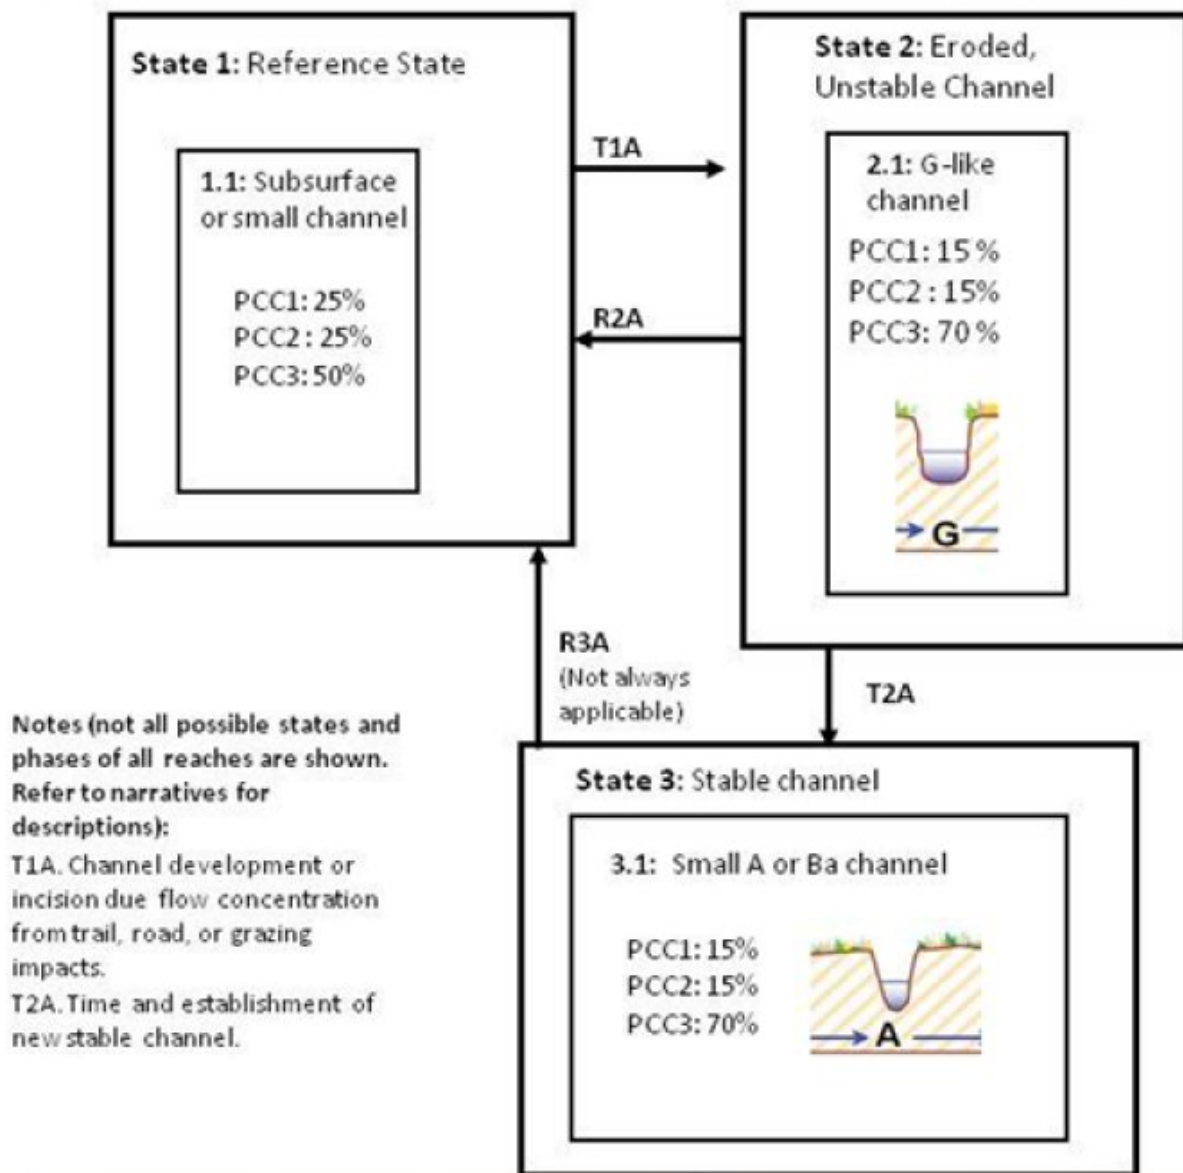
Figure 6. R022AX105CA STM

I.D.	Plant Association	Fluvial Surface/Landform
1	Thinleaf alder-Lemmon's willow	Drainageway
2	Lemmon's willow and sedges	Floodplain
3	Quaking aspen	Drainageway, margins

Transition 1.1a State 1 to 2

This transition is triggered by grazing, road development, or trails that increase flow to the channel and cause it to down cut into an unstable G type channel.

Restoration pathway 2.1a State 2 to 1

Transition 2.1a State 2 to 3

This transition occurs when the channel has widened over time, and has more sloped banks with vegetation. This may occur if disturbances are removed or managed properly or as the channel adjusts to accommodate the disturbances.

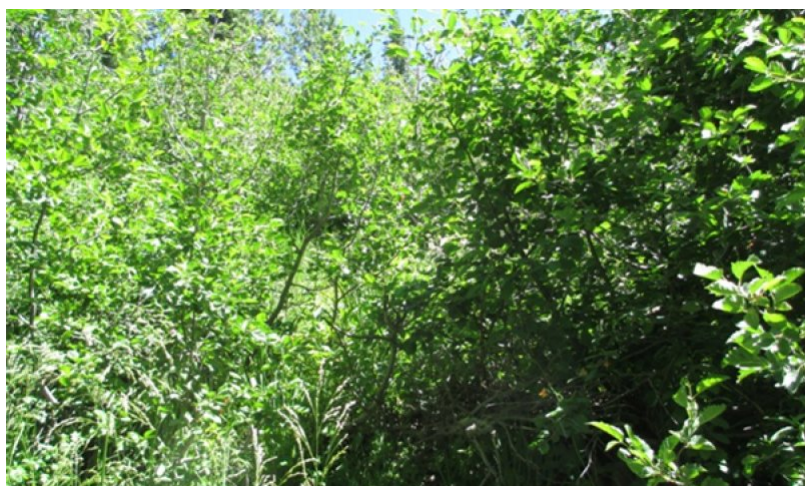
Figure 8. CC1

This phase does not have a defined channel. There may be small rivulets, or signs of surface flow through sedges or moss. This phase occurs at headwater seeps, or where slopes break from steeper drainage slopes, and flow goes subsurface. This phase has several community components that do not always occur together in one location, but repeat along the length of the stream. CC1, Drainageway This community occurs in the steeper, more confined seeps and springs. It is dominated by thinleaf alder and Lemmon's willow. Thinleaf alder prefers flowing water, and although there may not be a surface channel, the steeper slopes and sandy soils, allow for rapid subsurface flow. Thinleaf alder often occurs on areas subject to flooding and high disturbances, however these areas are relatively stable. Thinleaf alder fixes nitrogen, captures fine sediments in its roots during spring sheep flows, and produces copious amounts of leaf litter. These attributes help develop a nutrient rich soil surface. Lemmon's willow is more tolerant to prolonged saturation and will occur in areas with lower slopes, or finer soil textures. Common species in this community component are Columbian monkshood (*Aconitum columbianum*), Pacific onion (*Allium validum*), western columbine (*Aquilegia formosa*), Brewer's bittercress (*Cardamine breweri*), fringed willowherb (*Epilobium ciliatum*), scarlet fritillary (*Fritillaria recurva*), bedstraw (*Galium* sp.), common cowparsnip (*Heracleum maximum*), starry false lily of the valley (*Maianthemum stellatum*), Brewer's miterwort (*Mitella breweri*), seep monkeyflower (*Mimulus guttatus*), woollyhead parsnip (*Sphenosciadium capitellatum*), and fowl mannagrass (*Glyceria striata*).

CC1, Drainageway

The soil for this component has not been developed in NASIS, but pedon data has been collected at several sites, and will be added in the future. The soils have 15 inches of organic horizons over sandy soils below. Taxonomy is Typic Endoaquents. Water features are near the surface, and the soil remains wet throughout most of summer. CC1 is associated with this component.

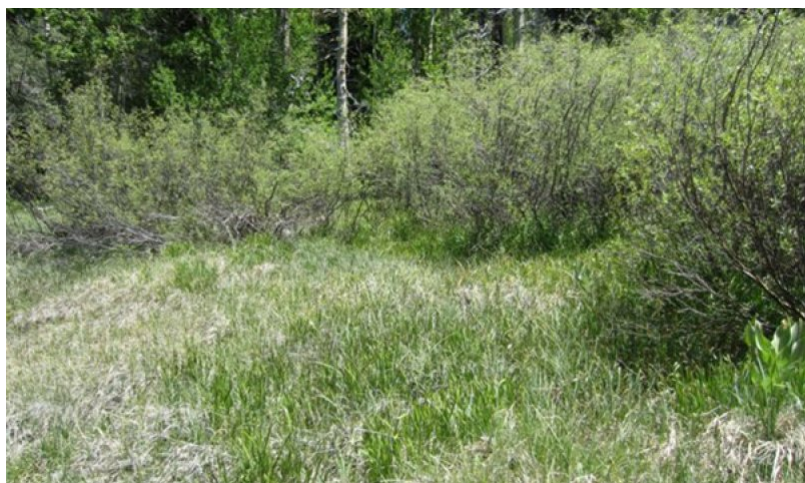
Figure 9. CC2

CC2, Floodplain This community occurs in broader sloping meadows. Recent alluvium may be deposited over older outwash deposits. Lemmon's willow and sedges are dominant, with a diversity of associated species. Geyer willow (*Salix geyeriana*) and shining willow (*Salix lucida*) are occasionally present. Thinleaf alder occurs in patches, or along surface channels. Whitestem gooseberry (*Ribes inerme* var. *inerme*) is present under the canopy of willows, and roundleaf snowberry (*Symphoricarpos rotundifolius*) occurs on the drier meadow edges. This community is heavily dominated by grass and grass-like. Nebraska sedge (*Carex nebrascensis*) is common and often abundant. Other grass grass-like include bentgrass (*Agrostis* sp.), water sedge (*Carex aquatilis*), slenderbeak sedge (*Carex athrostachya*), other sedges (*Carex* spp.), slimstem reedgrass (*Calamagrostis stricta*), nearlyblack sedge (*Carex subnigricans*), Northwest Territory sedge (*Carex utriculata*), blister sedge (*Carex vesicaria*), tufted hairgrass (*Deschampsia cespitosa*), slender hairgrass (*Deschampsia elongata*), fowl mannagrass (*Glyceria striata*), rushes (*Juncus* spp.), straightleaf rush (*Juncus orthophyllus*), and muhly (*Muhlenbergia* sp.). In drier or more disturbed areas brome (*Bromus* sp.), meadow barley (*Hordeum brachyantherum*), squirreltail (*Elymus elymoides*), and Kentucky bluegrass (*Poa pratensis*) increase. Common forbs include common yarrow (*Achillea millefolium*), nettleleaf giant hyssop (*Agastache urticifolia*), Pacific onion, Brewer's angelica (*Angelica breweri*), fireweed

CC2, Floodplain

The Tahoe, gravelly phase (coarse-loamy, mixed, superactive, acid, frigid Cumulic Humaquepts) soil occurs in areas where alluvium has accumulated, forming sloped meadows. This component occurs at the lower elevations of this ecological site. The surface texture is mucky silt loam and subsurface textures are mucky silt loam and gravelly coarse sand. The Tahoe, gravelly phase component is not flooded or ponded to occasionally or flooded or ponded for up to long durations, CC2 is associated with this soil component.

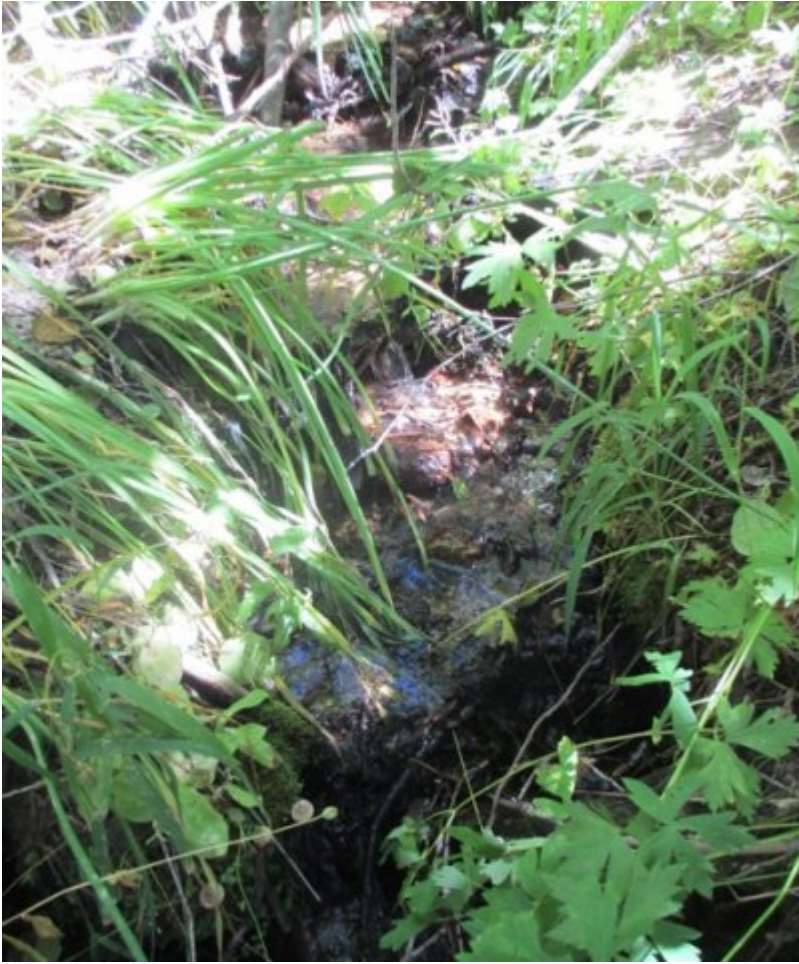
Figure 12. G Channel

This state is an unstable state with an actively eroding gully or G type channel.

This phase has a single or multiple eroded gully-like channels. In some areas small sections of the stream caved in to subsurface channels, eventually connecting to a continuous surface channel. Erosion is evident along the banks. This can be a natural process caused by infrequent large flood events, or by human induced triggers. The effect on the vegetation is as general drying of the meadow, as subsurface flow is intercepted and drained more rapidly from the site. In some cases the water table is lowered by a foot or more. The community composition remains relatively similar, but upland species may replace wetland obligate species as the site becomes drier. CC1, Drainageway This community may remain similar in composition to State 1, since it is in the wettest area, and thinleaf alder may benefit from the increased surface flow. CC2, Floodplain This community will be most impacted by drying conditions. Thinleaf alder may increase along the new gully like channel. The meadow edges may see an increase of upland species such as roundleaf snowberry (*Symphoricarpos rotundifolius*), brome (*Bromus* sp.), meadow barley (*Hordeum brachyantherum*), squirreltail (*Elymus elymoides*), and Kentucky bluegrass (*Poa pratensis*). Forbs such as common yarrow (*Achillea millefolium*), fireweed (*Chamerion angustifolium* ssp. *circumvagum*), Sierra stickseed (*Hackelia nervosa*), slender cinquefoil (*Potentilla gracilis*), arrowleaf ragwort (*Senecio triangularis*), woollyhead parsnip (*Sphenosciadium capitellatum*), western aster (*Symphyotrichum ascendens*), aster (*Symphyotrichum* sp.), Fendler's meadow-rue (*Thalictrum fendleri*), and California false hellebore (*Veratrum californicum*) may increase in place of sedges. Quaking aspen and Sierra lodgepole pine (*Pinus contorta* var. *murrayana*) may increase. CC3, Drainageway margins This community may be unaffected by hydrologic changes in this phase.

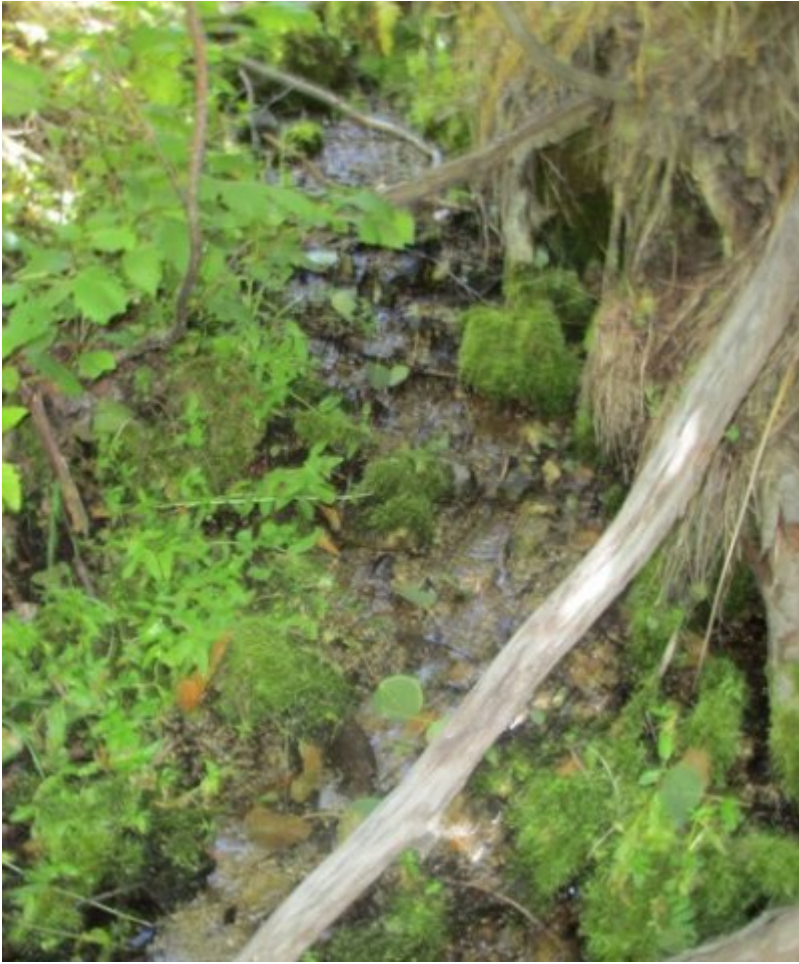
Figure 13. A Channel

This state has a small stable A or Ba type channel. The banks are sloped, and vegetated and stabilized by thinleaf alder or other roots. Moss is common on the banks or gravels and cobbles.

This phase is defined with a stable A or Ba channel type. Due to the confinement of the channel, flooding does not occur on the meadow, CC2. In some areas these meadows may still have a connection to the spring or seep, and maintain high water tables throughout the year. Community composition remains similar to state 1, but CC2 may become drier and dominated by more upland species as identified in State 2.
