Ecological site R022AX105CA Steep Mountain Drainageways

Provisional. A provisional ecological site description has undergone quality control and quality assurance review. It contains a working state and transition model and enough information to identify the ecological site.

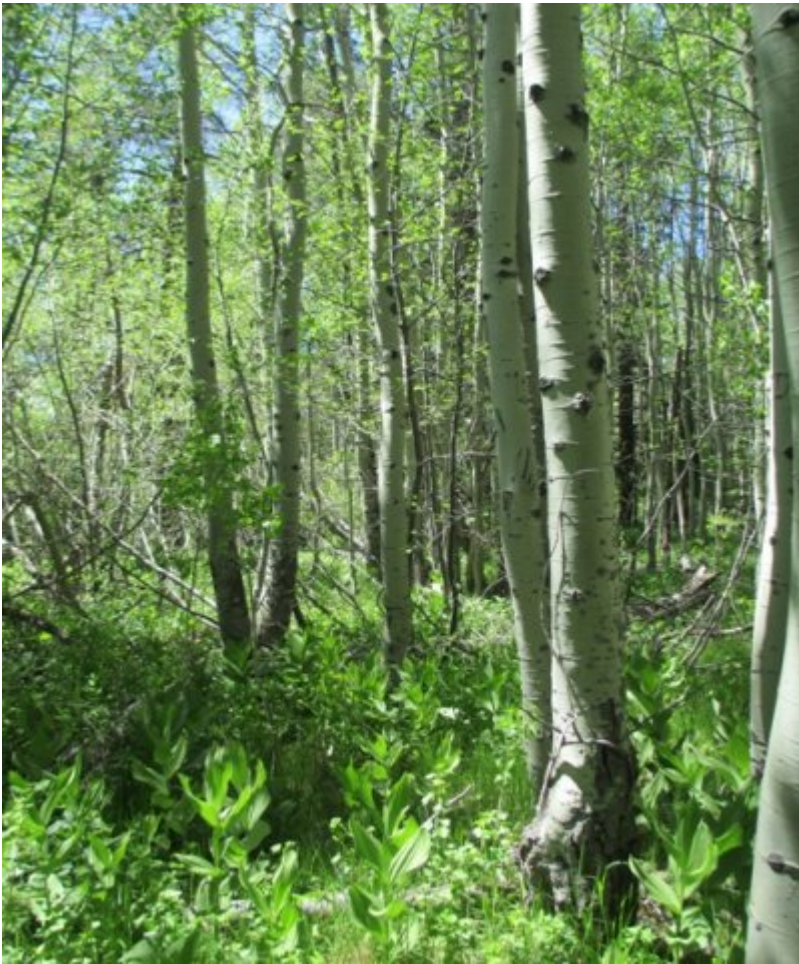
Figure 10. CC3

The dominant soil associated with this site is a higher order component, Aquic Xerorthents. It occurs on the side slopes of small drainageways. The soils have formed in a mix of alluvium and colluvium. The surface texture is sandy loam, with subsurface textures of sandy loam, coarse sandy loam, gravelly sandy loam, loamy coarse sand, and sandy loam. CC3 is associated with this site.
