Ecological site R022BI210CA Frigid Loamy Flood Plains

Major Land Resource Area (MLRA): 022B–Southern Cascade Mountains

State and transition model

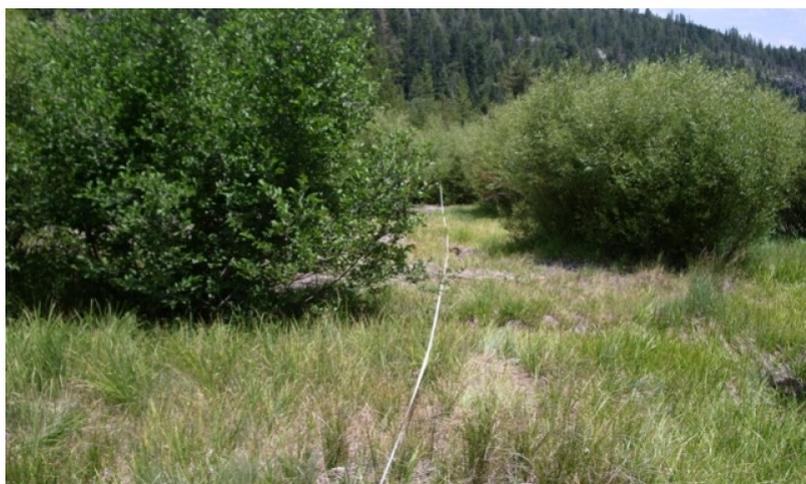
Figure 3. Lemmons Willow-Thinleaf Alder Community

The plant communities along the C channel occur in distinct zones related to variable water table depth and disturbance events. Approximately 45% of the total vegetation is a thinleaf alder community that forms a continuous stringer immediately adjacent to the stream where the water table stays relatively high year round. A mixed thinleaf alder/ Lemmon's willow community occupies the floodplains and accounts for 35% of the total vegetation. This community requires seasonal flooding and a water table that normally remains within 3 feet of the surface. Both thinleaf alder and Lemmon's willow are flood and shade tolerant and act as an important stabilizing component of the streambank. These shrubs produce copious amounts of seeds in the fall and winter and seeds germinate immediately after dispersal when conditions are favorable. Germination and seedling establishment is optimal on exposed mineral substrate. Thinleaf alder may also reproduce vegetatively through spreading underground rhizomes or suckers, but Lemmon's willow does not have this capacity. Both species can re-sprout vigorous following a top cut or fire. Streambanks anchored by these shrubs are stable and can withstand relatively severe spring runoff and flooding. As alder and willow thickets develop after floods finer fluvial deposits are trapped within the extensive root networks, facilitating soil development. In addition, thinleaf alder improves soil fertility through the addition of nitrogen to the soil from nitrogen-fixing root nodules and a nitrogen-rich leaf litter. The improved soil texture and fertility enables establishment and retention of an understory dominated by sedges. The extensive root mats formed by the sedge component further stabilizes the streambank. Drought and flood are the primary forces that drive transitions between alternate community phases. A lower water table from prolonged drought facilitates encroachment of the upland community on the floodplain and an associated reduction in the thinleaf alder/Lemmon's willow community. Conversely, a flood destroys sections of the thinleaf alder community within the active channel and favors establishment of the pioneering native herb community that colonizes recently exposed substrate and provides valuable forage and habitat for wildlife. Plant Community Component (PCC) and Composition: PCC1: 45% - Thinleaf Alder Community: This community is found on the stream banks of the active channel. Data was not collected for this community component, for this state. However, it most likely has similar species as PCC1b, which is present in the constrained C channel in State 3. Thinleaf alder is the dominant shrub, associated species may be squirrel tail (*Elymus elymoides*), paniced bulrush (*Scirpus microcarpus*), common rush (*Juncus effusus*), smallwing sedge (*Carex microptera*), bigleaf sedge (*Carex amplifolia*), swordleaf rush (*Juncus ensifolius*), fowl mannagrass (*Glyceria striata*), bentgrass (*Agrostis* spp.), narrowfruit sedge (*Carex specifica*),

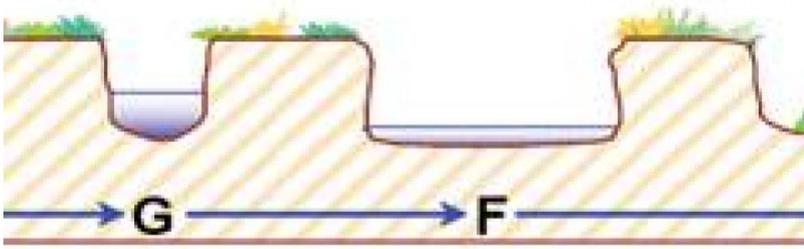
Figure 4. Rosgen Stream Succession Scenario #9

As the “C” type channel in State 1 down-cuts through deposits naturally or as a result of stream bank erosion, an entrenched low gradient “G” type channel develops. This gully-like entrenched channel is unstable and will naturally begin to widen over time into an entrenched “F” type channel. The broadly entrenched “F” type channel allows for sediment deposition, which builds point bars and floodplains with a meandering channel. As riparian vegetation begins to reestablish on the new floodplains, channel stability increases, and an entrenched “C” type channel with a developed floodplain and a meandering channel will eventually develop within the entrenched “F” type channel. This new entrenched “C” type channel may resemble the original “C” type channel with wetland plant communities, but it will be constrained by terraces to the lower floodplain area. The old floodplain becomes a terrace, disconnected from flood events. The terrace has a lower seasonal water table which supports a greater proportion of upland plant communities.

Additional stream classification data is required to determine which channel types are expressed as the C channel evolves in response to disturbance. In a typical succession scenario, the "C" type channel in State 1 down-cuts into an entrenched low gradient "G" type channel that naturally begins to widen over time into an entrenched "F" type channel. The plant community components associated with these possible successional channel types is not known. However, deeply incised "G" and "F" channels generally lose the wetland obligate species and become dominated by upland grass, shrub and/or forest plant communities. As the water table lowers at the site, the adjacent conifer community of Sierra lodgepole and white fir would encroach and reduce the thinleaf alder and mixed willow riparian community. Upland grass species like blue wildrye and western needlegrass would begin to dominate the native herbaceous community.

This transition can occur naturally as the “C” type channel in State 1 down-cuts through the valley bottom. The channel on this site supports cobble-bottom (C3), gravel-bottom (C4), and sand-bottom (C5) reaches which have moderate to very high erosion potentials, respectively. Bank erosion is a natural river adjustment process and can be the result of mass wasting, liquification, freeze-thaw, fluvial entrainment, and ice scour. The glacial outwash and alluvial deposits in the U-shaped valley bottom are gradually eroded through these processes. This transition can also be initiated by a disturbance that alters the hydrology of the site or impacts the vegetation along the stream bank. Alterations that can affect the hydrology of this site include channel realignment and/or confinement, culvert installations, and road construction. Such alterations straightened the channel, eliminating its ability to meander. This increases the shear stress along the stream bank, which accelerates stream bank erosion, thereby increasing sediment supply and decreasing sediment transport capacity. As the channel straightens it has a shorter course down the valley, creating a steeper gradient. The stream may adjust by headcutting into the base level of the channel until it establishes a new gradient through the meadow. As the stream bed is lowered, so is the water table in the meadow. The new larger and steeper channel can contain more flow, reducing the frequency of flooding and the extent of the floodplain, creating terraces. Cattle grazing and/or the seeding of non-native grass for forage can cause a similar entrenchment of the channel but through a different mechanism. When cattle reduce vegetation and trample the exposed stream banks, the resulting erosion also leads to eventual straightening and headcutting of the channel. Likewise, when non-native grasses displace the native riparian sedges and rushes, the stabilizing root mats that help prevent erosion are also removed.

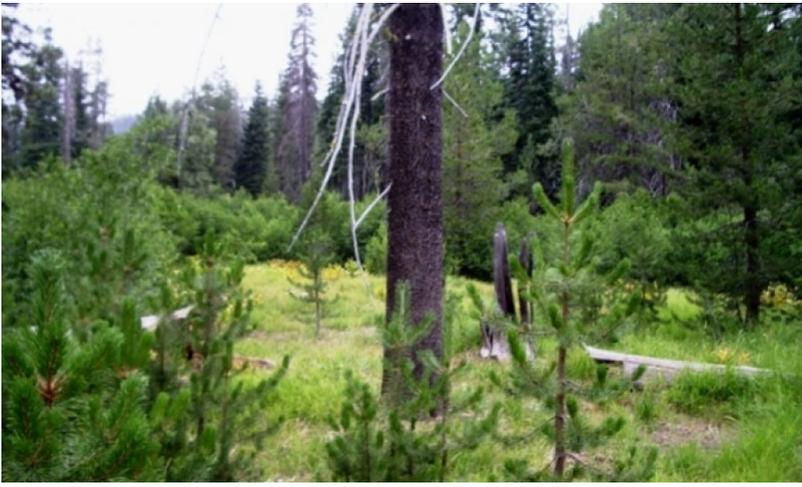
Figure 6. PCC4 encroaching PCC1b

This community phase results from prolonged drought. Drought reduces the water flow in the stream and lowers the seasonal water table. A lower water table facilitates encroachment of the upland Sierra lodgepole pine- white fir forest on the floodplain, and nearly eliminates the thinleaf alder/Lemmon's willow community. Estimate of plant community component composition in this phase: PCC1b: 22% PCC2b: 3% PCC3b: 15% PCC4: 60%
