Ecological site R022BI210CA Frigid Loamy Flood Plains

Major Land Resource Area (MLRA): 022B–Southern Cascade Mountains

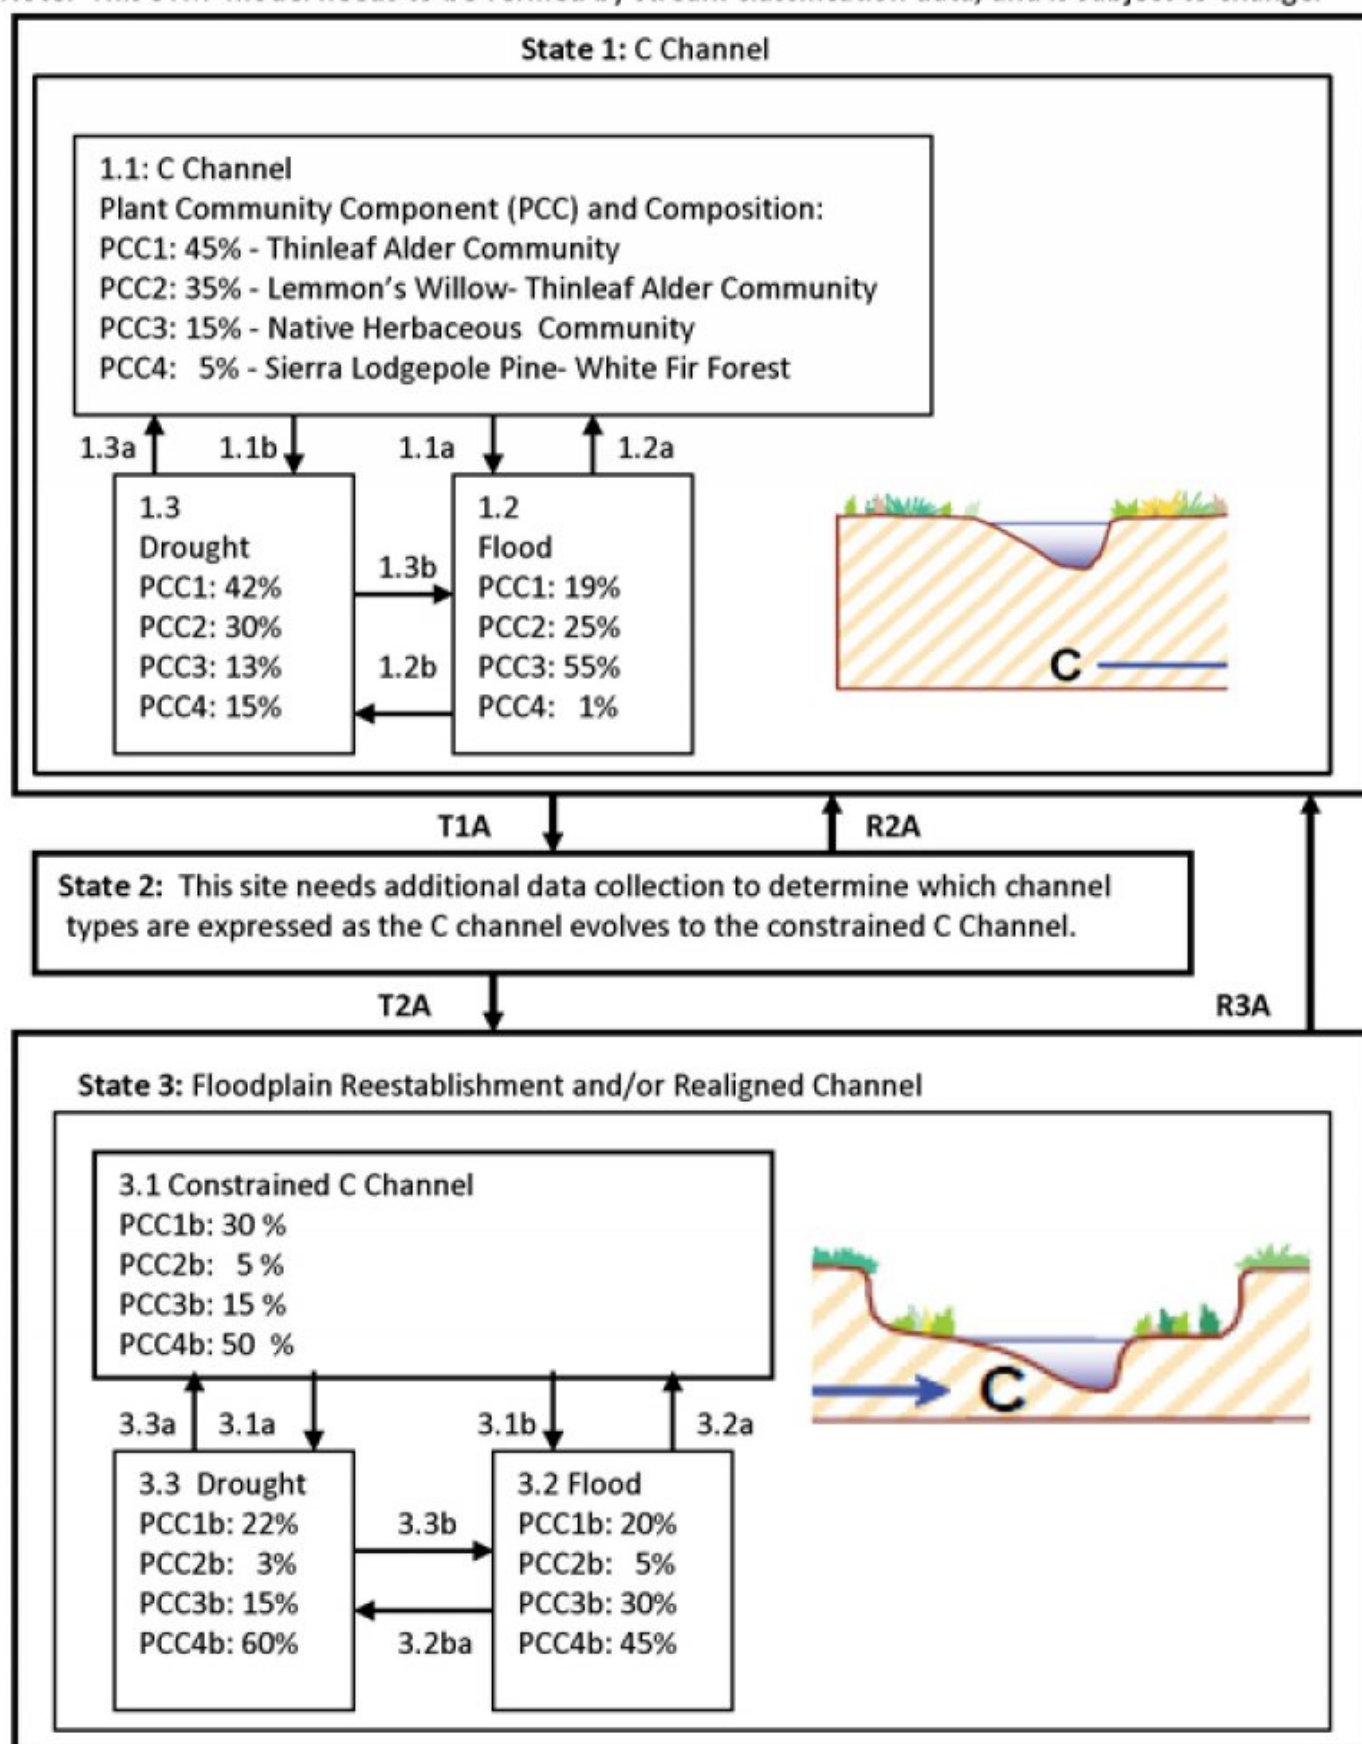
Figure 2. Frigid Loamy Floodplains Model

This ecological site is a complex of riparian plant communities that are interrelated by hydrology. This is a relatively new concept for ecological sites. The state and transition diagram below illustrates the change in plant community component composition as a result of disturbance, rather than focusing on the succession of one plant community. Although there is considerable qualitative experience supporting the pathways and transitions within the State and Transition Model (STM), there is no quantitative information to specifically identify threshold parameters that distinguish between natural equilibrium and altered states in this ecological site. For information on STMs, see the following citations: Bestelmeyer et al. 2003, Bestelmeyer et al. 2009, and Stringham and Shaver 2003.

State 1

This state is a single thread C type channel set in a broad valley bottom with gentle slopes associated with Holocene alluvial deposits. C channels are considered slightly entrenched and have a moderate to high width to depth ratio. Sinuosity is moderate to high, resulting in a well-defined meandering channel. The slope is low gradient and point bar formation and riffle/pool morphology are common features. C channels tend to be wide and shallow with a well-defined floodplain and may have alluvial terraces of abandoned floodplains. Obligate wetland species dominate the site in the undisturbed community phase. A shrub community comprised of thinleaf alder is found on the stream banks of the active channel while a mixed community of thinleaf alder/Lemmon's willow is found on the floodplains. A pioneer plant community of native herbs is found on recently exposed substrate, generally along the stream channel, but may also be found on upper side channels. The adjacent upland habitat is coniferous forest of Sierra lodgepole pine and white fir.

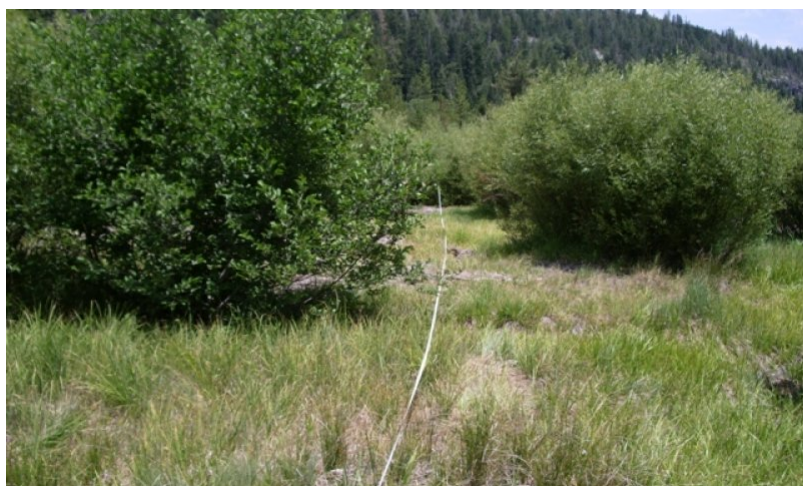
Figure 3. Lemmons Willow-Thinleaf Alder Community

The plant communities along the C channel occur in distinct zones related to variable water table depth and disturbance events. Approximately 45% of the total vegetation is a thinleaf alder community that forms a continuous stringer immediately adjacent to the stream where the water table stays relatively high year round. A mixed thinleaf alder/ Lemmon's willow community occupies the floodplains and accounts for 35% of the total vegetation. This community requires seasonal flooding and a water table that normally remains within 3 feet of the surface. Both thinleaf alder and Lemmon's willow are flood and shade tolerant and act as an important stabilizing component of the streambank. These shrubs produce copious amounts of seeds in the fall and winter and seeds germinate immediately after dispersal when conditions are favorable. Germination and seedling establishment is optimal on exposed mineral substrate. Thinleaf alder may also reproduce vegetatively through spreading underground rhizomes or suckers, but Lemmon's willow does not have this capacity. Both species can re-sprout vigorously following a top cut or fire. Streambanks anchored by these shrubs are stable and can withstand relatively severe spring runoff and flooding. As alder and willow thickets develop after floods finer fluvial deposits are trapped within the extensive root networks, facilitating soil development. In addition, thinleaf alder improves soil fertility through the addition of nitrogen to the soil from nitrogen-fixing root nodules and a nitrogen-rich leaf litter. The improved soil texture and fertility enables establishment and retention of an understory dominated by sedges. The extensive root mats formed by the sedge component further stabilizes the streambank. Drought and flood are the primary forces that drive transitions between alternate community phases. A lower water table from prolonged drought facilitates encroachment of the upland community on the floodplain and an associated reduction in the thinleaf alder/Lemmon's willow community. Conversely, a flood destroys sections of the thinleaf alder community within the active channel and favors establishment of the pioneering native herb community that colonizes recently exposed substrate and provides valuable forage and habitat for wildlife. Plant Community Component (PCC) and Composition: PCC1: 45% - Thinleaf Alder Community: This community is found on the stream banks of the active channel. Data was not collected for this community component, for this state. However, it most likely has similar species as PCC1b, which is present in the constrained C channel in State 3. Thinleaf alder is the dominant shrub, associated species may be squirrel tail (*Elymus elymoides*), paniced bulrush (*Scirpus microcarpus*), common rush (*Juncus effusus*), smallwing sedge (*Carex microptera*), bigleaf sedge (*Carex amplifolia*), swordleaf rush (*Juncus ensifolius*), fowl mannagrass (*Glyceria striata*), bentgrass (*Agrostis* spp.), narrowfruit sedge (*Carex specifica*),

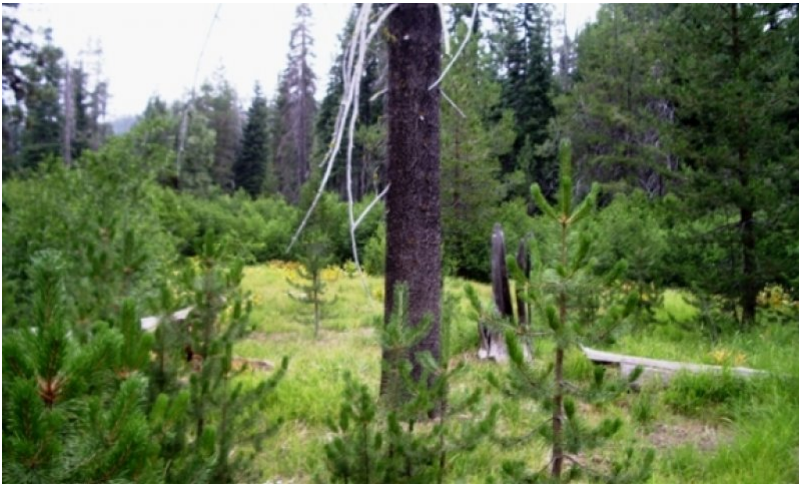
Figure 6. PCC4 encroaching PCC1b

This community phase results from prolonged drought. Drought reduces the water flow in the stream and lowers the seasonal water table. A lower water table facilitates encroachment of the upland Sierra lodgepole pine- white fir forest on the floodplain, and nearly eliminates the thinleaf alder/Lemmon's willow community. Estimate of plant community component composition in this phase: PCC1b: 22% PCC2b: 3% PCC3b: 15% PCC4: 60%
