Ecological site R022BI213CA **Frigid Sandy Flood Plains**

Major Land Resource Area (MLRA): 022B–Southern Cascade Mountains

R022BI213CA-Frigid Sandy Flood Plains

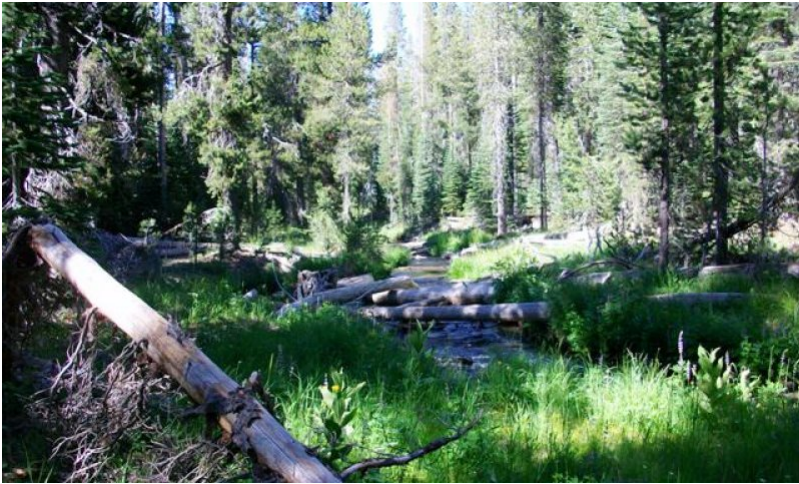
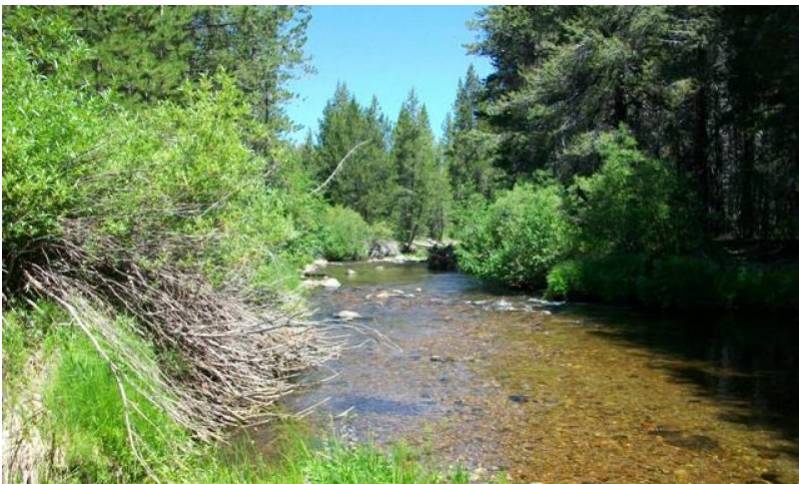
Figure 4. Sandy Flood Plains 2

This state is a single thread B type channel found on the deep, coarse volcanic deposits erupted from Lassen Peak or in alluvium. B channels are considered moderately entrenched and have a moderate to high width to depth ratio. Sinuosity is moderate, resulting in a riffle-dominated channel with infrequently spaced scour pools. B type channels are sediment-limited systems but this site supports unstable gravel-bottom (B4) and sand bottom (B5) reaches that have high erosion potential. The sensitivity to disturbance is high for both B4 and B5 types and vegetation exerts a moderate controlling influence on stream dynamics. Obligate wetland species dominate the site in the undisturbed community phase. A shrub community of thinleaf alder/ willow is found on the stream banks of the active channel and the floodplain. A pioneer plant community of native herbs is found on recently exposed substrate, generally along the stream channel, but may also be found on upper side channels. The adjacent upland habitat is coniferous forest of Sierra lodgepole pine.

The plant community along the B channel occurs in distinct zones related to variable water table depth and disturbance events. Approximately 65% of the total vegetation is a thinleaf alder/willow community that forms a continuous stringer immediately adjacent to the stream where the water table stays relatively high year round. Both thinleaf alder and Lemmon's willow are flood and shade tolerant and act as an important stabilizing component of the streambank. These shrubs produce copious amounts of seeds in the fall and winter and seeds germinate immediately after dispersal when conditions are favorable. Germination and seedling establishment is optimal on exposed mineral substrate. Thinleaf alder may also reproduce vegetatively through spreading underground rhizomes or suckers, but Lemmon's willow does not have this capacity. Both species can re-sprout vigorous following a top cut or fire. Streambanks anchored by these shrubs are stable and can withstand relatively severe spring runoff and flooding. As alder and willow thickets develop after floods finer fluvial deposits are trapped within the extensive root networks, facilitating soil development. In addition, thinleaf alder improves soil fertility through the addition of nitrogen to the soil from nitrogen-fixing root nodules and a nitrogen-rich leaf litter. The improved soil

texture and fertility enables establishment and retention of an understory dominated by sedges. The extensive root mats formed by the sedge component further stabilizes the streambank. Drought and flood are the primary forces that drive transitions between the alternate community phases. A lower water table from prolonged drought facilitates encroachment of the upland community on the floodplain and an associated reduction in the thinleaf alder/ willow community. Conversely, a flood destroys sections of the riparian shrub community within the active channel and favors establishment of the pioneering native herb community that colonizes recently exposed substrate and provides valuable forage and habitat for wildlife. Plant Community Component (PCC) and Composition: PCC1: (65%)- Thinleaf Alder-Willow Community This is the plant community along the banks. Thinleaf alder (*Alnus incana* ssp. *tenuifolia*) is the most common shrub but Lemmon's willow (*Salix lemmonii*) and shining willow (*Salix lucida*) are occasionally present. Sedge (*Carex* spp.), willowherb (*Epilobium* spp.), fowl mannagrass (*Glyceria striata*), and field horsetail (*Equisetum arvense*) are present as well as scattered forbs listed in PCC2. PCC2: (20%)-Native Herbaceous Community This Plant community is found on point bars and floodplains. Common species are common yarrow (*Achillea millefolium*), Idaho bentgrass (*Agrostis idahoensis*), pearly everlasting (*Anaphalis margaritacea*), rosy pussytoes (*Antennaria rosea*), aster (*Aster* sp.), sedge (*Carex* sp.), cryptantha (*Cryptantha* sp.), slender hairgrass (*Deschampsia elongata*), squirreltail (*Elymus elymoides*), blue wildrye (*Elymus glaucus*), field horse tail (*Equisetum arvense*), meadow barley (*Hordeum brachyantherum*), rush (*Juncus* sp.), mountain rush (*Juncus articus* ssp. *littoralis*), dwarf mountain ragwort (*Senecio fremontii*), and cinquefoil (*Potentilla* spp.). PCC 3: (15%)- Sierra Lodgepole Pine Forest This moist lodgepole pine forest is present on rarely flooded floodplain. Sierra lodgepole pine (*Pinus contorta* ssp. *murrayana*) is dominant and provides 15-45 percent cover over a grassy understory. Some of the species listed in PCC2 are also in the understory. Common plants are western needlegrass (*Achnatherum occidentale*), California brome (*Bromus carinatus*), squirreltail (*Elymus elymoides*), blue wildrye (*Elymus glaucus*), (*Eriogonum pyrolifolium*), groundsmoke (*Gayophytum* sp.), meadow barley (*Hordeum brachyantherum*), (mountain rush (*Juncus articus* ssp. *littoralis*), Pacific lupine (*Lupinus lepidus*), bearded melicgrass (*Melica aristata*), and gooseberry (*Ribes* sp.).

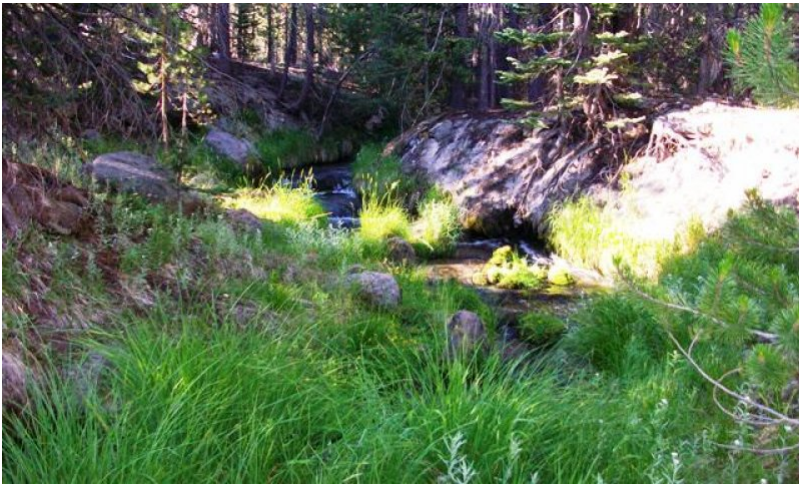
Figure 7. Transitional Stream Channel

B type channels can become unstable due to disturbances which impact the stream bank vegetation, change the flow regime, or alter the channel morphology. Overgrazing and excessive trampling by livestock can seriously reduce streambank stability. Additional stream classification data is required to determine which channel types are expressed as the B channel evolves in response to disturbance. Continued disturbance can entrench the stream. The Rosgen Stream Succession Scenario #6 diagram is displayed below. In this possible succession scenario, the “B” type channel in State 1 down-cuts into an entrenched low gradient “G” type channel that naturally begins to widen over time into an entrenched “Fb” type channel. The plant community components associated with these possible successional channel types is not known. However, deeply incised “G” and “Fb” channels generally lose the wetland obligate species and become dominated by upland grass, shrub and/or forest plant communities. As the water table lowers at the site, the adjacent conifer community of Sierra lodgepole pine and white fir would encroach and reduce the thinleaf alder and mixed willow riparian community. Upland grass species like blue wildrye and western needlegrass would begin to dominate the native herbaceous community. Eventually, a new entrenched “B” type channel may form that resembles the original “B” type channel. The entrenched channel still supports some wetland plant communities but it is constrained by terraces which have a upland plant communities.

This transition can occur naturally as the “B” type channel in State 1 down-cuts through the deep coarse volcanic deposits erupted from Lassen Peak. The channel on this site supports gravel-bottom (B4), and sand bottom (B5) reaches which have high erosion potentials. Bank erosion is a natural river adjustment process and can as the result of mass wasting, liquification, freeze-thaw, fluvial entrainment, and ice scour. The coarse colluvial and alluvial deposits in the valley bottom are gradually eroded through these processes. This transition can be initiated by a disturbance that alters the hydrology of the site including channel realignment and/or confinement, culvert installations, and road construction. Such alterations straightened the channel, eliminating its ability to meander. This increases the shear stress along the stream bank, which accelerates stream bank erosion, thereby increasing sediment supply and decreasing sediment transport capacity. As the channel straightens it has a shorter course down the valley, creating a steeper gradient. The stream may adjust by headcutting into the base level of the channel until it establishes a new gradient through the meadow. As the stream bed is lowered, so is the water table

in the meadow. The new larger and steeper channel can contain more flow, reducing the frequency of flooding and the extent of the floodplain, creating terraces. Disturbances such as cattle grazing and/or the seeding of non-native grass for forage that impacts the vegetation along the stream bank can cause a similar entrenchment of the channel but through a different mechanism. When cattle reduce vegetation and trample the exposed stream banks, the resulting erosion also leads to eventual straightening and headcutting of the channel. Likewise, when non-native grasses displace the native riparian sedges and rushes, the stabilizing root mats that help prevent erosion are also removed.

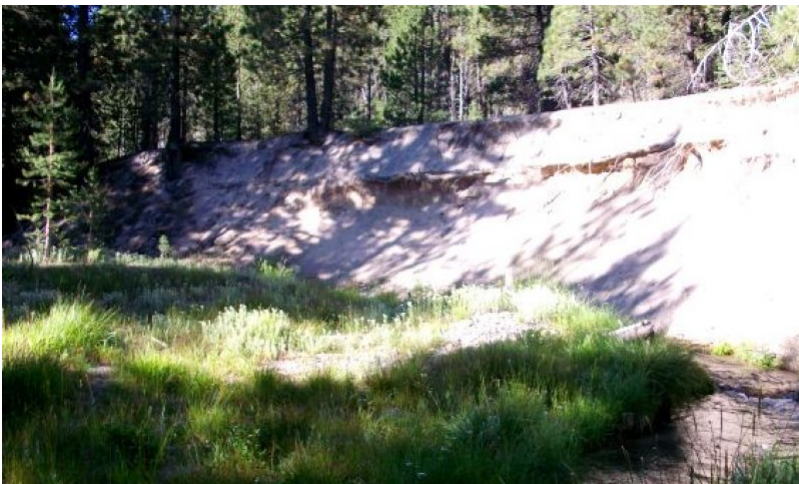
Figure 8. Constrained B Channel

The constrained B Channel on this ecological site has further downcut through the deep, coarse volcanic deposits erupted from Lassen Peak. As sediment deposition in the broadly entrenched “F” type channel continued, the vegetation increases channel stability and eventually channel sinuosity returns and a new meandering channel will develop that has similar morphological features of the original B channel but is constrained by the old floodplain, which is now a hydrologically disconnected dry terrace. The obligate wetland species that dominate the site in the undisturbed community phase, have been reduced under the drier conditions, so that the riparian shrub community of thinleaf alder/ willow along the stream banks of the active channel now occupies only 20% of the total vegetation. The pioneer plant community of native herbs persists on recently exposed substrate, but may have more non-natives and a greater proportion of upland grasses than sedges. The adjacent upland Sierra lodgepole pine and mixed conifer forest is now the dominate vegetation.

The constrained B channel has similar morphological features of the original B channel, but the floodplain is now a hydrologically disconnected dry terrace. The water table is much lower and the adjacent upland Sierra lodgepole pine and mixed conifer forest is now the dominate vegetation. This community phase has the three plant community components of Community Phase 1.1, but the species composition has changed to include non-native species such as Kentucky bluegrass (*Poa pratensis*), common dandelion (*Taraxicum officinale*), common mullein (*Verbascum thapsus*), and rat-tail fescue (*Vulpia myuros*). The proportion of these community components has also shifted as the stream channel incised through the debris flow or glacial deposits, creating a dry terrace that supports much more upland forest (PCC4). The riparian communities are now confined to a smaller area within the new floodplain

so that the thinleaf alder community/willow (PCC1b) now occupies only 20% of the total vegetation and the herbaceous community (PCC2b) comprises only 10%. The sedges along the channel have been replaced by grasses because of lower water tables. The Sierra lodgepole pine forest (PCC3b) occupies more area on the dry terrace and the adjacent White Fir-Jeffrey Pine Forest (PCC4) has encroached so that upland vegetation may eventually occupy 70% of the formerly riparian vegetation. PCC1b: (20%) - Thinleaf Alder-Willow Community This plant community along exist along the active stream banks. Thinleaf alder (*Alnus incana* ssp. *tenuifolia*) is the most common shrub but Lemmon's willow (*Salix lemmonii*) and shining willow (*Salix lucida*) are occasionally present. Sedge (*Carex* spp.), willowherb (*Epilobium* spp.), fowl mannagrass (*Glyceria striata*), and field horsetail (*Equisetum arvense*) are present as well as scattered forbs listed in PCC2b. PCC2b: (10%) - Herbaceous Community This plant community is found on point bars and floodplains. Common species are common yarrow (*Achillea millefolium*), Idaho bentgrass (*Agrostis idahoensis*), pearly everlasting (*Anaphalis margaritacea*), rosy pussytoes (*Antennaria rosea*), aster (*Aster* sp.), sedge (*Carex* sp.), cryptantha (*Cryptantha* sp.), slender hairgrass (*Deschampsia elongata*), squirreltail (*Elymus elymoides*), blue wildrye (*Elymus glaucus*), field horse tail (*Equisetum arvense*), meadow barley (*Hordeum brachyantherum*), rush (*Juncus* sp.), mountain rush (*Juncus articus* ssp. *littoralis*), dwarf mountain ragwort (*Senecio fremontii*), and cinquefoils (*Potentilla* spp.). PCC3b: (35%) - Sierra Lodgepole Pine Forest This moist lodgepole pine forest is present on upper floodplains or low terraces. Sierra lodgepole pine (*Pinus contorta* ssp. *murrayana*) is dominant and provides 15-45 percent cover over a grassy understory. Some of the species listed in PCC2b are also in the understory. Common plants are western needlegrass (*Achnatherum occidentale*), California brome (*Bromus carinatus*), squirreltail (*Elymus elymoides*), blue wildrye (*Elymus glaucus*), (*Eriogonum pyrolifolium*), groundsmoke (*Gayophytum* sp.), meadow barley (*Hordeum brachyantherum*), mountain rush (*Juncus articus* ssp. *littoralis*), Pacific lupine (*Lupinus lepidus*), bearded melicgrass (*Melica aristata*), and gooseberry (*Ribes* sp.) PCC4: (35%) - White fir-Jeffrey Pine Forest This forest community is present on upper terraces. It is dominated by white fir (*Abies concolor*) and Jeffrey pine (*Pinus jeffreyi*), with some Sierra lodgepole pine (*Pinus contorta* ssp. *murrayana*). The understory has moderate cover of grasses and forbs. Common plants are western needlegrass (*Achnatherum occidentale*), California brome (*Bromus carinatus*), squirreltail (*Elymus elymoides*), groundsmoke (*Gayophytum* sp.), and Kentucky bluegrass (*Poa pratensis*). Once this community has established on the terraces, it is less involved with the riparian stream dynamics and more influenced by forest dynamics which involve forest pathogens and fire. Please refer to the White Fir-Jeffrey Pine Ecological Site Description (F022BI103CA) or the Jeffrey pine- Fir Forest Ecological Site Description (F022BI106CA) for more information regarding forest dynamics and succession. At higher elevations California red fir replaces white fir on this landscape position (F022BI115CA). A Quaking aspen (*Populus tremuloides*)- Sierra lodgepole pine (*Pinus contorta* ssp. *murrayana*) ecological site (F022BI105CA) is adjacent to the riparian corridor at lower elevations on broad valleys. The production data in the table below is a compilation of all the community types. ESIS does not currently support multiple tables for several community types in one phase. To identify species by plant community component refer to the narrative above rather than the table.

This transition occurs when continued sediment deposition in the broadly entrenched “Fb” type channel allows riparian vegetation to reestablish on the new floodplain. The vegetation increases channel stability and eventually channel sinuosity returns creating a new “B” type channel that is more entrenched and constrained than the original “B” channel.
