# Ecological site R022BI215CA Frigid Gravelly Flood Plains

Major Land Resource Area (MLRA): 022B–Southern Cascade Mountains

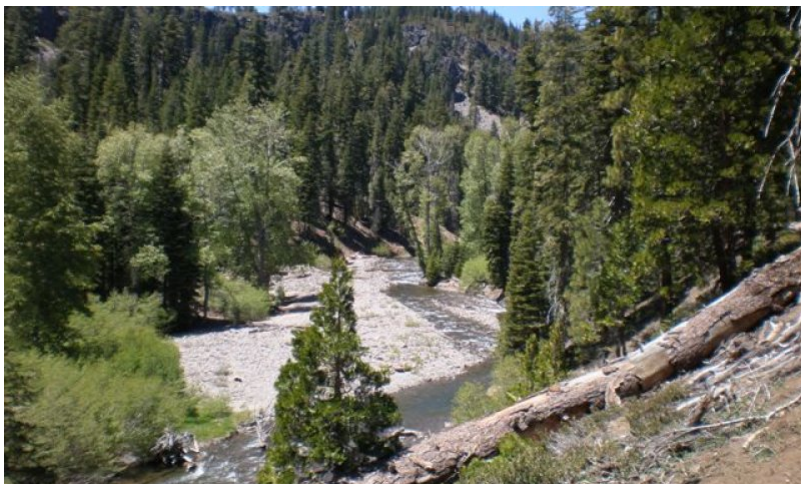
**Figure 4. Gravelly Flood Plains, Kings Creek**

This C Channel has re-established a floodplain and natural sinuosity. It is constrained by the old flood plain, which is now a hydrologically disconnected terrace.
