Ecological site R034AA010UT

Riparian Complex Perennial Gravelly VIII/E4 (Geyers Willow/Northwest Territory Sedge)

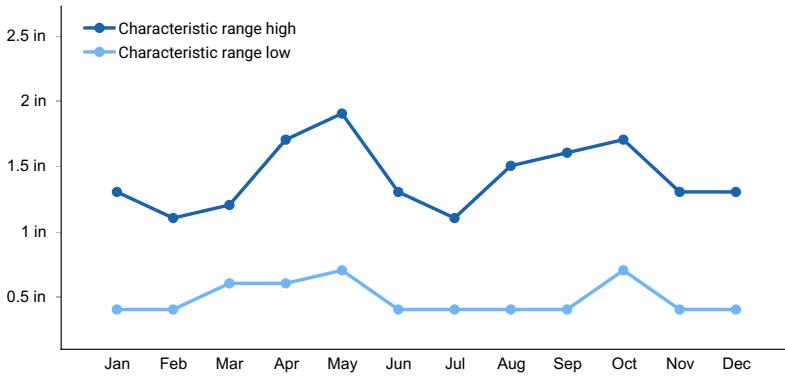
Figure 1. Monthly precipitation range

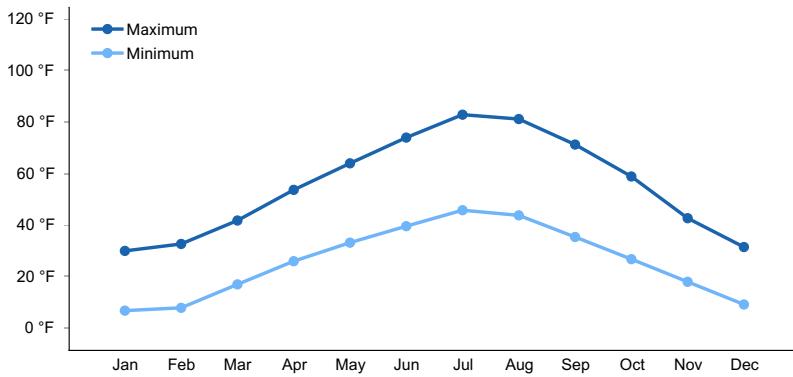
Figure 2. Monthly average minimum and maximum temperature

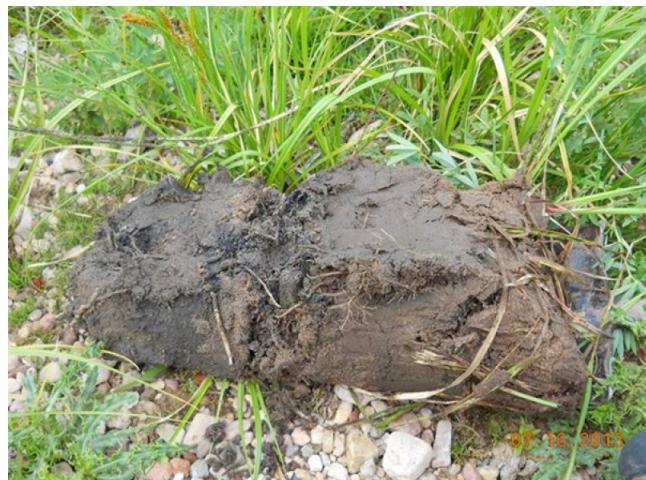
Figure 3. Point bar/streambank soil core

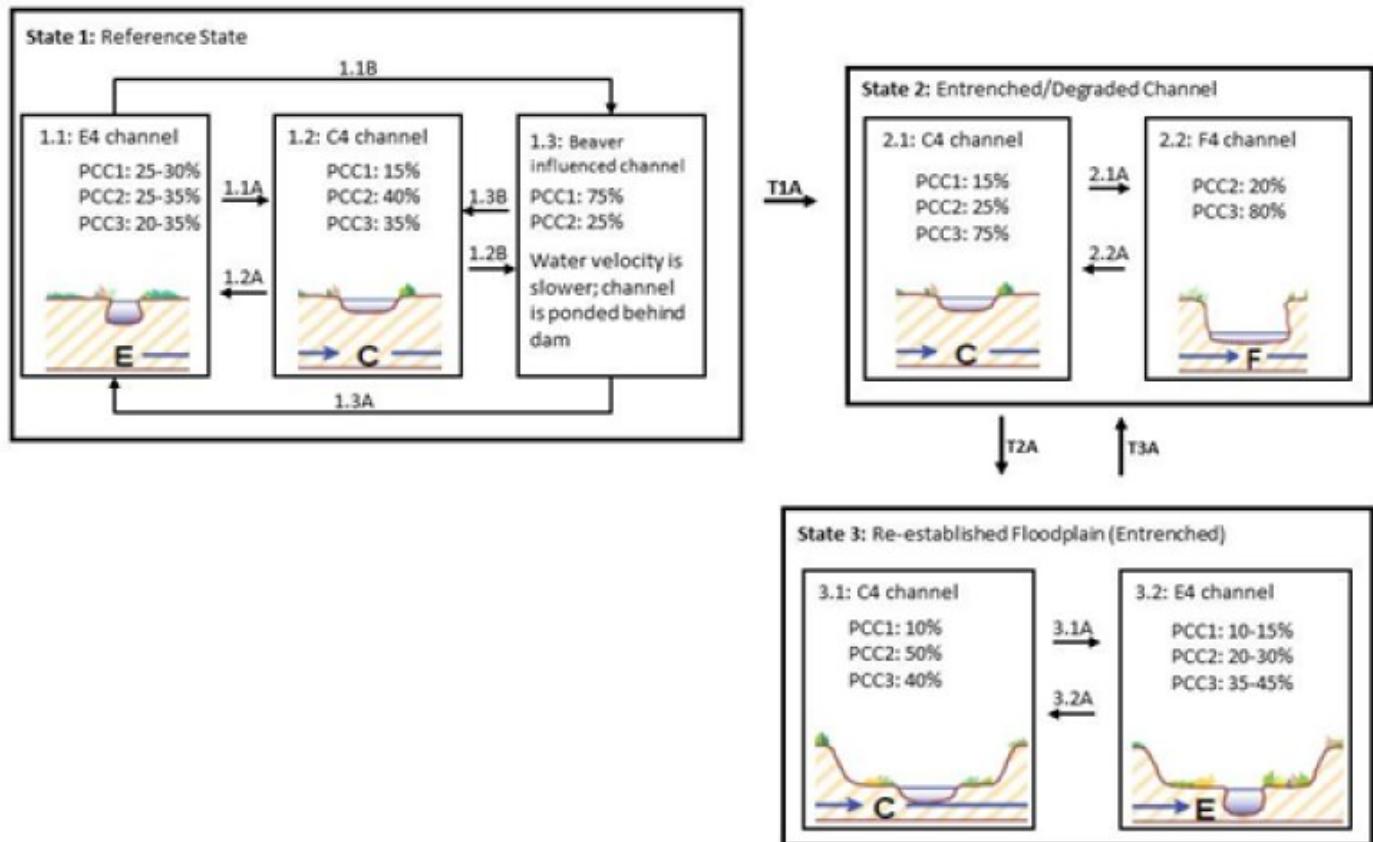
Figure 4. State and Transition Model for R034AA010UT

Notes (not all possible states and phases of all reaches are shown. Refer to narratives for descriptions):

- This site was only observed and sampled on 1 stream
- Wide alluvial valley (Rosgen type VIII), perennial flow, high stream sinuosity and low slope
- 3 fluvial surfaces and 3 plant community components

- Channel is stabilized by deep-rooted, rhizomatous graminoids, willows, or a combination of both
- Community pathway 1.1A may occur with above average flooding or native ungulate grazing

- Community pathway 1.2A can occur from increased bank stabilizing vegetation, decreasing channel width
- TIA can occur from continued lack of bank stabilizing floodplain vegetation and bank disturbance

- Beaver dams can be found on this site in State 1 and 3. Presence of beaver dams drastically change the channel morphology and hydrology by widening the riparian area and slowing water to create more aquatic habitat

- States are influenced by channel disturbance, alteration of stream bank vegetation and lack of beaver.

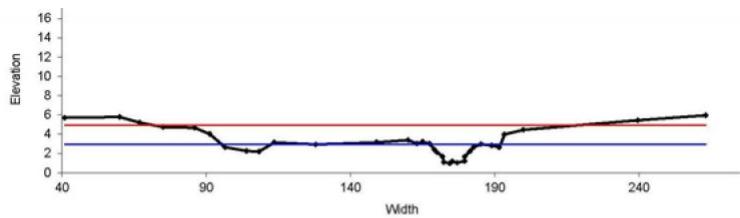
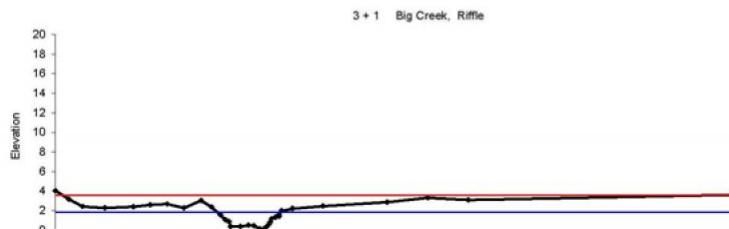
Figure 7. Representative stream cross sections.

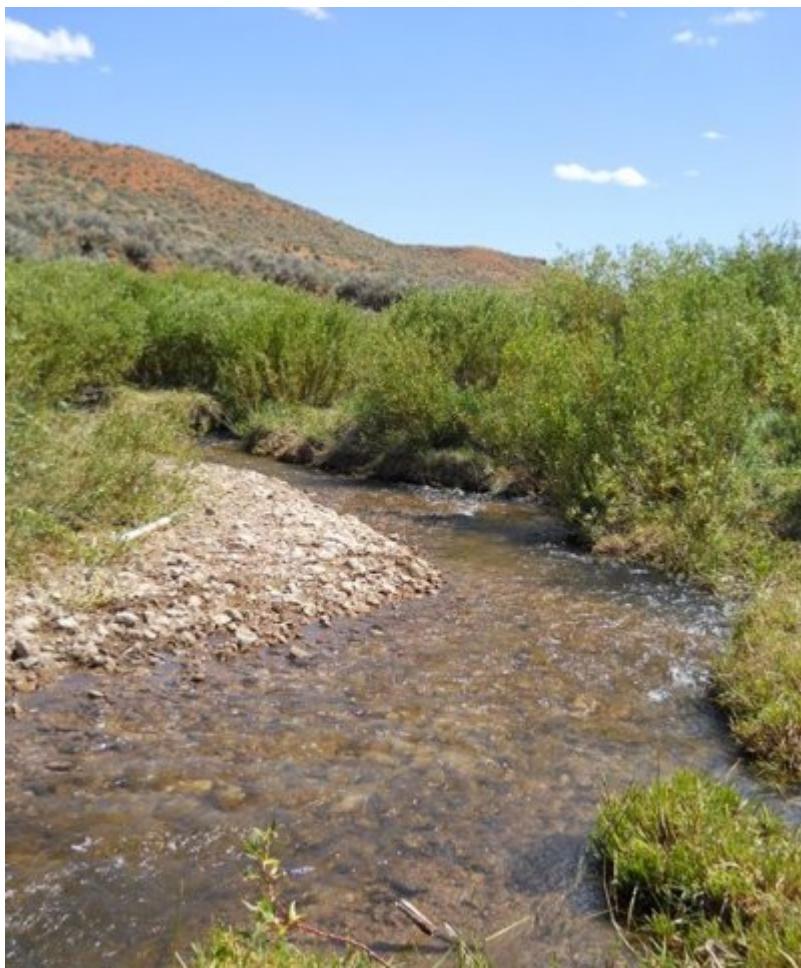
Figure 13. C4 Channel with shrubs in PCC1

This phase has a slightly wider channel and more deposition and erosion occurring around the meander bends. This phase may occur after large floods or may occur after beaver dam failure, which leaves sediment accumulated behind a dam exposed to be colonized by plants or eroded. All plant community components may be present in this phase.

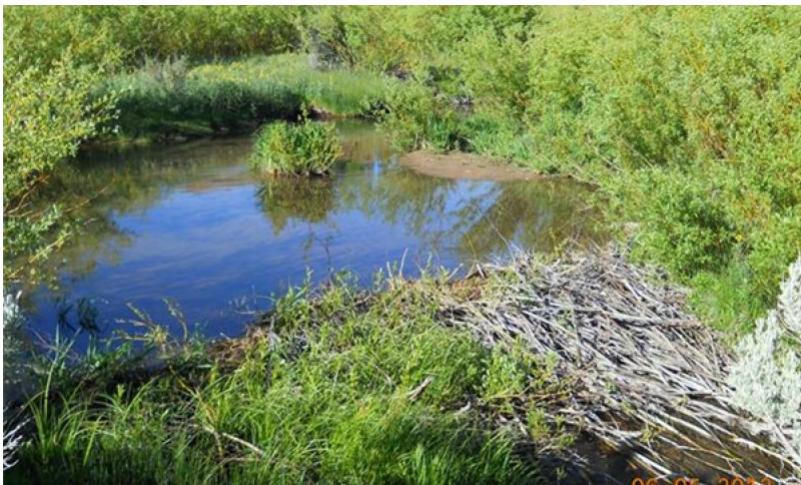
Figure 14. Stream channel impounded behind beaver dam

This phase is characterized by beaver activity that includes dams and foraging. Damming can create ponded water upstream and temporarily alter the hydrology of the system. This can create a wetter environment where more obligate wetland species may occur. Plant community components included in this phase are the sedge/willow and the graminoid/forb communities. Plant community component 3, graminoid/willow, may be present in this site, but often with beaver dams, the higher water table creates an environment that is not as suitable for willows.

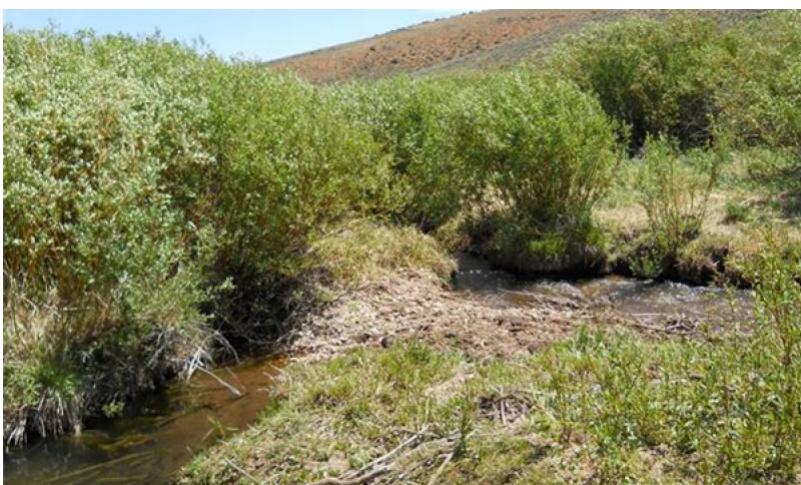
Figure 15. Small beaver dam

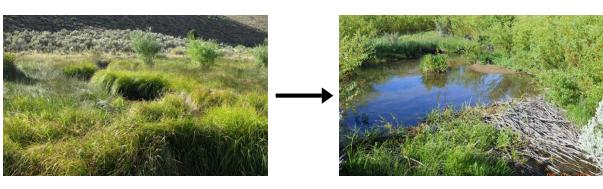
Beaver activity, beaver dam

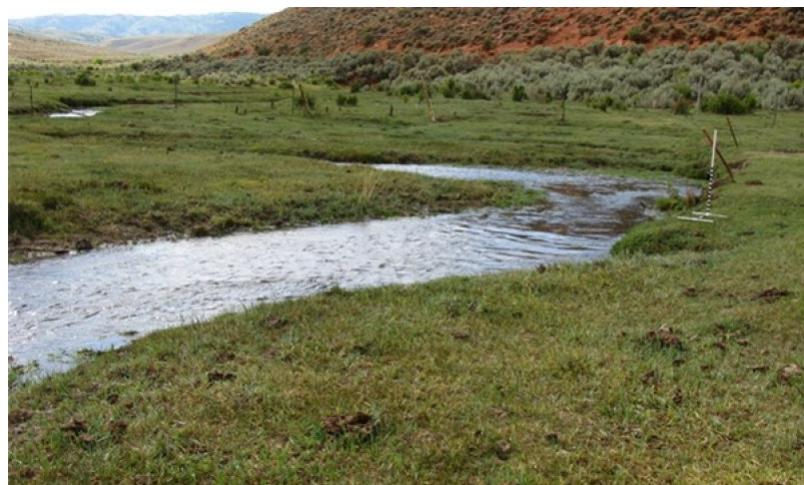
Figure 16. Grazed C4 channel with little willows or sedges re

This phase has a shift in vegetation composition in all plant community components. Northwest territory sedge is often missing from PCC1 and is replaced by other graminoids that may not have the same root structure and bank holding capability of sedges.

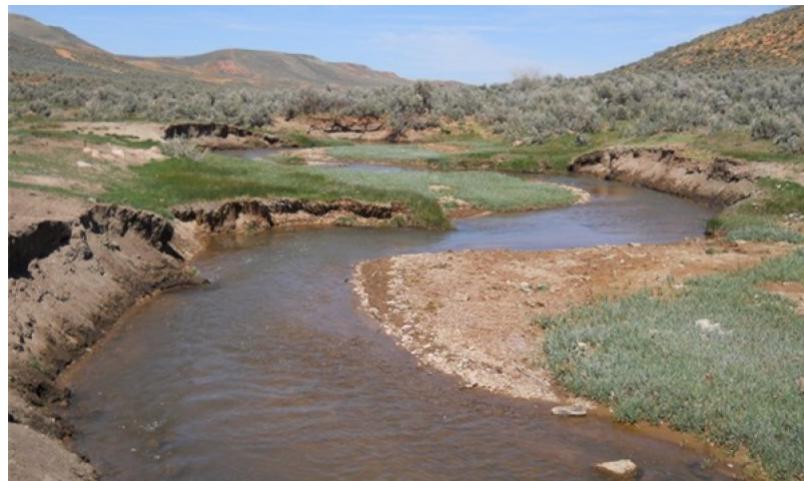
Figure 17. Downcut C4 channel with deposition on pointbars th

This phase is similar to 1.2.

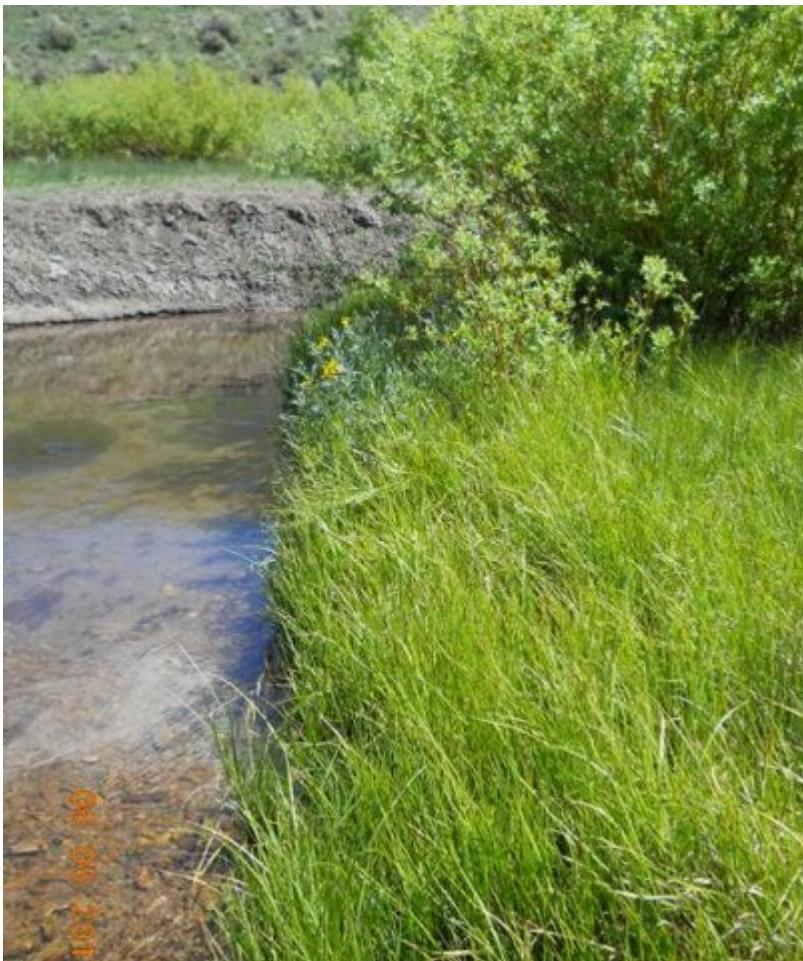
Figure 18. PCC1 established after downcutting.

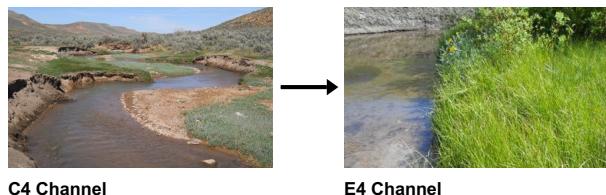
Vegetation re-establishment

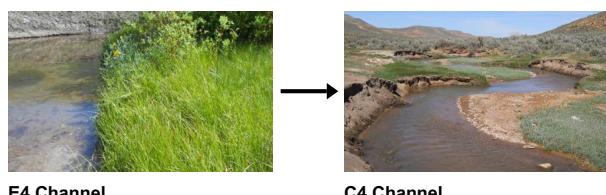
Flooding results in sediment deposition and erosion and scouring of vegetation on stream banks around meanders or removal of vegetation from native ungulate grazing
