Ecological site R034AA010UT

Riparian Complex Perennial Gravelly VIII/E4 (Geyers Willow/Northwest Territory Sedge)

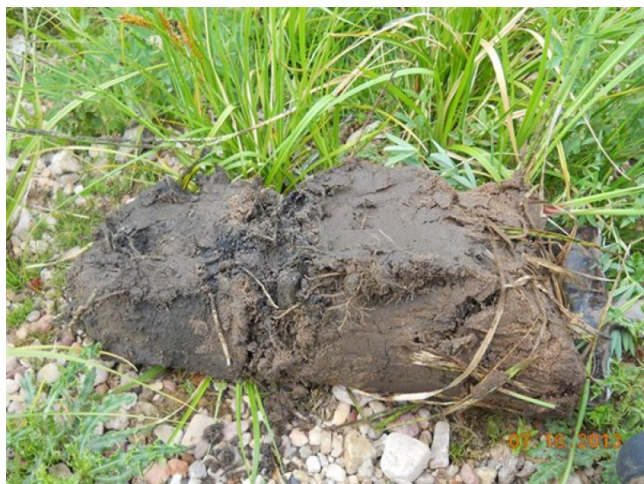
Figure 3. Point bar/streambank soil core

Soils are typically variable in stream valley bottoms because of the stream sediment deposition on flood plains and throughout the valley bottom as the channel naturally migrates. Soils on this site range from sandy to loamy on the surface. Point bars are typically sandy to very gravelly sand, flood plains and flood-plain steps are typically loamy. Sand and gravel lenses throughout the profile are common on all fluvial surfaces. Buried A horizons are also typically on fluvial influenced soils. The typical fluvial surfaces found on this site are point bars, flood plains and flood-plain steps. The tables below represent the variability between all fluvial surfaces

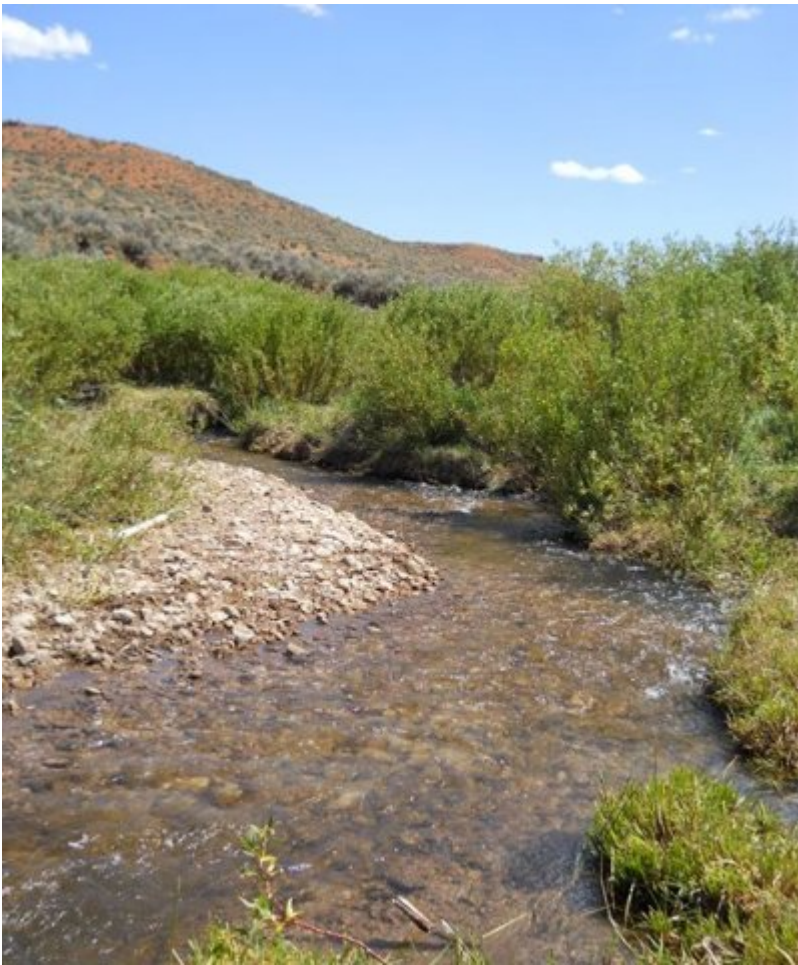
Figure 13. C4 Channel with shrubs in PCC1

This phase has a slightly wider channel and more deposition and erosion occurring around the meander bends. This phase may occur after large floods or may occur after beaver dam failure, which leaves sediment accumulated behind a dam exposed to be colonized by plants or eroded. All plant community components may be present in this phase.

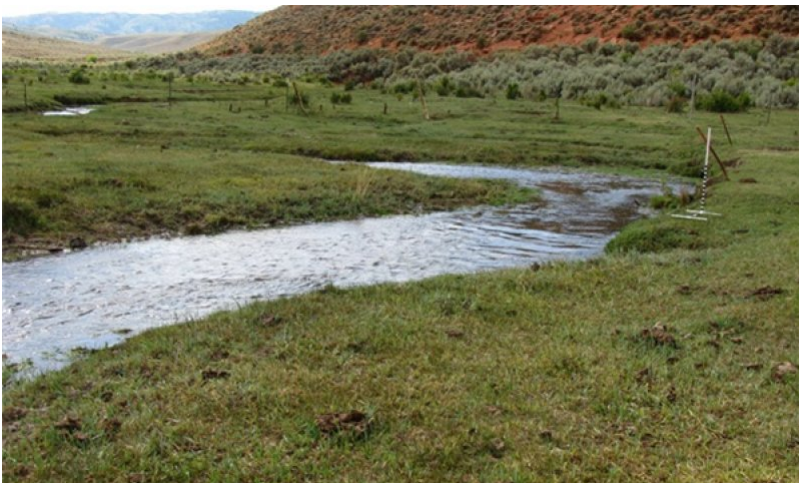
Figure 16. Grazed C4 channel with little willows or sedges re

This phase has a shift in vegetation composition in all plant community components. Northwest territory sedge is often missing from PCC1 and is replaced by other graminoids that may not have the same root structure and bank holding capability of sedges.

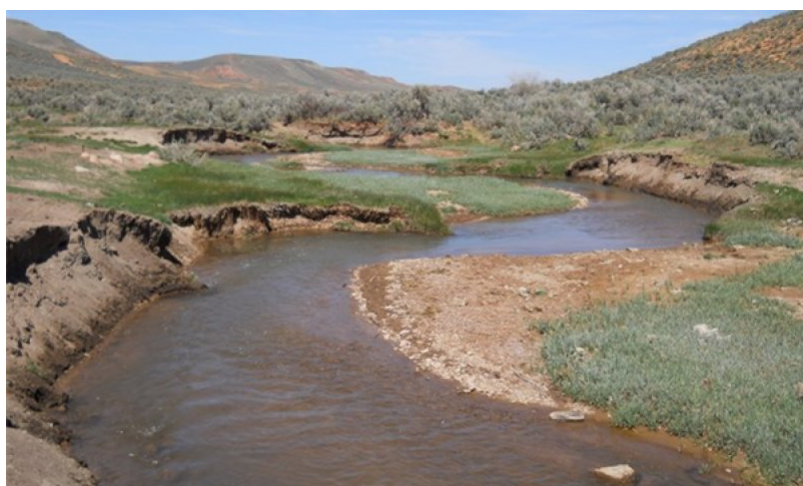
Figure 17. Downcut C4 channel with deposition on pointbars th

This phase is similar to 1.2.

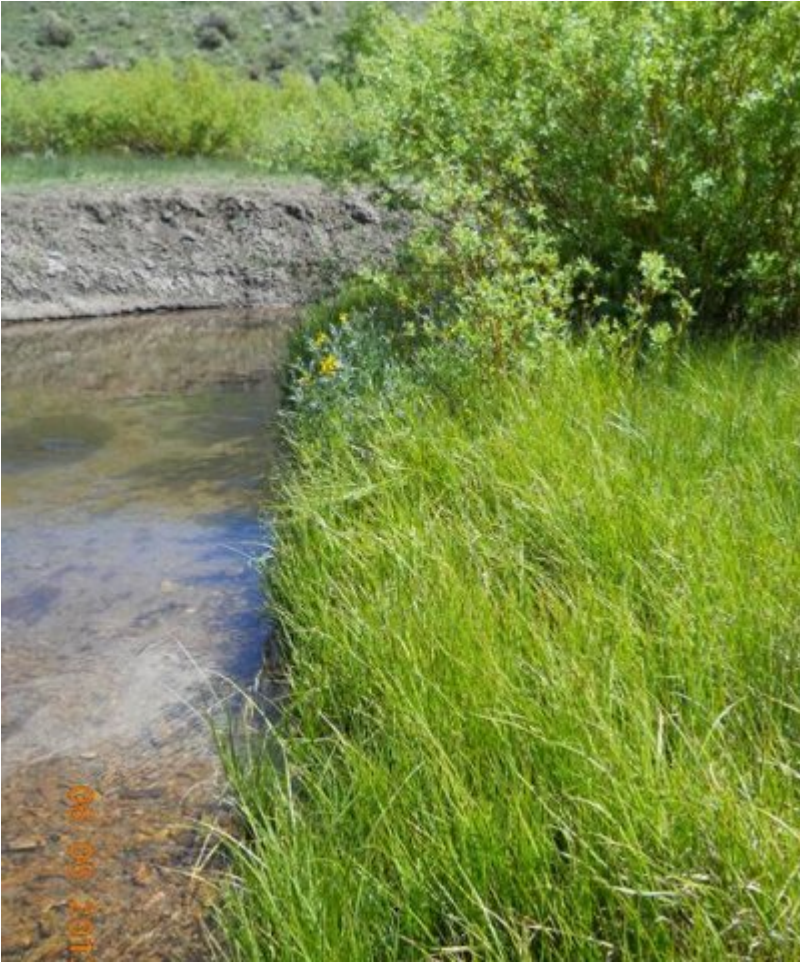
Figure 18. PCC1 established after downcutting.
