Ecological site R034AA010UT

Riparian Complex Perennial Gravelly VIII/E4 (Geyers Willow/Northwest Territory Sedge)

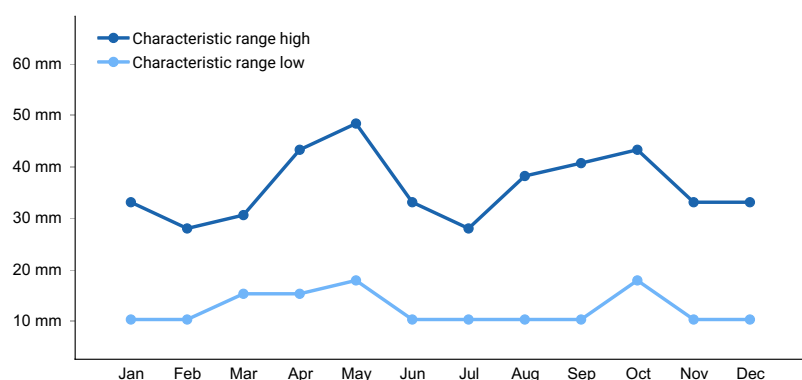
**Figure 1. Monthly precipitation range**

The average annual precipitation is 10 to 15 inches. Peak precipitation occurs as snow from October through April. This site has cold winters and short summers. Occasional convective thunderstorms produce small amounts of rain from June through September. The average annual temperature is 25 to 55 degrees F. The freeze-free period ranges from 95 to 115 days.

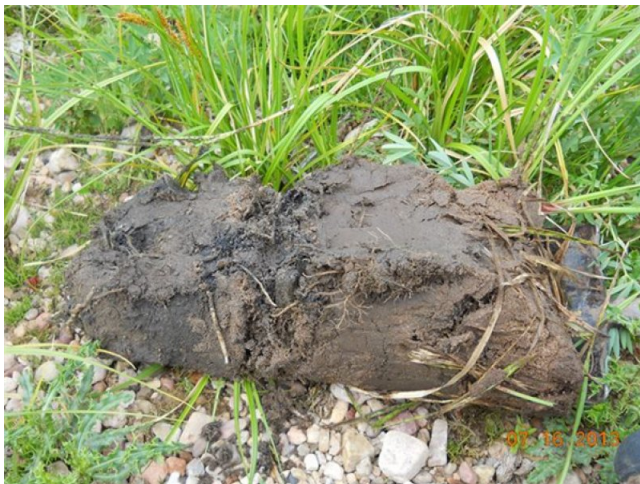
Figure 3. Point bar/streambank soil core

Soils are typically variable in stream valley bottoms because of the stream sediment deposition on flood plains and throughout the valley bottom as the channel naturally migrates. Soils on this site range from sandy to loamy on the surface. Point bars are typically sandy to very gravelly sand, flood plains and flood-plain steps are typically loamy. Sand and gravel lenses throughout the profile are common on all fluvial surfaces. Buried A horizons are also typically on fluvial influenced soils. The typical fluvial surfaces found on this site are point bars, flood plains and flood-plain steps. The tables below represent the variability between all fluvial surfaces

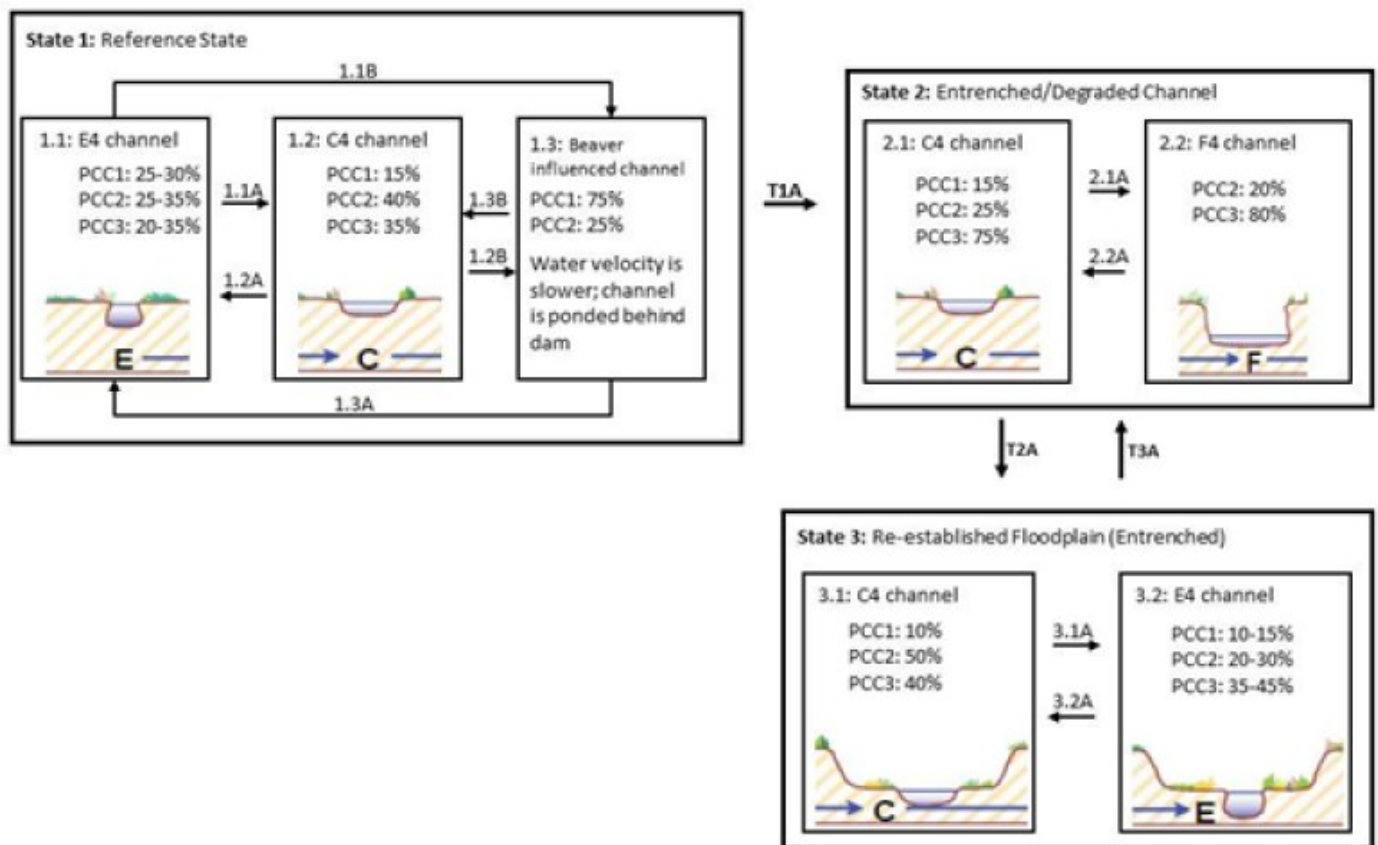
Figure 4. State and Transition Model for R034AA010UT

I.D.	Plant Association	Fluvial Surface/Landform
1	Sedge ( <i>Carex</i> sp)/Willow ( <i>Salix</i> sp)	Floodplain
2	Baltic rush ( <i>Juncus arcticus</i> ssp. <i>littoralis</i> )/mesic forbs	Floodplain Step
3	Graminoids/Willow ( <i>Salix</i> sp)	Low Terrace

Notes (not all possible states and phases of all reaches are shown. Refer to narratives for descriptions):

- This site was only observed and sampled on 1 stream
- Wide alluvial valley (Rosgen type VIII), perennial flow, high stream sinuosity and low slope
- 3 fluvial surfaces and 3 plant community components

- Channel is stabilized by deep-rooted, rhizomatous graminoids, willows, or a combination of both
- Community pathway 1.1A may occur with above average flooding or native ungulate grazing

- Community pathway 1.2A can occur from increased bank stabilizing vegetation, decreasing channel width
- T1A can occur from continued lack of bank stabilizing floodplain vegetation and bank disturbance

- Beaver dams can be found on this site in State 1 and 3. Presence of beaver dams drastically change the channel morphology and hydrology by widening the riparian area and slowing water to create more aquatic habitat

- States are influenced by channel disturbance, alteration of stream bank vegetation and lack of beaver.

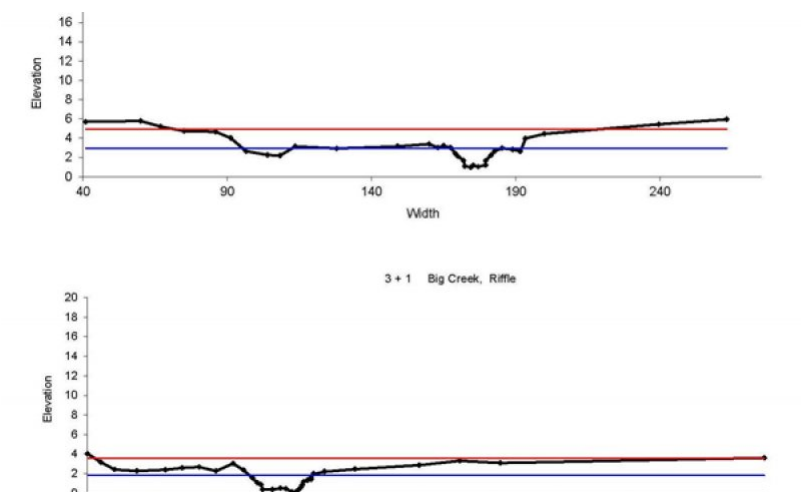
Figure 7. Representative stream cross sections.

This phase has a narrow and deep meandering channel with well-developed vegetation on the streambanks, predominantly composed of sedges and willows. The flood plain receives regular flooding from snowmelt in the spring. All plant community components may be present in this phase. Plant Community Component Descriptions: Plant community components are related to proximity to the stream channel and depth to water table and beaver activity. The plant communities will shift spatially depending on channel position and beaver activity, where there will be more of the streambank/flood plain community (PCC1) under the influence of beaver and PCC3 may not be present where beaver dams impound the stream channel. Northwest Territory sedge is found closest to the stream channel or in low swales in the floodplain where the water table is high. Northwest Territory sedge and Nebraska sedge are able to tolerate inundation for extended periods of time, which is why they are found in areas with high water table. Their root structure also allows them to withstand flood events. The rhizomatous nature of these sedges allow them to dominate areas where they are found, leading to low diversity (Hoag & Zierke 1998). Willows can come into this community under the correct conditions. Willows require fresh wet sediment for germination and this occurs at the site after high flow deposits sediment on the floodplain. Willow typically occurs on this site further away from the channel, but still within the streambank/floodplain community. Booth's willow is not tolerant of shading and can germinate after flooding if sediment deposition occurs (Esser 1992). This plant community has been associated with beaver complexes and also has been found to establish on old beaver dams where bare sediment is exposed. Booth's willow is typically found on moist coarse soil but it cannot tolerate inundation for extended periods of time (Esser 1992). A typical trend found on former beaver influenced channels is to go from open water to Northwest Territory sedge, then to Booth's willow (Esser 1992). Plant community component 2 is drier than plant community component 1 and is further from the stream and has a deeper water table. The community is composed of various graminoids and forbs, particularly Baltic rush and in one location tufted hair grass. Plant community component 3 is dominated by graminoids and willow. Geyer's willow is the dominant shrub in this community and it is typically found in clumps with other shrubs found around the base. Geyer's willow is also associated with beaver activity. This willow can develop in abandoned and sediment filled beaver ponds, so it is often found further away from the channel.

The stream channel in reference condition is an E4 Rosgen stream type. The stream is typically narrow and deep with undercut banks and overhanging vegetation. This channel has a very low width/depth ratio and high sinuosity. The water surface slope is less than two percent. The water velocity in this channel is in balance with the sediment

Entrenchment Ratio (floodprone width/bankfull width): 2.2; 100

Width/Depth Ratio (bankfull width/bankfull depth at riffle): 2.0;10

Sinuosity (stream length/valley length): 1.3; 2.6

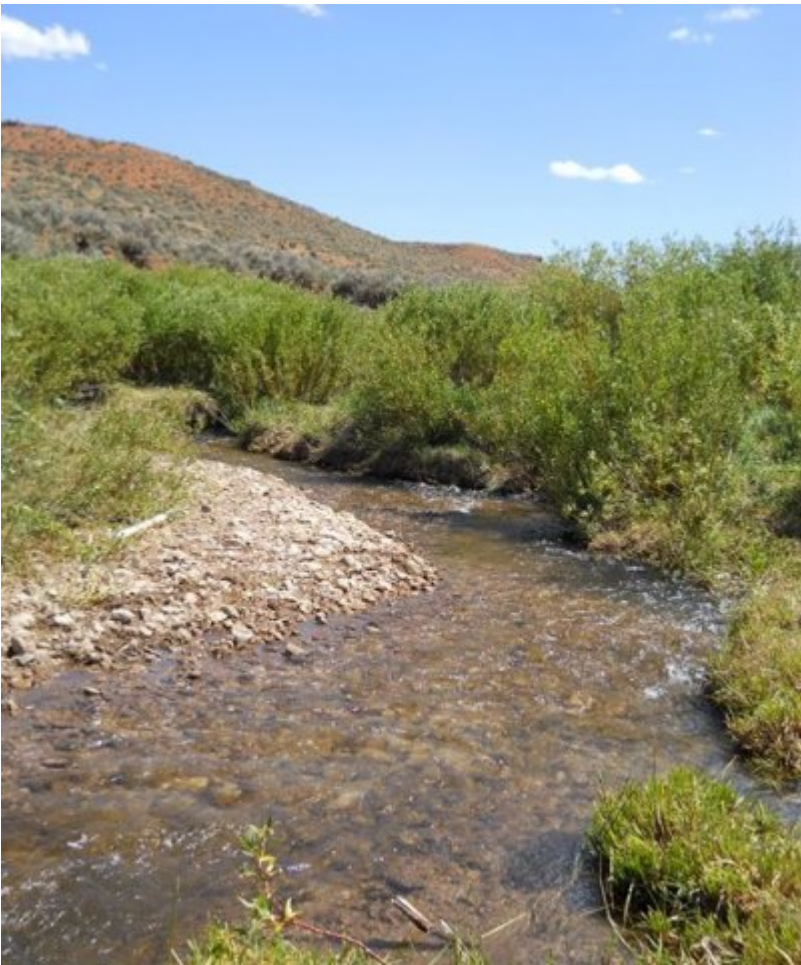
Figure 13. C4 Channel with shrubs in PCC1

This phase has a slightly wider channel and more deposition and erosion occurring around the meander bends. This phase may occur after large floods or may occur after beaver dam failure, which leaves sediment accumulated behind a dam exposed to be colonized by plants or eroded. All plant community components may be present in this phase.

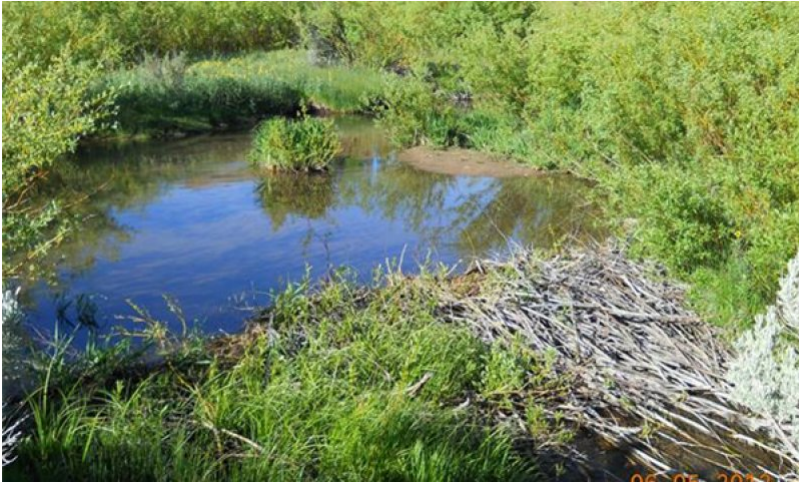
Figure 14. Stream channel impounded behind beaver dam

This phase is characterized by beaver activity that includes dams and foraging. Damming can create ponded water upstream and temporarily alter the hydrology of the system. This can create a wetter environment where more obligate wetland species may occur. Plant community components included in this phase are the sedge/willow and the graminoid/forb communities. Plant community component 3, graminoid/willow, may be present in this site, but often with beaver dams, the higher water table creates an environment that is not as suitable for willows.

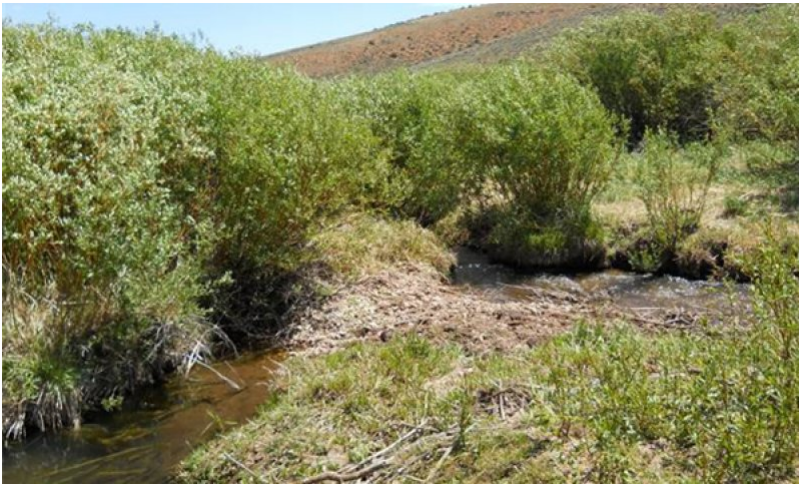
Figure 15. Small beaver dam

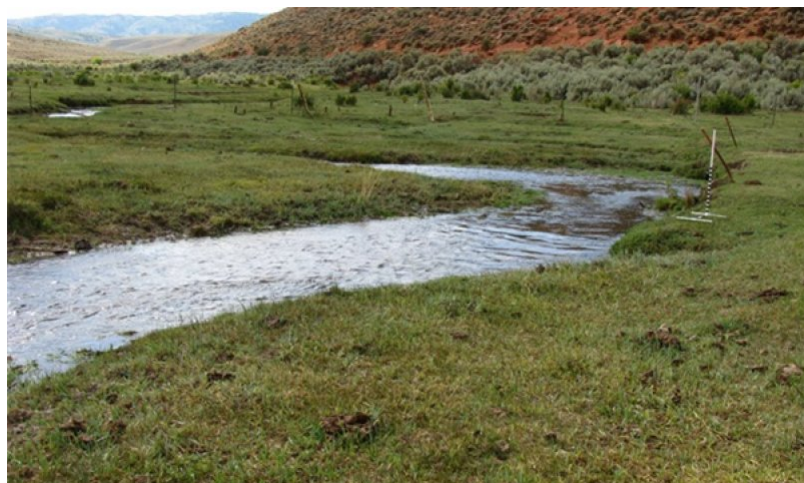
Figure 16. Grazed C4 channel with little willows or sedges re

This phase has a shift in vegetation composition in all plant community components. Northwest territory sedge is often missing from PCC1 and is replaced by other graminoids that may not have the same root structure and bank holding capability of sedges.

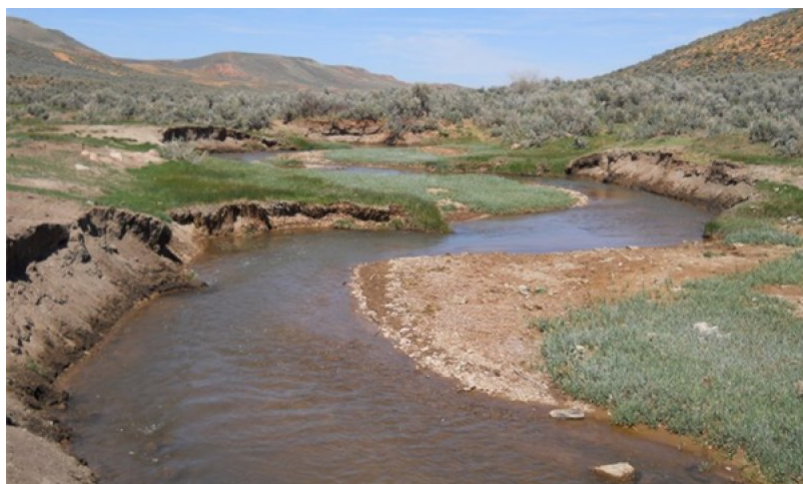
Figure 17. Downcut C4 channel with deposition on pointbars th

This phase is similar to 1.2.

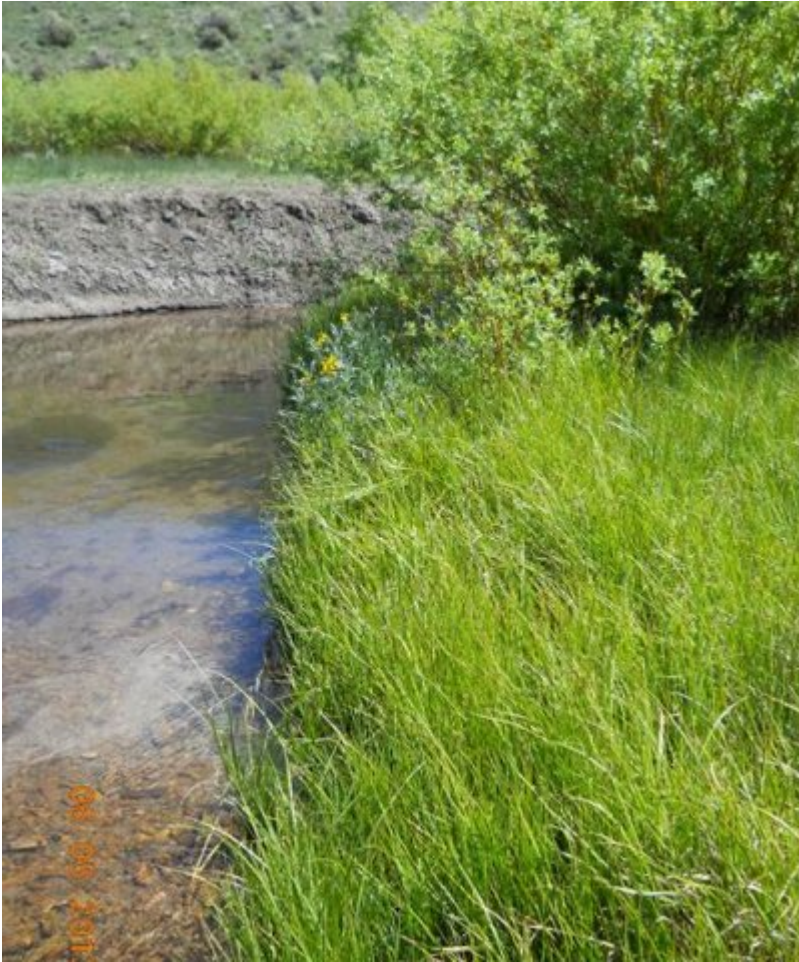
Figure 18. PCC1 established after downcutting.
