Ecological site R034AA011UT

Riparian Complex Perennial Gravelly VIII/E4 (Northwest Territory Sedge)

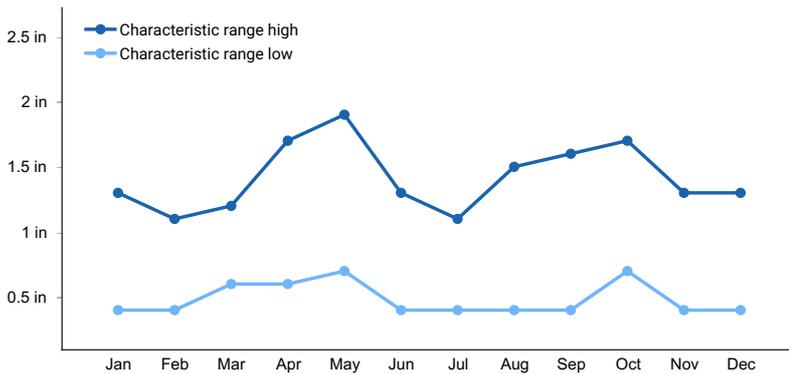
Figure 1. Monthly precipitation range

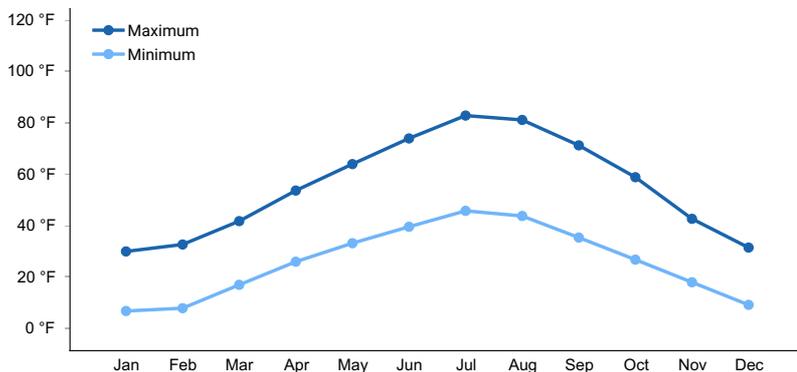
Figure 2. Monthly average minimum and maximum temperature

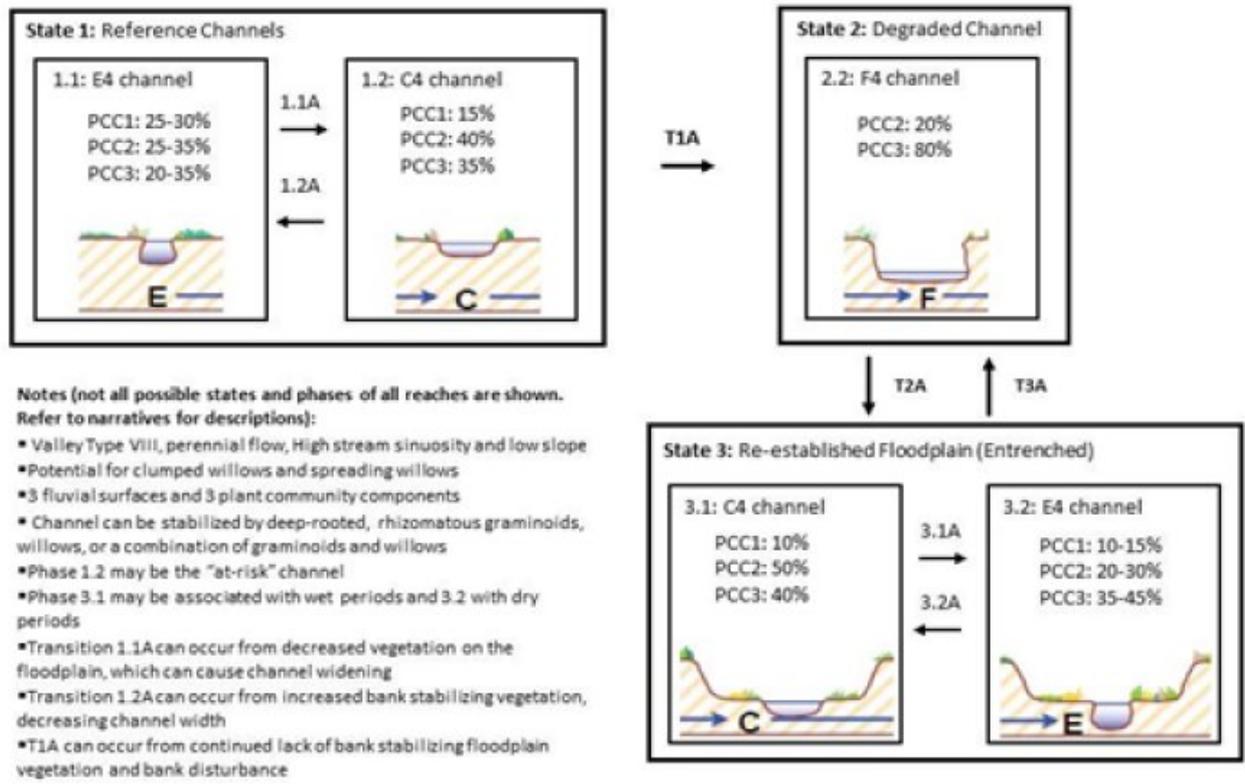
I.D.	Plant Association	Fluvial Surface/Landform
1	Beaked sedge (<i>Carex utriculata</i>) / Nebraska sedge (<i>C. nebrascensis</i>)	Streambank/Floodplain
2	Baltic rush (<i>Juncus arcticus</i> ssp. <i>littoralis</i>) / mesic forbs	Floodplain
3	Mixed mesic shrubs/clustered field sedge (<i>Carex praegracilis</i>)	Floodplain step

Figure 3. State and Transition Model R034AA011UT

The reference state for this site is a low gradient, meandering, very low width/depth stream channel with associated streambank, flood plain and flood-plain step landforms and plant community components. The stream channel typically meanders across the entire valley bottom, which effects the placement of each plant community. All plant communities can be present in this state.

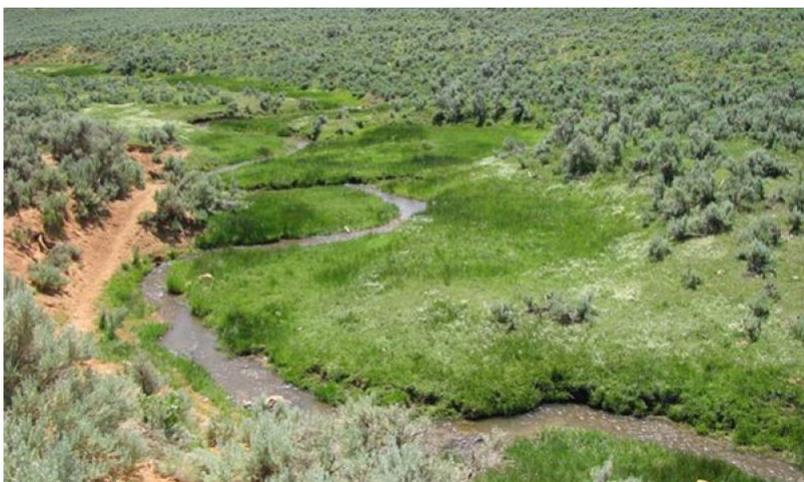
Figure 4. Site overview

This phase has a narrow and deep meandering channel with well-developed vegetation on the streambanks, predominantly composed of sedges and rushes. The flood plain receives regular flooding from snowmelt in the spring. All plant community components may be present in this phase.

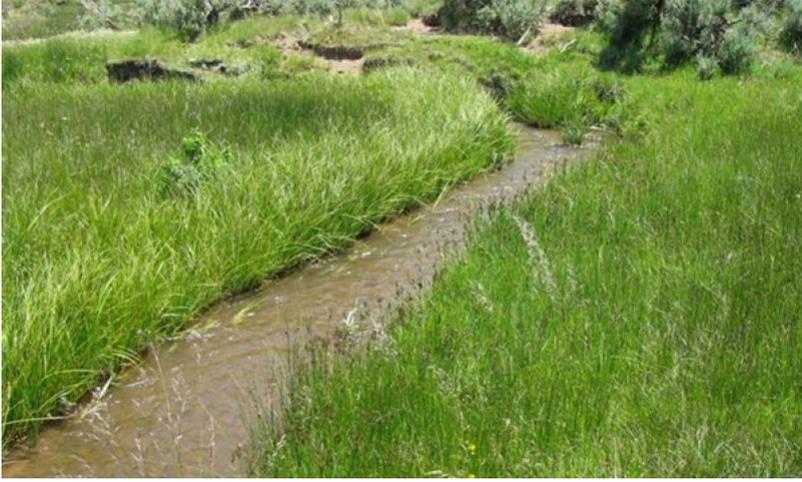
Figure 5. Streambank (PCC1) community

Northwest Territory sedge is found closest to the stream channel or in low swales in the floodplain where the water table is high. Northwest Territory sedge and Nebraska sedge are able to tolerate inundation for extended periods of time, which is why they are found in areas with high water table. Their root structure also allows them to withstand flood events. The rhizomatous nature of these sedges allow them to dominate areas where they are found, leading to low diversity (Hoag & Zierke 1998). Willows can come into this community under the correct conditions. Willows require fresh wet sediment for germination and this occurs at the site after high flow deposits sediment on the floodplain. Willow typically occurs on this site further away from the channel, but still within the streambank/floodplain community.

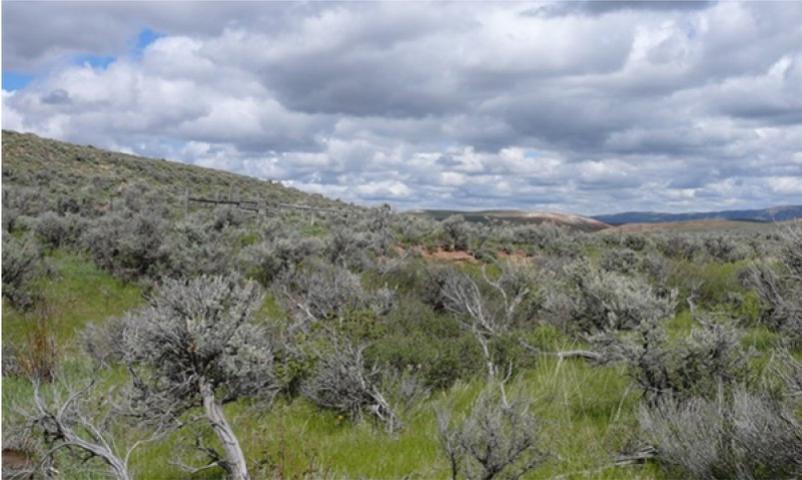
Figure 6. Flood-plain step plant community (PCC3)

Plant community component 3 is dominated by graminoids and shrubs, specifically currant, rose, basin big sagebrush, and shrubby cinquefoil. Shrubby cinquefoil is the dominant shrub. This community is typically found on stable fluvial surfaces with soil development (Padgett et al. 1989). This community is composed of species that are shallow rooted and will provide little streambank stability if the stream cuts into this community (Padgett et al. 1989).

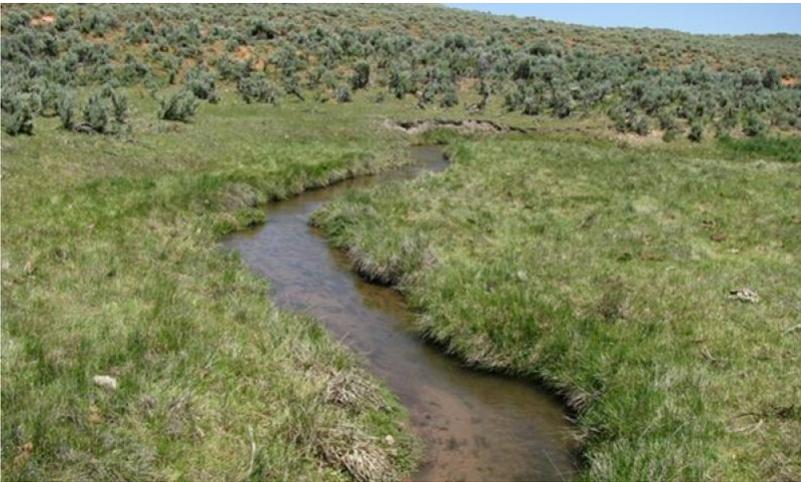
Figure 10. Grazing effects on plant community components

Observed grazing influence on this site has been attributed to bank sloughing and shrub decline (WICHE 75). Northwest Territory sedge is typically not found in areas with heavy grazing while Nebraska sedge appears to be more tolerant of grazing. These sedges have similar root structures and both provide bank stability. Surveys performed on this site in the 1970s indicate that shrubs were present, but provided low cover and were decadent. Lack of shrubs presently indicates that conditions for willow regeneration have not been present. Grazing impacts may also lead to a change in plant community composition. Kentucky bluegrass is a non-native grass often found within this site. This grass is shallow rooted and does not have the bank stability capacity of rhizomatous sedges. This shift in plant communities has an effect on stream bank stability. Riparian meadow communities dominated by sedges and rushes have a much greater root densities than grasses (Manning et al. 1989). So when these communities are degraded and lose the sedges and Kentucky bluegrass established, it decreases the stream bank stability (Manning et al. 1989).

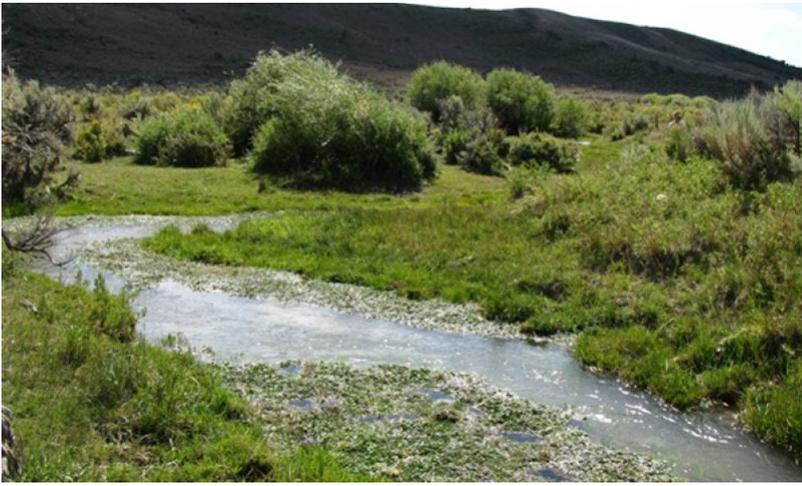
Figure 12. Channel narrowing with early colonizing species, C

This phase has a slightly wider channel and more deposition and erosion occurring around the meander bends. This phase may occur after large floods or may occur after grazing. All plant community components may be present in this phase.

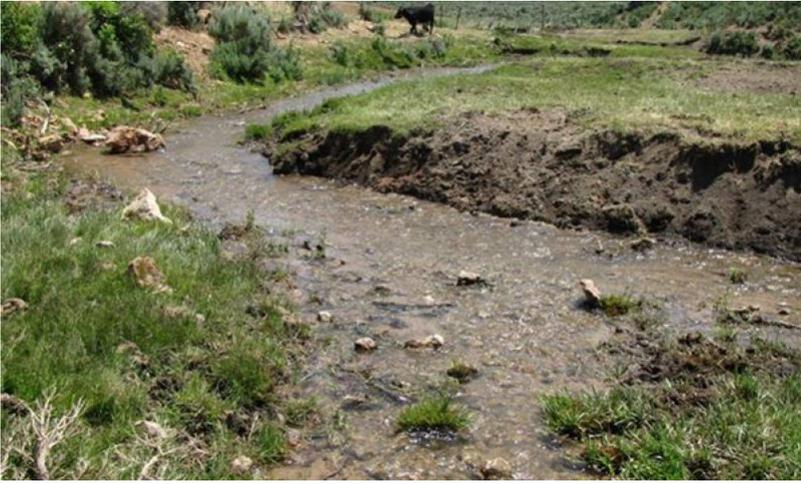
Figure 13. Eroded banks, loss of streambank plant community (

This phase results from excessive lateral erosion creating a wide, shallow stream with unstable streambanks. PCC 1 is largely lost in this phase.

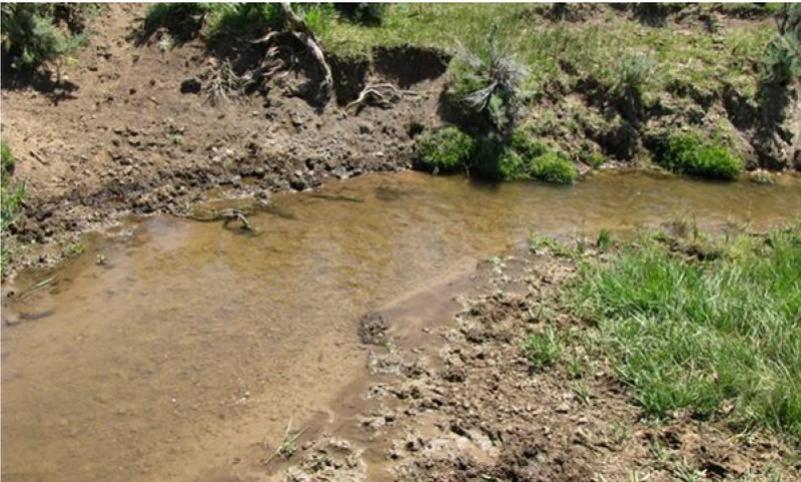
Figure 14. Bank erosion and channel widening

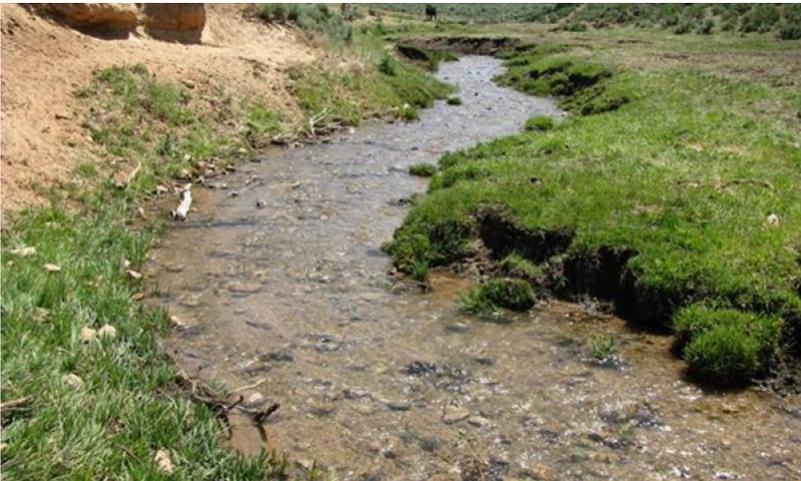
Figure 15. Bank sloughing and channel widening

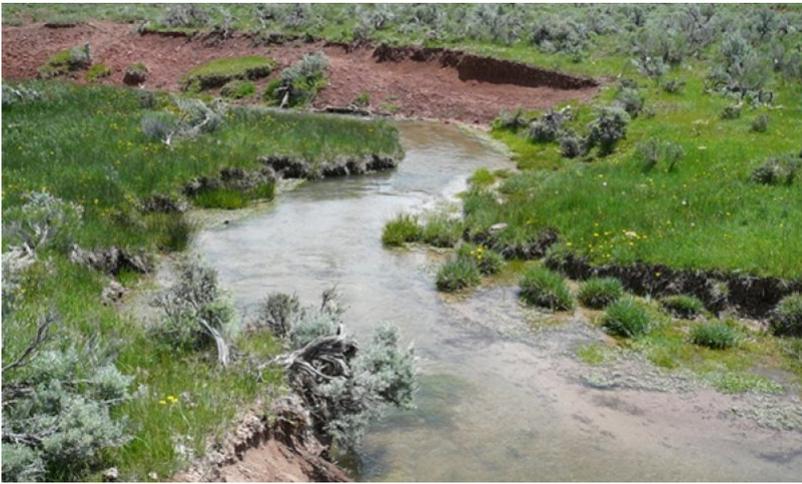
Figure 16. Channel widening

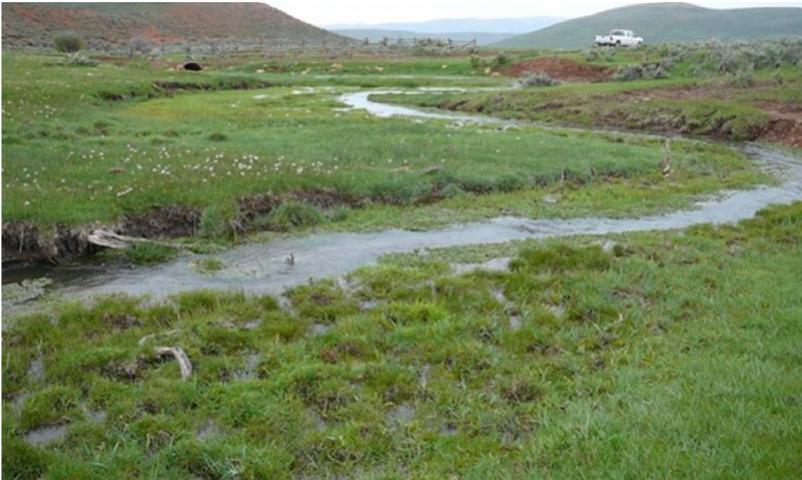
Figure 17. Early colonizing species beginning to establish on

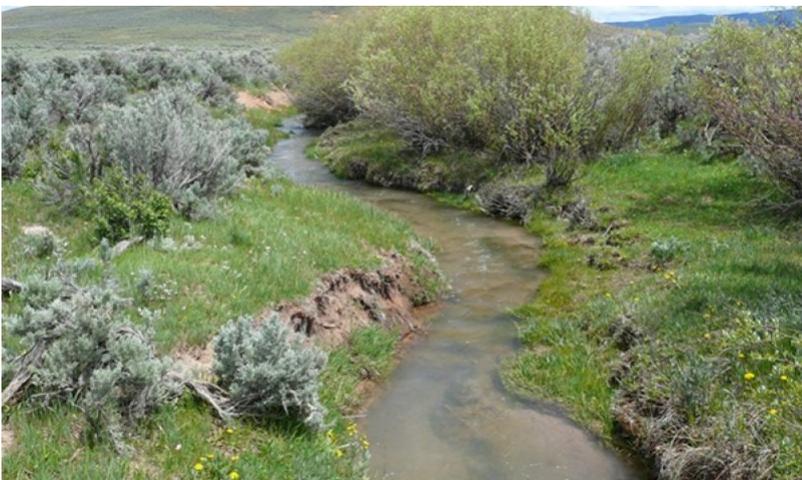
Figure 18. Channel narrowing after bank sloughing, stream bank

This phase functions similarly to 1.2 at a lower elevation with a narrower floodplain and plant community components.

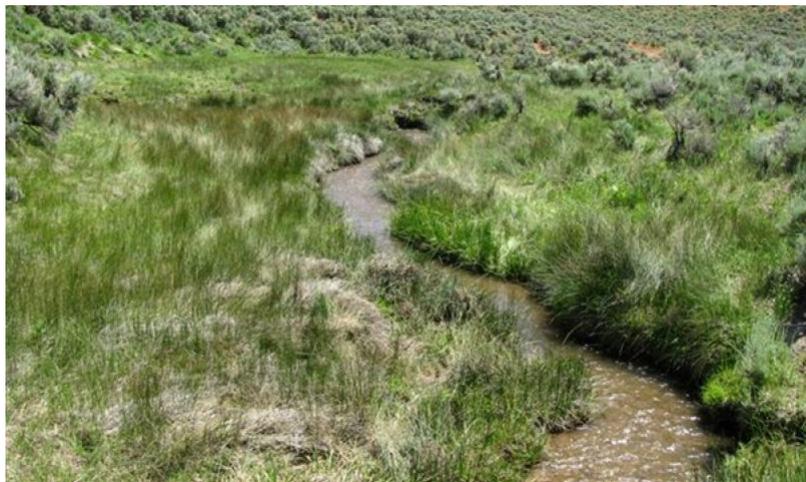
Figure 19. Recovering narrow channel

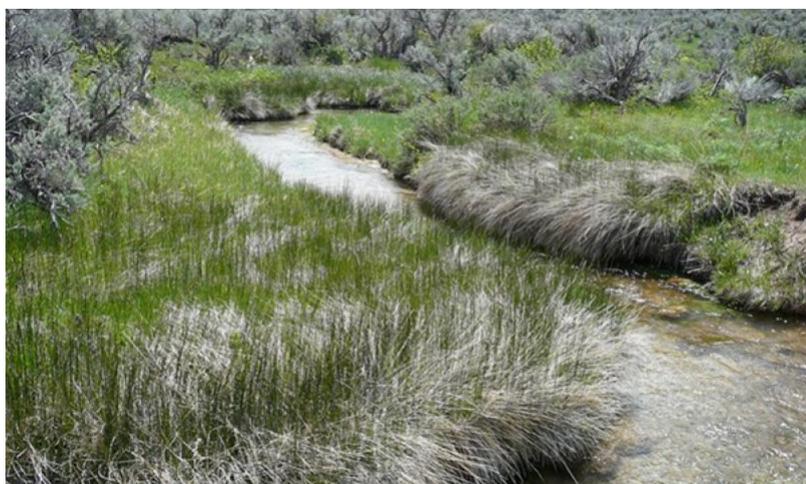
Figure 20. Streambank community establishing

This phase functions similarly to 1.1 at a lower elevation with a narrower floodplain and plant community components.
