Ecological site R034AA011UT

Riparian Complex Perennial Gravelly VIII/E4 (Northwest Territory Sedge)

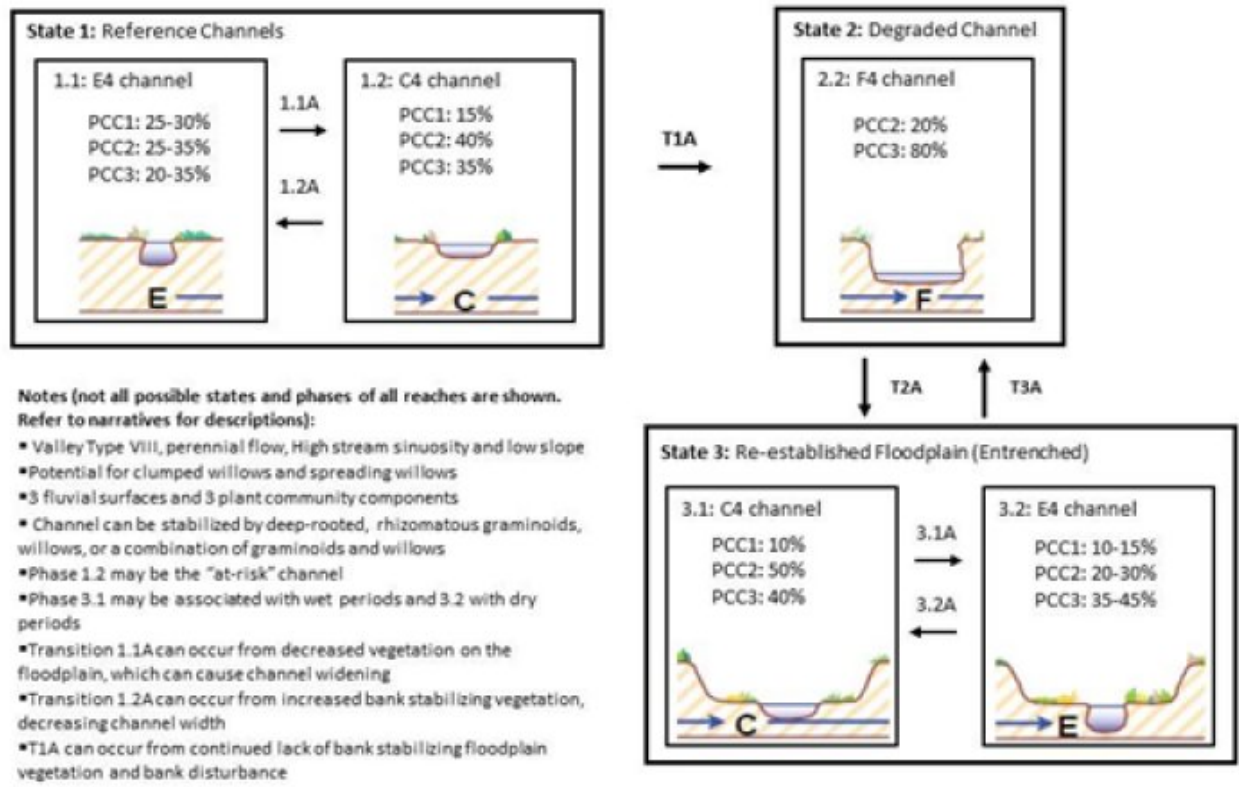
Figure 3. State and Transition Model R034AA011UT

I.D.	Plant Association	Fluvial Surface/Landform
1	Beaked sedge (<i>Carex utriculata</i>) / Nebraska sedge (<i>C. nebrascensis</i>)	Streambank/Floodplain
2	Baltic rush (<i>Juncus arcticus</i> ssp. <i>littoralis</i>) / mesic forbs	Floodplain
3	Mixed mesic shrubs/clustered field sedge (<i>Carex praegracilis</i>)	Floodplain step

Transition 1A State 1 to 2

Change in vegetation on the banks to shallow rooted species, decrease in bank stability and bank sloughing causing a change in channel geometry to a wider shallower channel

Transition 2A State 2 to 3

Vegetation re-establishment on streambanks and floodplain, rest from grazing pressure

Transition 3A State 3 to 2

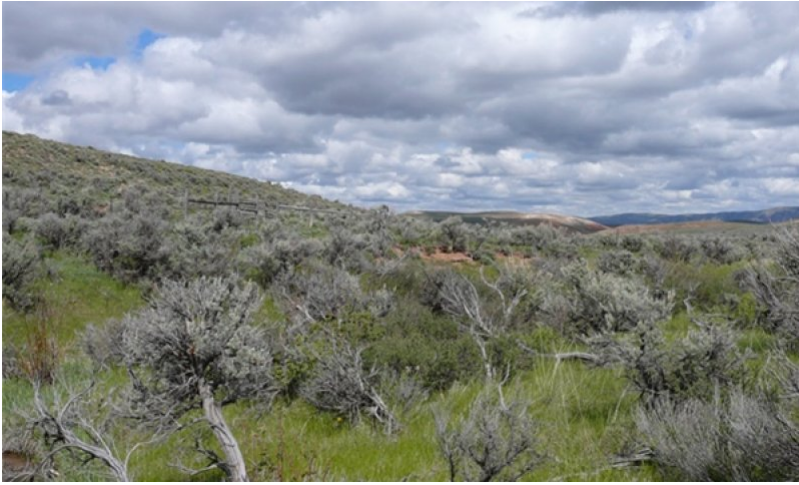
Figure 6. Flood-plain step plant community (PCC3)

Plant community component 3 is dominated by graminoids and shrubs, specifically currant, rose, basin big sagebrush, and shrubby cinquefoil. Shrubby cinquefoil is the dominant shrub. This community is typically found on stable fluvial surfaces with soil development (Padgett et al. 1989). This community is composed of species that are shallow rooted and will provide little streambank stability if the stream cuts into this community (Padgett et al. 1989).

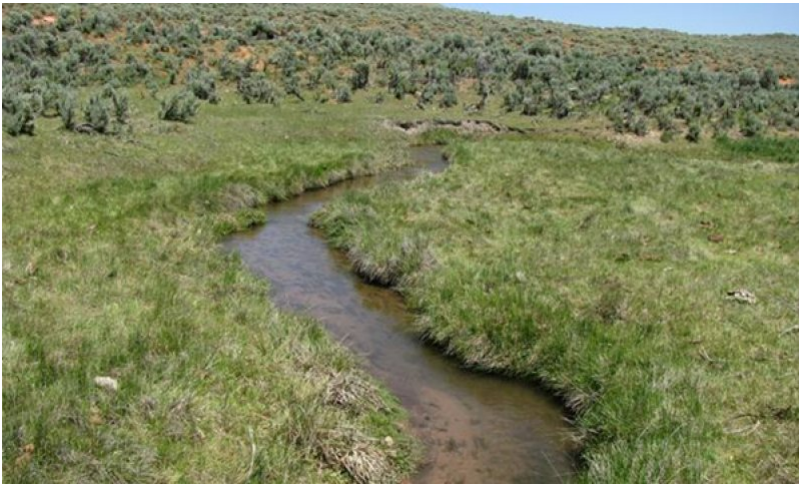
Figure 10. Grazing effects on plant community components

Observed grazing influence on this site has been attributed to bank sloughing and shrub decline (WICHE 75). Northwest Territory sedge is typically not found in areas with heavy grazing while Nebraska sedge appears to be more tolerant of grazing. These sedges have similar root structures and both provide bank stability. Surveys performed on this site in the 1970s indicate that shrubs were present, but provided low cover and were decadent. Lack of shrubs presently indicates that conditions for willow regeneration have not been present. Grazing impacts may also lead to a change in plant community composition. Kentucky bluegrass is a non-native grass often found within this site. This grass is shallow rooted and does not have the bank stability capacity of rhizomatous sedges. This shift in plant communities has an effect on stream bank stability. Riparian meadow communities dominated by sedges and rushes have a much greater root densities than grasses (Manning et al. 1989). So when these communities are degraded and lose the sedges and Kentucky bluegrass established, it decreases the stream bank stability (Manning et al. 1989).

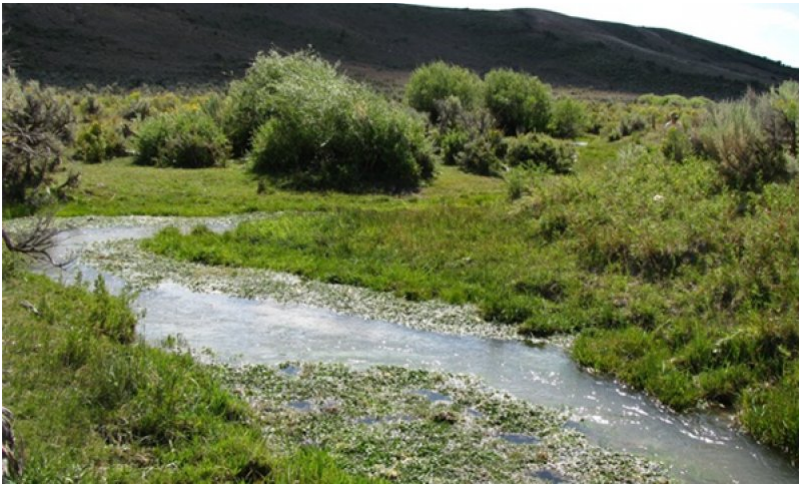
Figure 12. Channel narrowing with early colonizing species, C

This phase has a slightly wider channel and more deposition and erosion occurring around the meander bends. This phase may occur after large floods or may occur after grazing. All plant community components may be present in this phase.

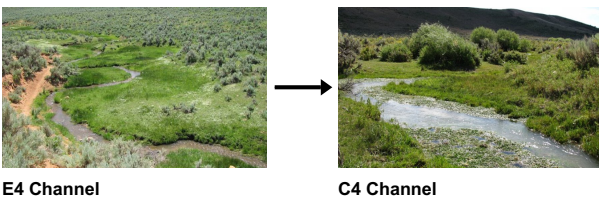
Pathway 1.1A Community 1.1 to 1.2

Flooding results in sediment deposition and erosion and scouring of vegetation on stream banks around meanders or removal of vegetation from native ungulate grazing

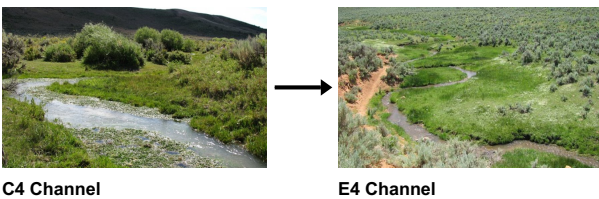
Pathway 1.2A Community 1.2 to 1.1

Vegetation re-establishment, specifically deep rooted, rhizomatous species

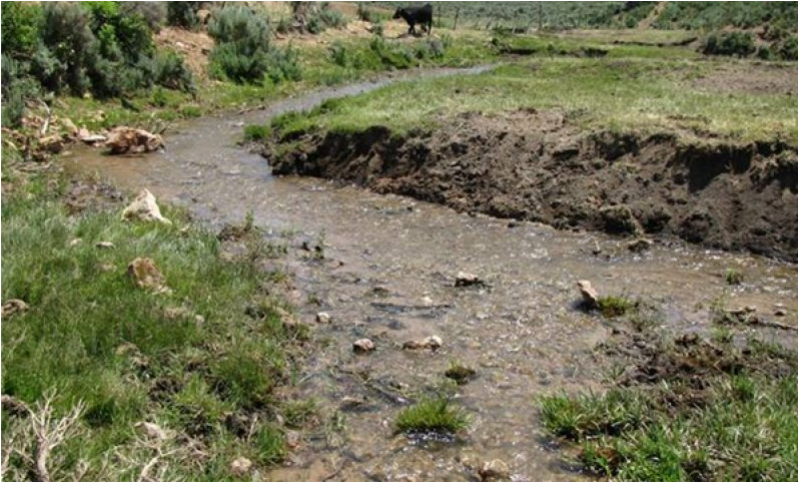
Figure 13. Eroded banks, loss of streambank plant community (

This state is characterized by a shift in the composition of plant community components due to season long grazing pressure. The sedges and willow typically found on the streambanks are particularly palatable to livestock and can be grazed at a level that weakens the plant eventually leading to loss from the site (i.e. Northwest Territory sedge). Kentucky bluegrass often replaces these sedges along the streambank (see Ecological Dynamics section). Bank sloughing is prevalent.

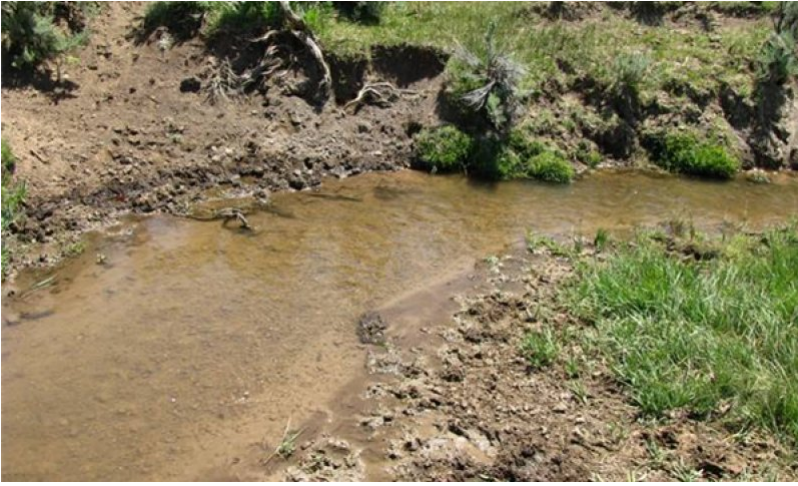
Figure 14. Bank erosion and channel widening

This phase results from excessive lateral erosion creating a wide, shallow stream with unstable streambanks. PCC 1 is largely lost in this phase.

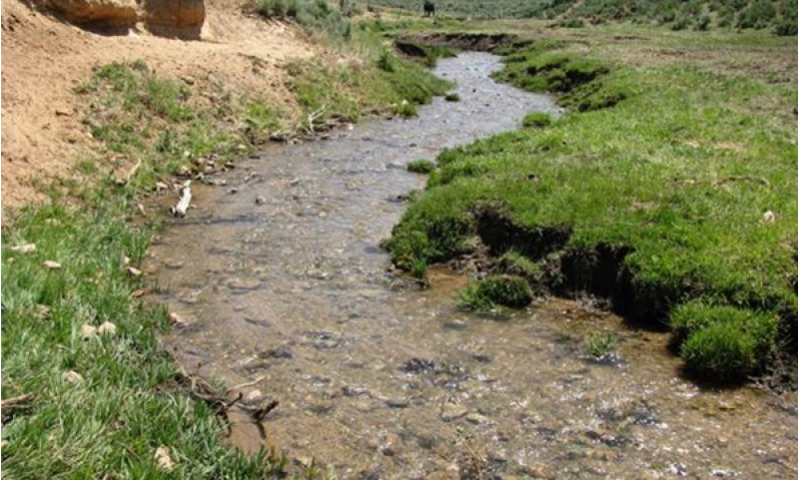
Figure 15. Bank sloughing and channel widening

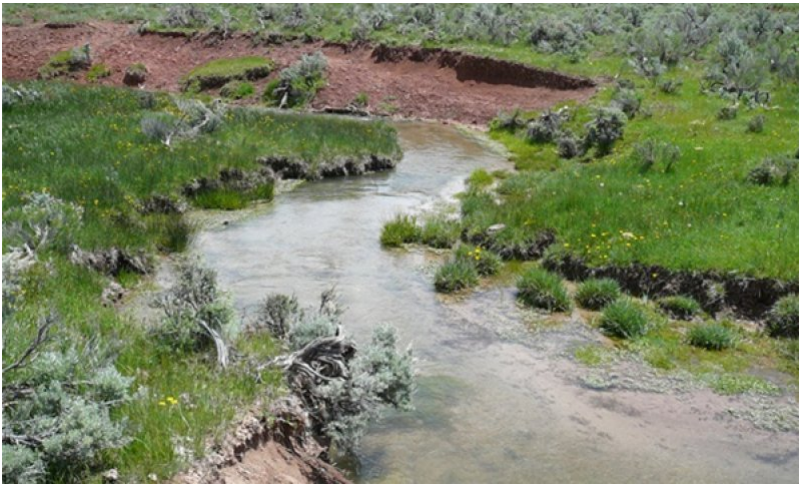
Figure 16. Channel widening

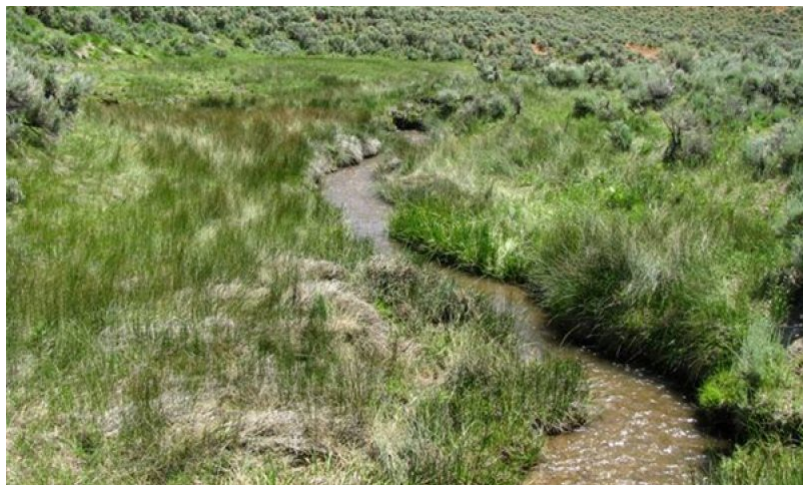
Figure 19. Recovering narrow channel

This phase functions similarly to 1.1 at a lower elevation with a narrower floodplain and plant community components.

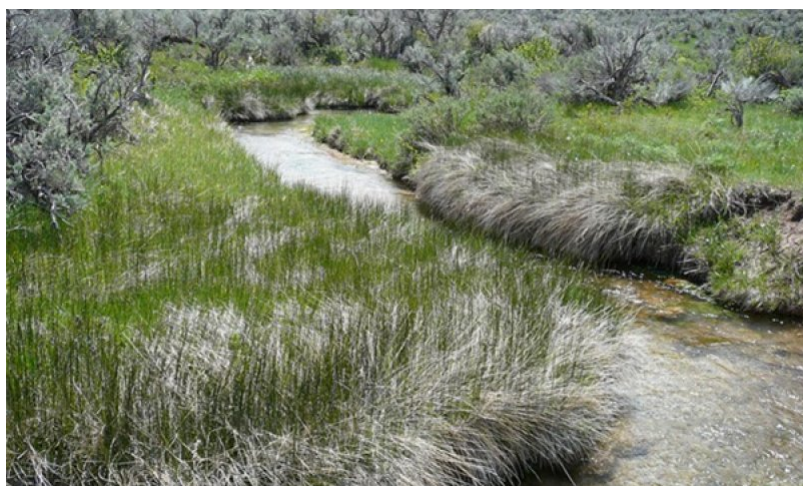
Figure 20. Streambank community establishing
