Ecological site R034AA011UT  
Riparian Complex Perennial Gravelly VIII/E4 (Northwest Territory Sedge)

Ecological site concept

This site is located in MLRA 34A. This site occurs in narrow alluvial valleys and typically occurs downstream of Riparian Complex Perennial Gravelly II/E4 (Northwest Territory Sedge/Baltic Rush) R034AA012UT riparian sites. This site has perennial flow that is high in the spring from snow melt and has some spring influence throughout the year. The streams within this site are dominated by gravel bed material and sandy/silty stream banks. Vegetation cover is high on this site and the roots of the graminoids hold the stream banks together during high flow. This site is characterized by low gradient, meandering E4 channel with high sinuosity.

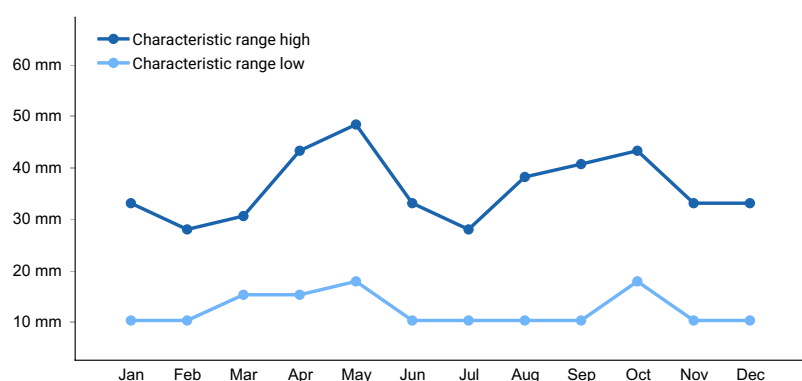
**Figure 1. Monthly precipitation range**

The average annual precipitation is 10 to 15 inches. Peak precipitation occurs as snow from October through April. This site has cold winters and short summers. Occasional convective thunderstorms produce small amounts of rain from June through September. The average annual temperature is 25 to 55 degrees F. The freeze-free period ranges from 95 to 115 days.

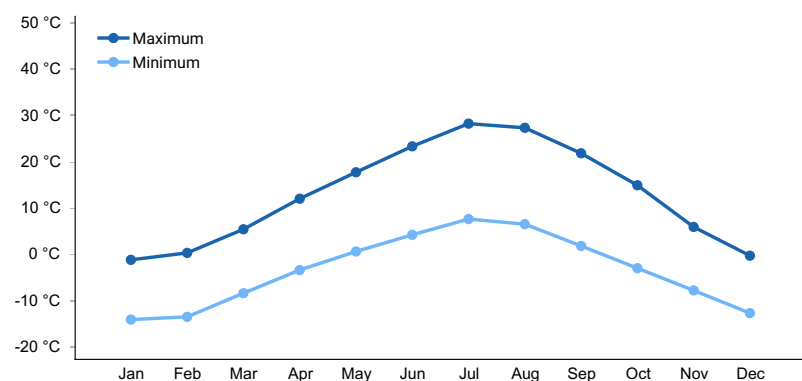
**Figure 2. Monthly average minimum and maximum temperature**

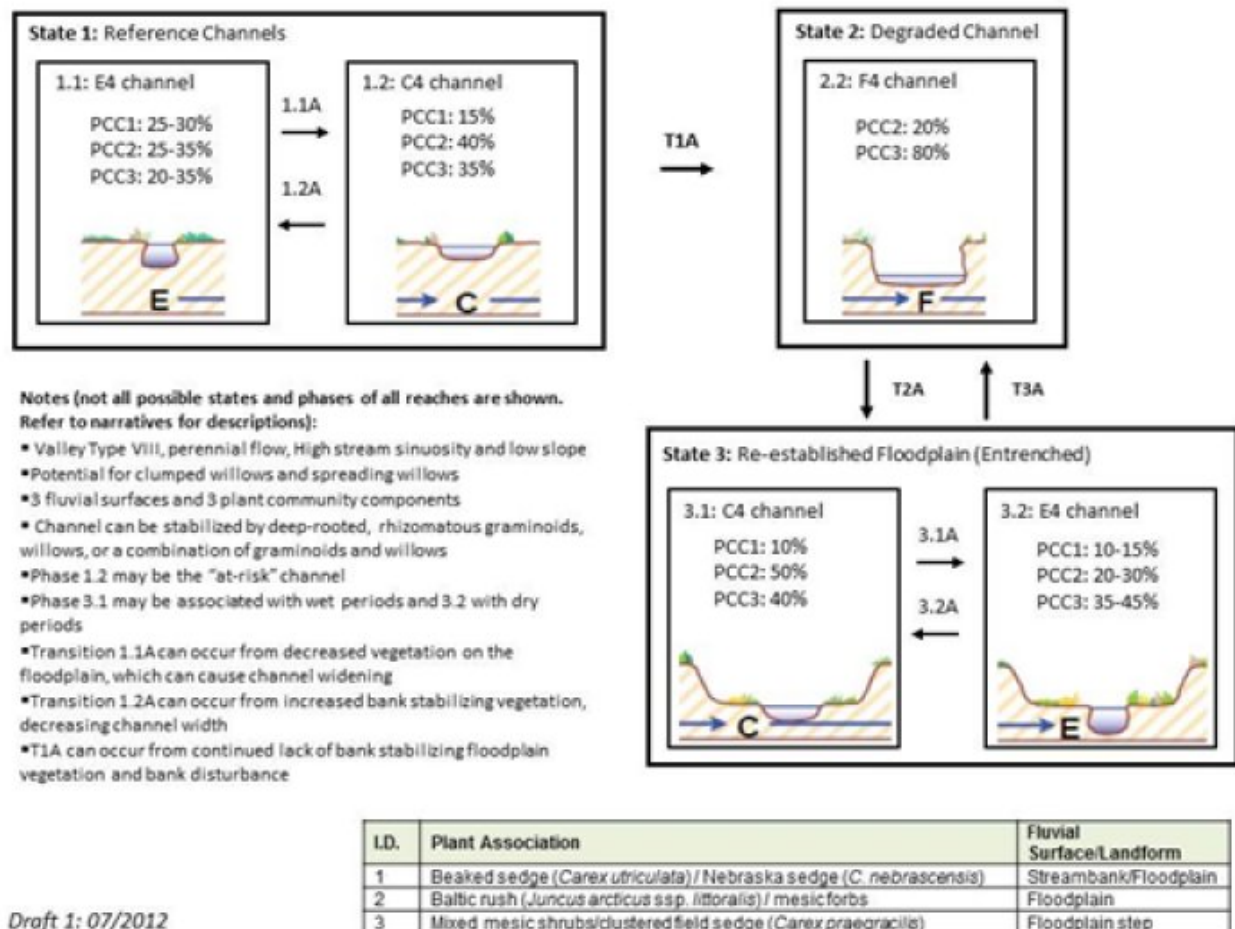
Figure 3. State and Transition Model R034AA011UT

Change in vegetation on the banks to shallow rooted species, decrease in bank stability and bank sloughing causing a change in channel geometry to a wider shallower channel

Vegetation re-establishment on streambanks and floodplain, rest from grazing pressure

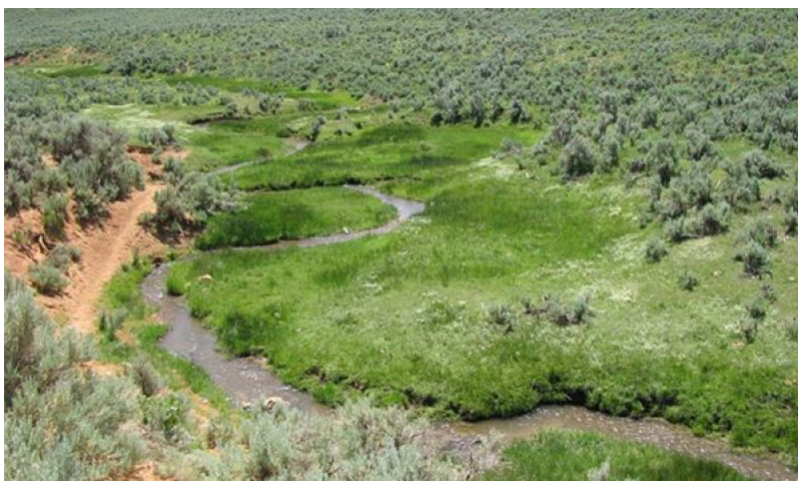
**Figure 4. Site overview**

This phase has a narrow and deep meandering channel with well-developed vegetation on the streambanks, predominantly composed of sedges and rushes. The flood plain receives regular flooding from snowmelt in the spring. All plant community components may be present in this phase.

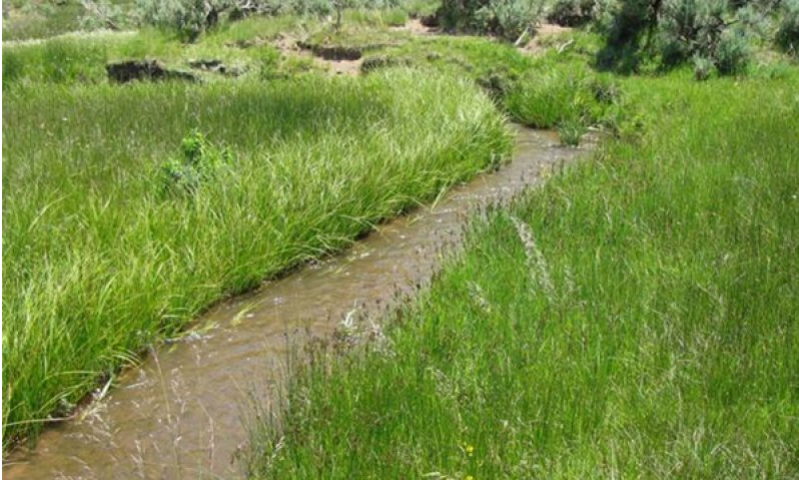
**Figure 5. Streambank (PCC1) community**

Northwest Territory sedge is found closest to the stream channel or in low swales in the floodplain where the water table is high. Northwest Territory sedge and Nebraska sedge are able to tolerate inundation for extended periods of time, which is why they are found in areas with high water table. Their root structure also allows them to withstand flood events. The rhizomatous nature of these sedges allow them to dominate areas where they are found, leading to low diversity (Hoag & Zierke 1998). Willows can come into this community under the correct conditions. Willows require fresh wet sediment for germination and this occurs at the site after high flow deposits sediment on the floodplain. Willow typically occurs on this site further away from the channel, but still within the streambank/floodplain community.

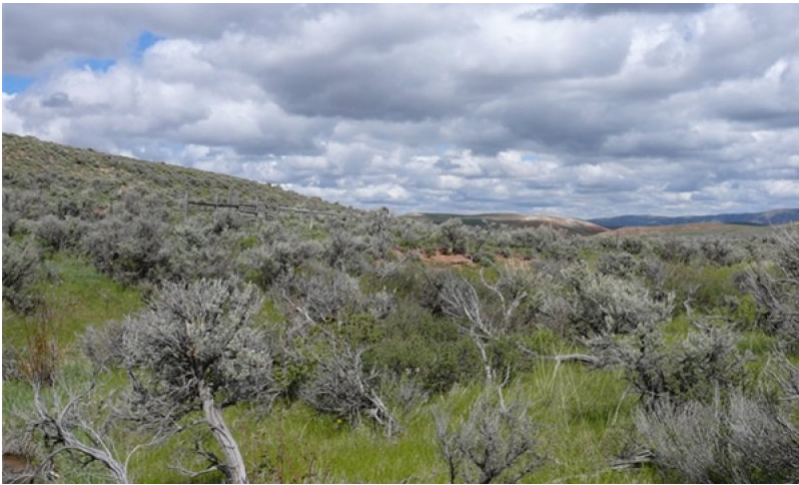
**Figure 6. Flood-plain step plant community (PCC3)**

Plant community component 3 is dominated by graminoids and shrubs, specifically currant, rose, basin big sagebrush, and shrubby cinquefoil. Shrubby cinquefoil is the dominant shrub. This community is typically found on stable fluvial surfaces with soil development (Padgett et al. 1989). This community is composed of species that are shallow rooted and will provide little streambank stability if the stream cuts into this community (Padgett et al. 1989).

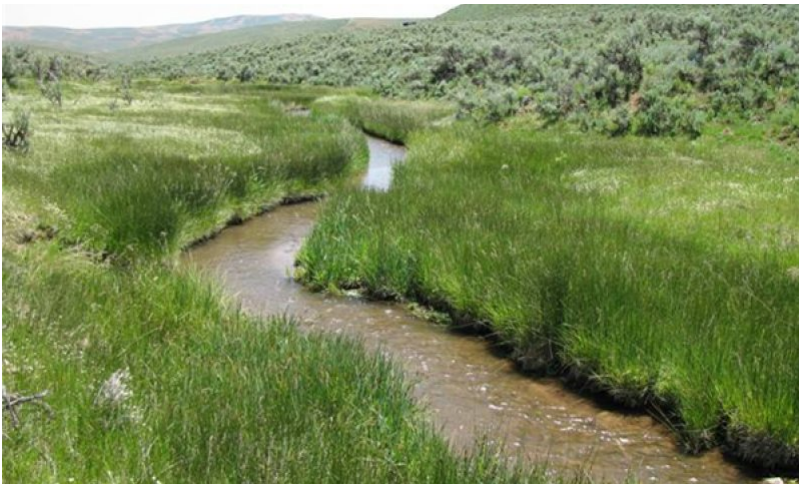
**Figure 7. Streambank and flood plain plant communities**

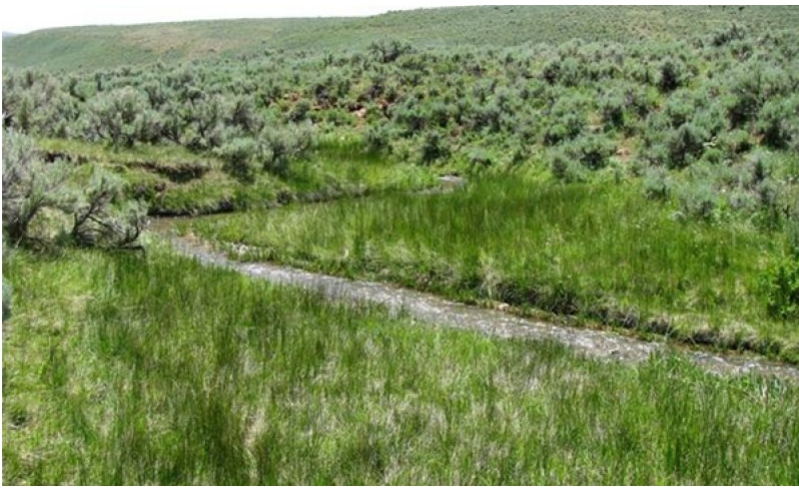
Figure 8. Flood plain plant communities with sagebrush on hills

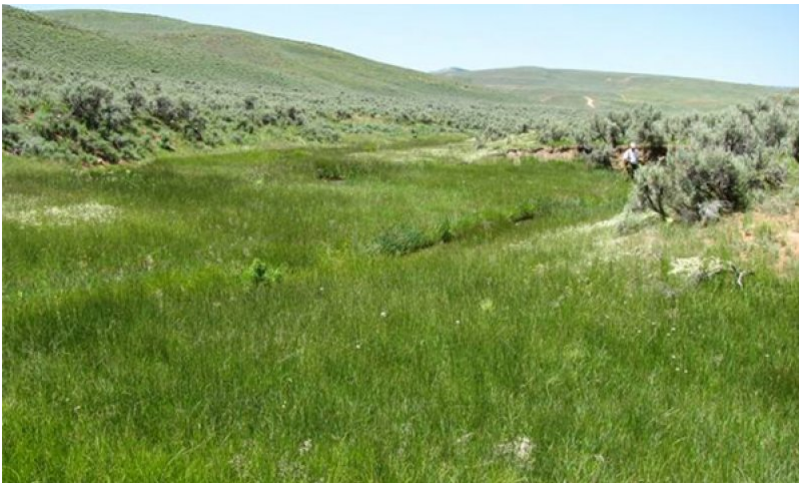
Figure 9. Graminoid dominated flood plain community

Plant community component 2 is drier than plant community component 1 and is further from the stream and has a deeper water table. The community is composed of various graminoids and forbs, particularly Baltic rush and in one location tufted hair grass.

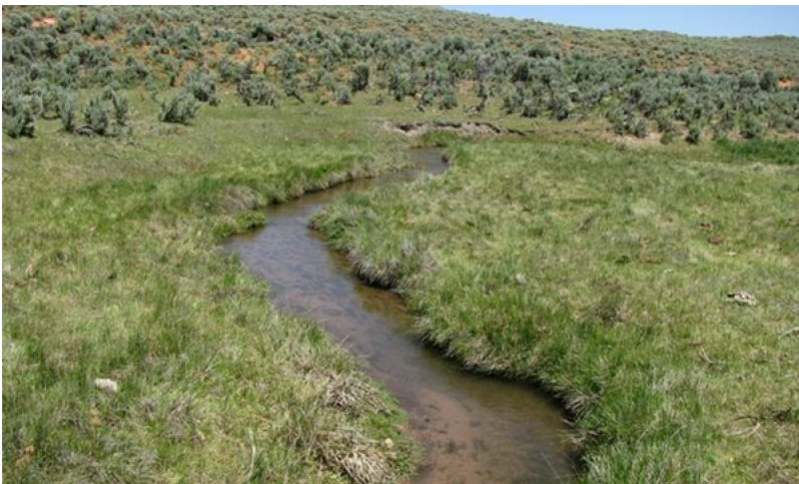
Figure 10. Grazing effects on plant community components

Observed grazing influence on this site has been attributed to bank sloughing and shrub decline (WICHE 75). Northwest Territory sedge is typically not found in areas with heavy grazing while Nebraska sedge appears to be more tolerant of grazing. These sedges have similar root structures and both provide bank stability. Surveys performed on this site in the 1970s indicate that shrubs were present, but provided low cover and were decadent. Lack of shrubs presently indicates that conditions for willow regeneration have not been present. Grazing impacts may also lead to a change in plant community composition. Kentucky bluegrass is a non-native grass often found within this site. This grass is shallow rooted and does not have the bank stability capacity of rhizomatous sedges. This shift in plant communities has an effect on stream bank stability. Riparian meadow communities dominated by sedges and rushes have a much greater root densities than grasses (Manning et al. 1989). So when these communities are degraded and lose the sedges and Kentucky bluegrass established, it decreases the stream bank stability (Manning et al. 1989).

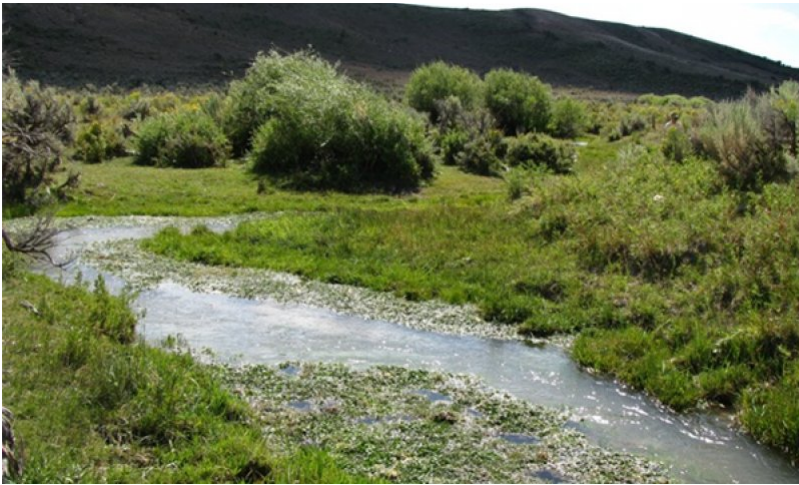
**Figure 12. Channel narrowing with early colonizing species, C**

This phase has a slightly wider channel and more deposition and erosion occurring around the meander bends. This phase may occur after large floods or may occur after grazing. All plant community components may be present in this phase.

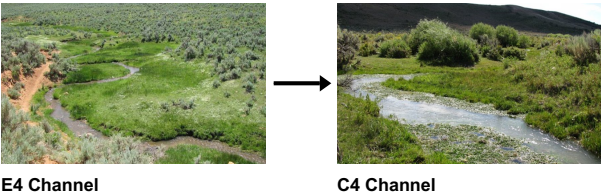
**Pathway 1.1A**  
**Community 1.1 to 1.2**

Flooding results in sediment deposition and erosion and scouring of vegetation on stream banks around meanders or removal of vegetation from native ungulate grazing

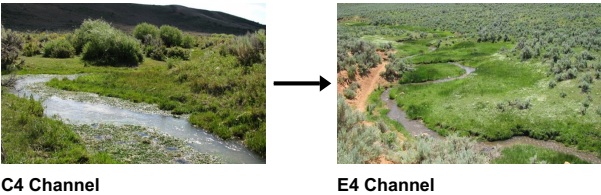
**Pathway 1.2A**  
**Community 1.2 to 1.1**

Vegetation re-establishment, specifically deep rooted, rhizomatous species

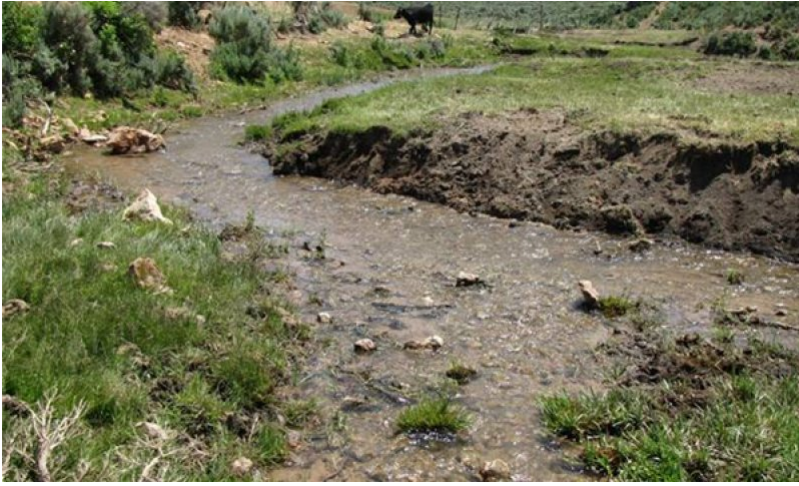
**Figure 13. Eroded banks, loss of streambank plant community (**

This phase results from excessive lateral erosion creating a wide, shallow stream with unstable streambanks. PCC 1 is largely lost in this phase.

This state is characterized by a shift in the composition of plant community components due to season long grazing pressure. The sedges and willow typically found on the streambanks are particularly palatable to livestock and can be grazed at a level that weakens the plant eventually leading to loss from the site (i.e. Northwest Territory sedge). Kentucky bluegrass often replaces these sedges along the streambank (see Ecological Dynamics section). Bank sloughing is prevalent.

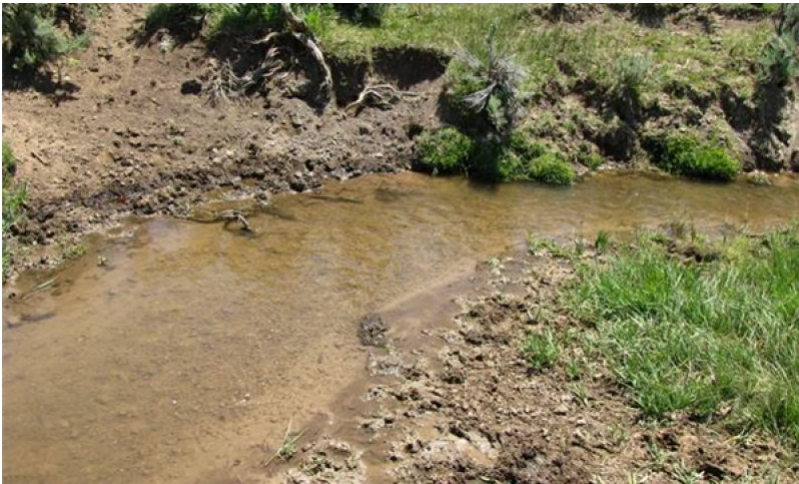
**Figure 14. Bank erosion and channel widening**

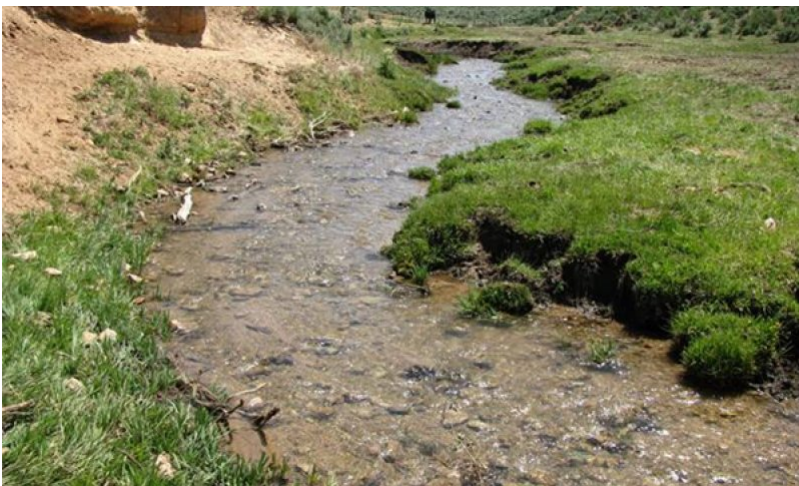
**Figure 15. Bank sloughing and channel widening**

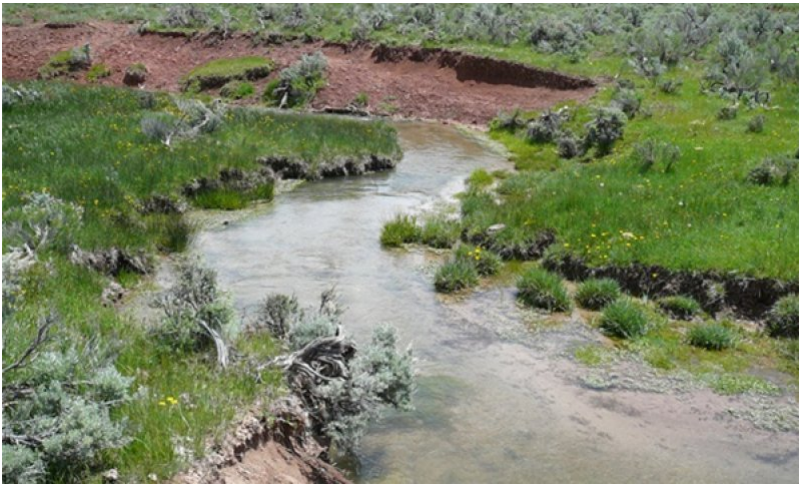
**Figure 16. Channel widening**

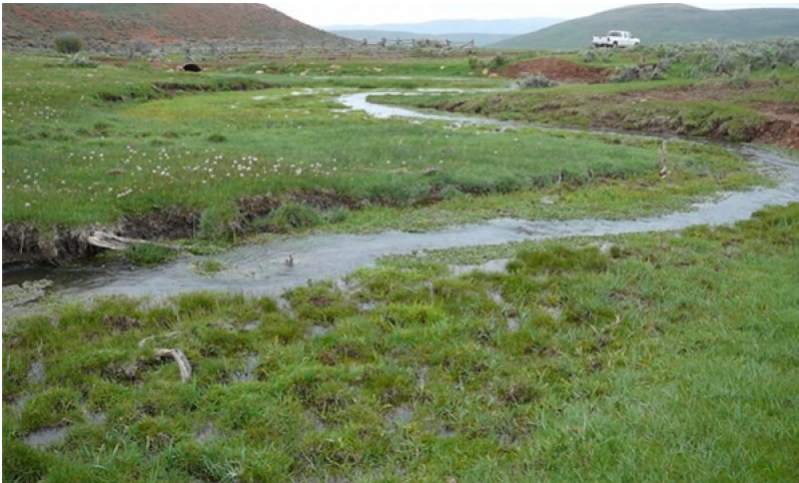
**Figure 17. Early colonizing species beginning to establish on**

This phase functions similarly to 1.2 at a lower elevation with a narrower floodplain and plant community components.

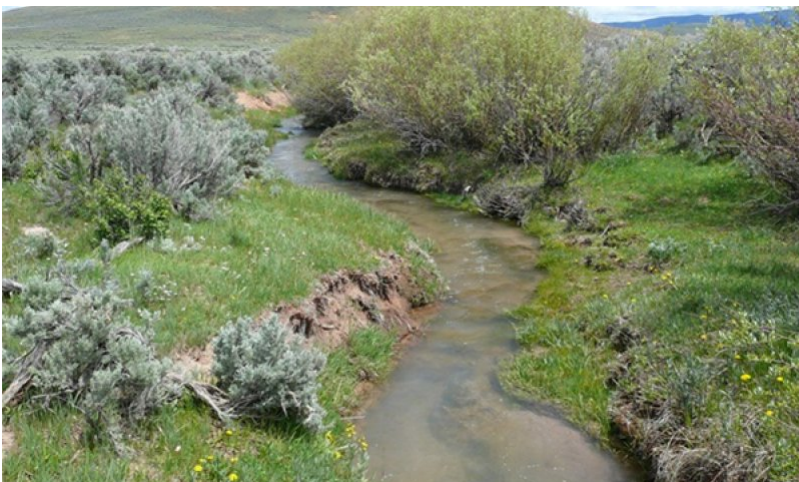
**Figure 18. Channel narrowing after bank sloughing, stream bank**

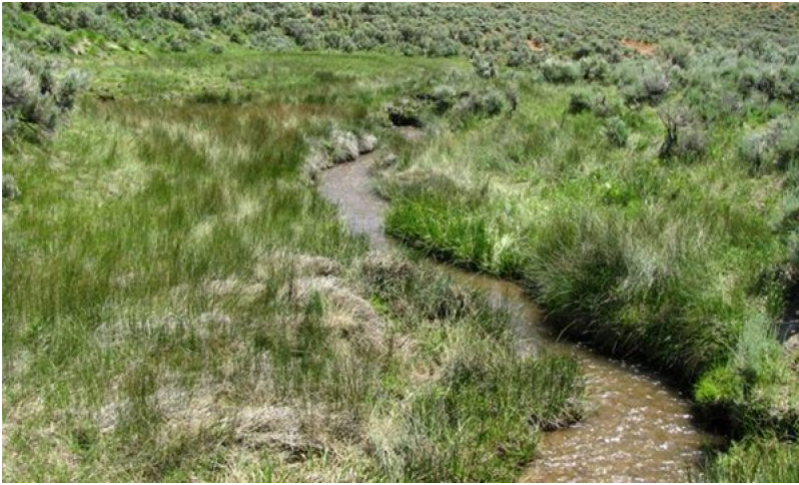
Figure 19. Recovering narrow channel

This phase functions similarly to 1.1 at a lower elevation with a narrower floodplain and plant community components.

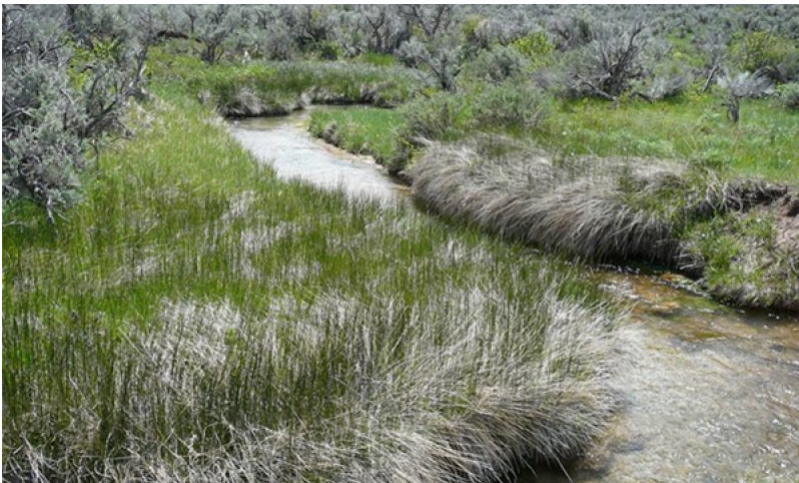
Figure 20. Streambank community establishing
