## Ecological site R034AA012UT Riparian Complex Perennial II/E4 (Nebraska Sedge/Baltic Rush)

Last updated: 9/07/2023  
Accessed: 04/25/2024

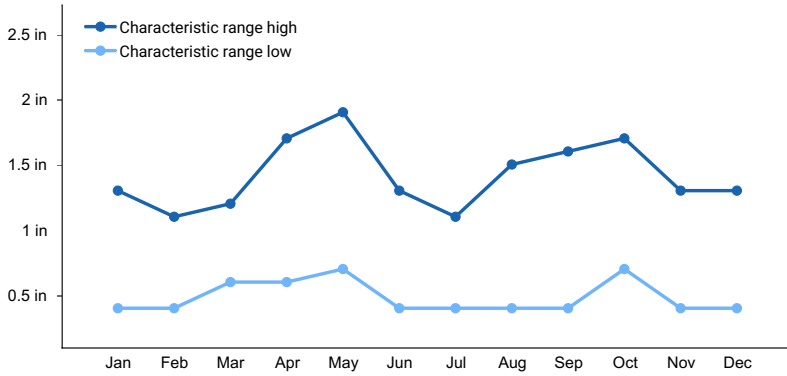
**Figure 1. Monthly precipitation range**

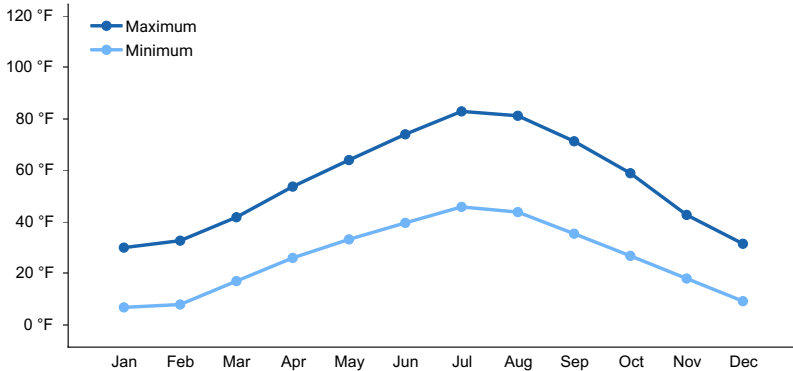
**Figure 2. Monthly average minimum and maximum temperature**

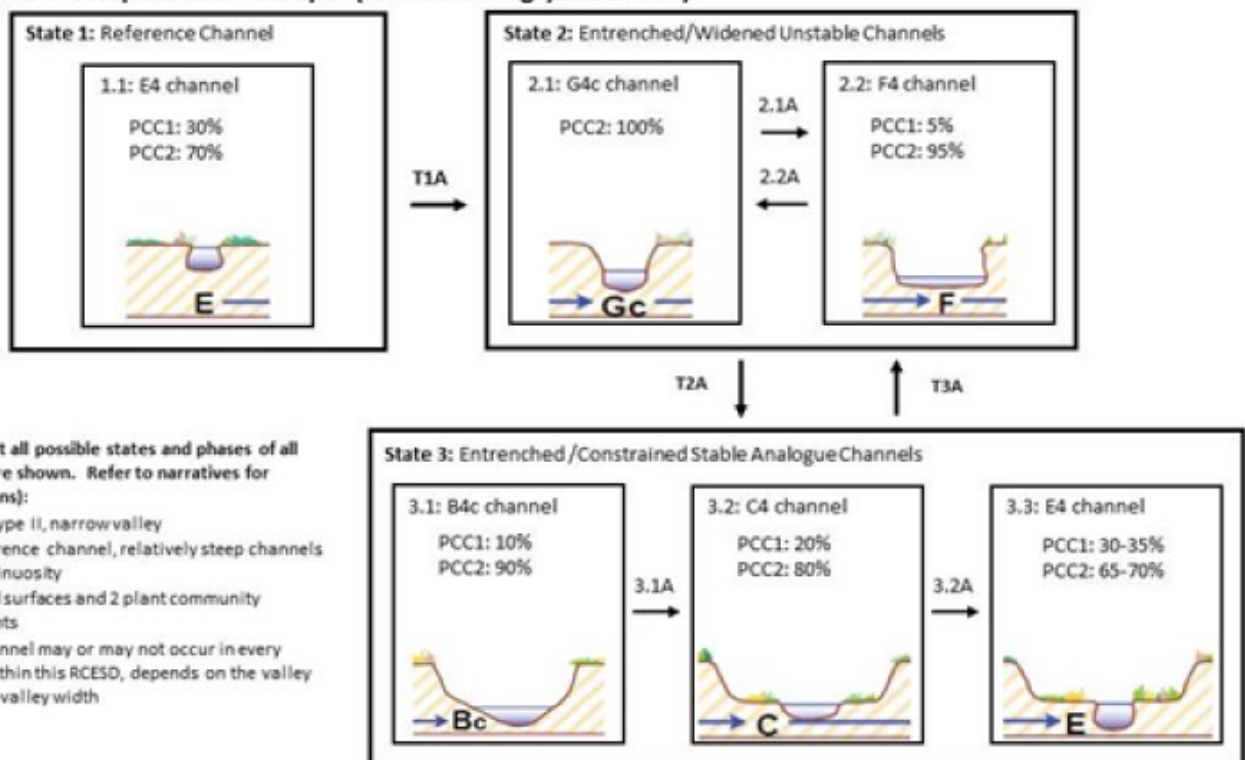
Figure 3. R034AA012UT State and Transition Model

I.D.	Plant Association	Fluvial Surface/Landform
1	Northwest Territory sedge ( <i>Carex utriculata</i> ) / Nebraska sedge ( <i>C. nebrascensis</i> )	Floodplain
2	Baltic rush ( <i>Juncus arcticus</i> ssp. <i>littoralis</i> ) / mesic forbs	Floodplain Step

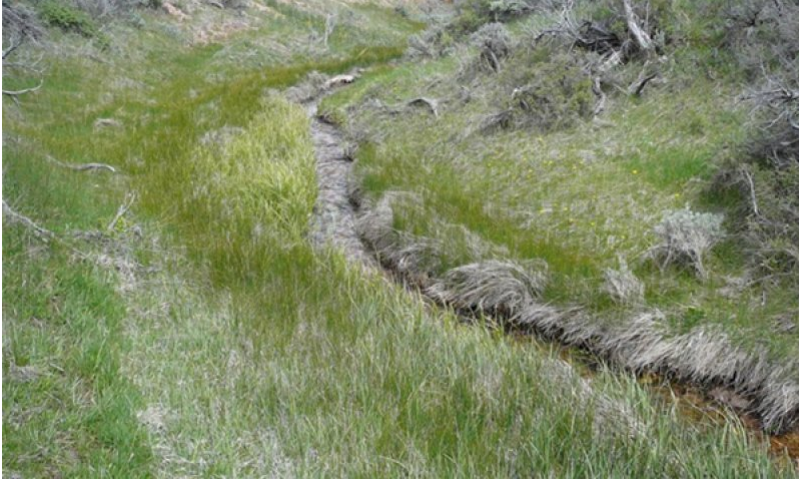
Figure 4. Narrow flood plain with streambank (PCC1)

Community Phase 1.1 has a narrow and deep channel with well-developed vegetation on the streambanks, predominantly composed of sedges and rushes. The flood plain receives regular flooding from snowmelt in the spring. All plant community components may be present in this phase.

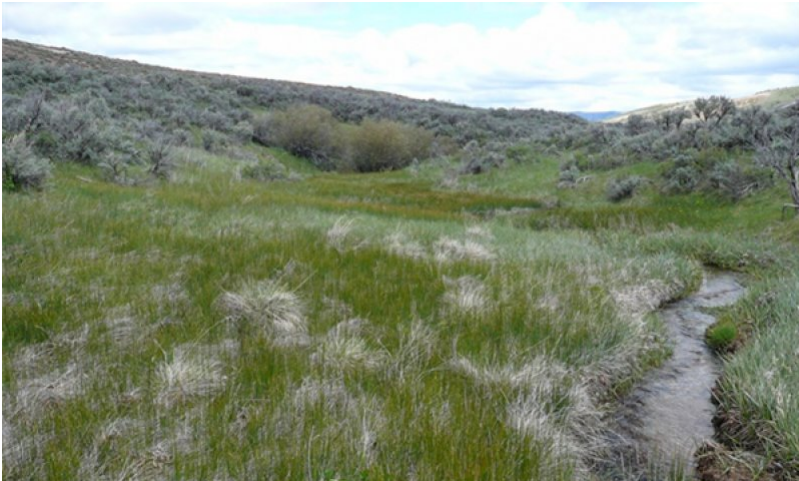
Figure 5. Flood plain plant community (PCC2)

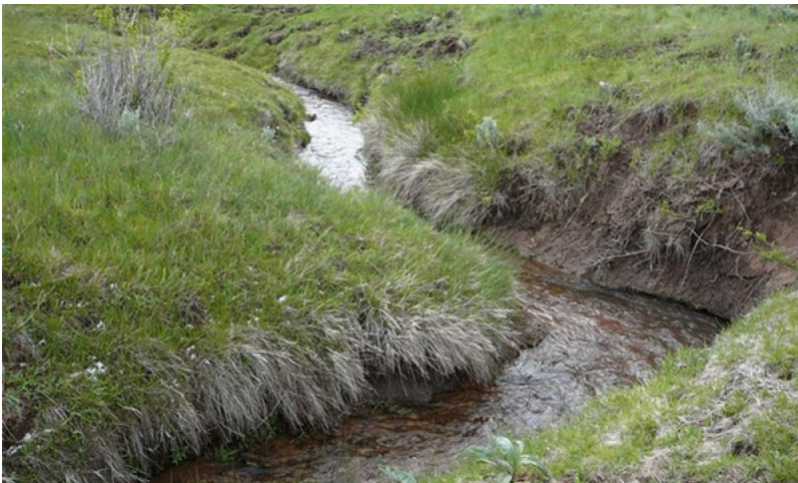
Figure 7. Eroded banks, channel downcut

The stream channel within the G4c Channel Community Phase is vertically unstable. Once the channel down-cuts, the water table within the flood plain typically deepens and the plant community shifts to drier plant species. Plant Community Component 1 is typically lost from this phase.

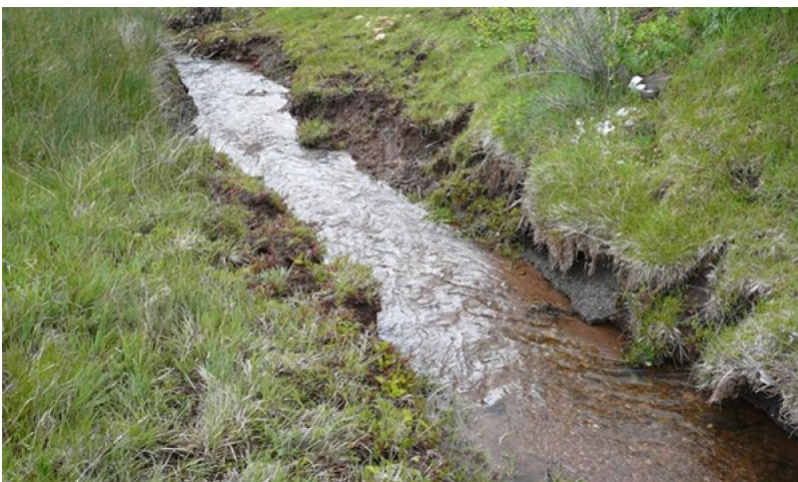
Figure 8. Bank sloughing, loss of streambank (PCC1) plant component lost

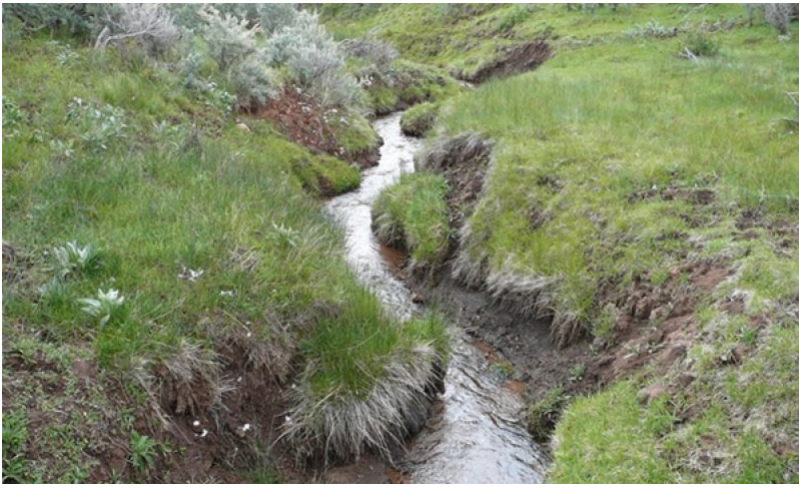
**Figure 9. Bank erosion, stream disconnected from previous flood plain**

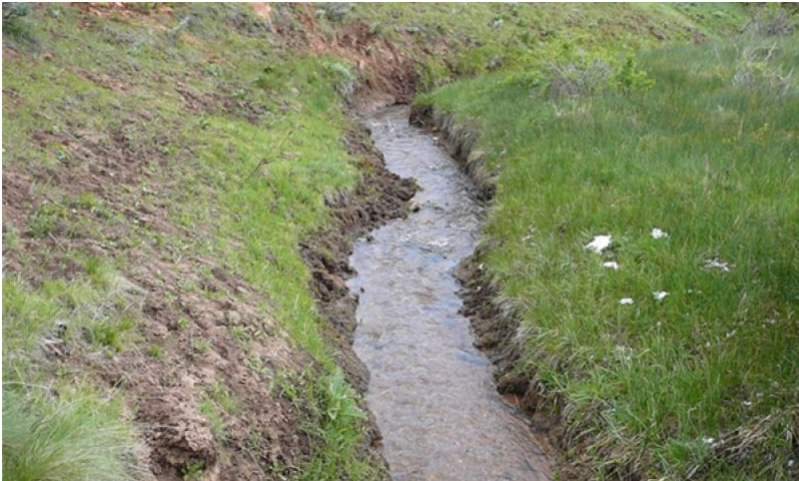
**Figure 10. Downcut, wider channel**

The channel within the F4 Channel Community Phase is lateral unstable. Bank sloughing is common as the channel begins to widen. Plant Community Component 1 is often absent in this phase.

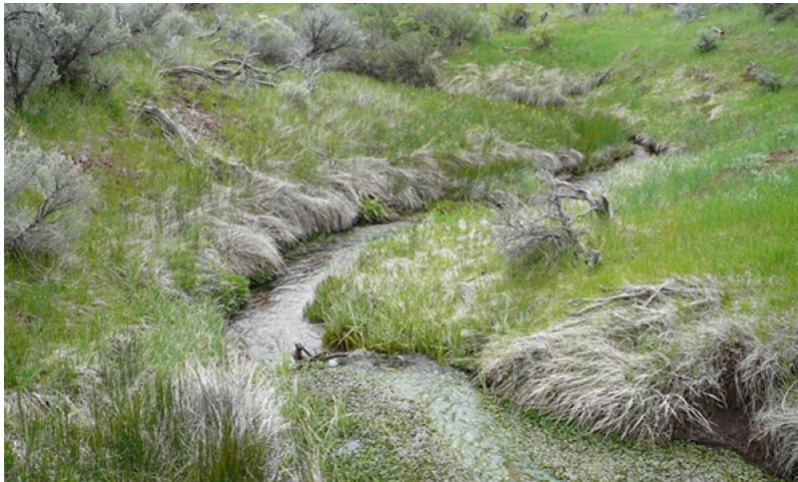
Figure 11. Channel recovery at lower elevation

The E4 Channel Community Phase functions similarly to 1.1 at a lower elevation with a narrower floodplain and plant community components.
