Ecological site R034AA012UT Riparian Complex Perennial II/E4 (Nebraska Sedge/Baltic Rush)

Figure 3. R034AA012UT State and Transition Model

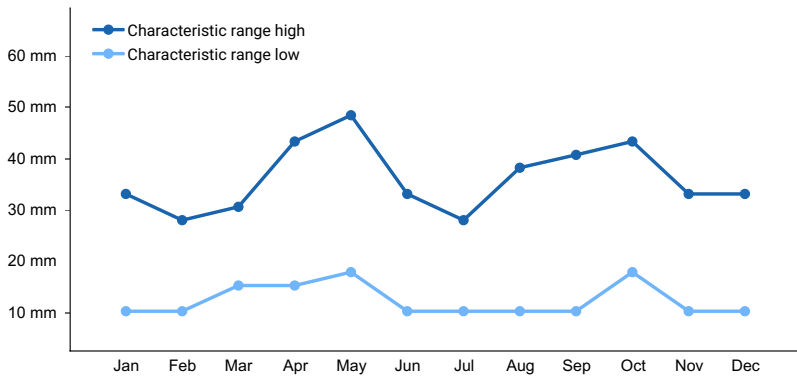
Figure 1. Monthly precipitation range

The average annual precipitation is 10 to 15 inches. Peak precipitation occurs as snow from October through April. This site has cold winters and short summers. Occasional convective thunderstorms produce small amounts of rain from June through September. The average annual temperature is 25 to 55 degrees Fahrenheit. The freeze-free period ranges from 95 to 115 days.

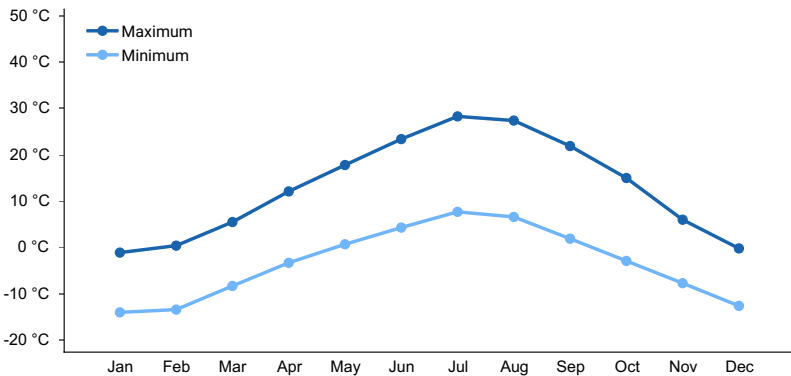
Figure 2. Monthly average minimum and maximum temperature

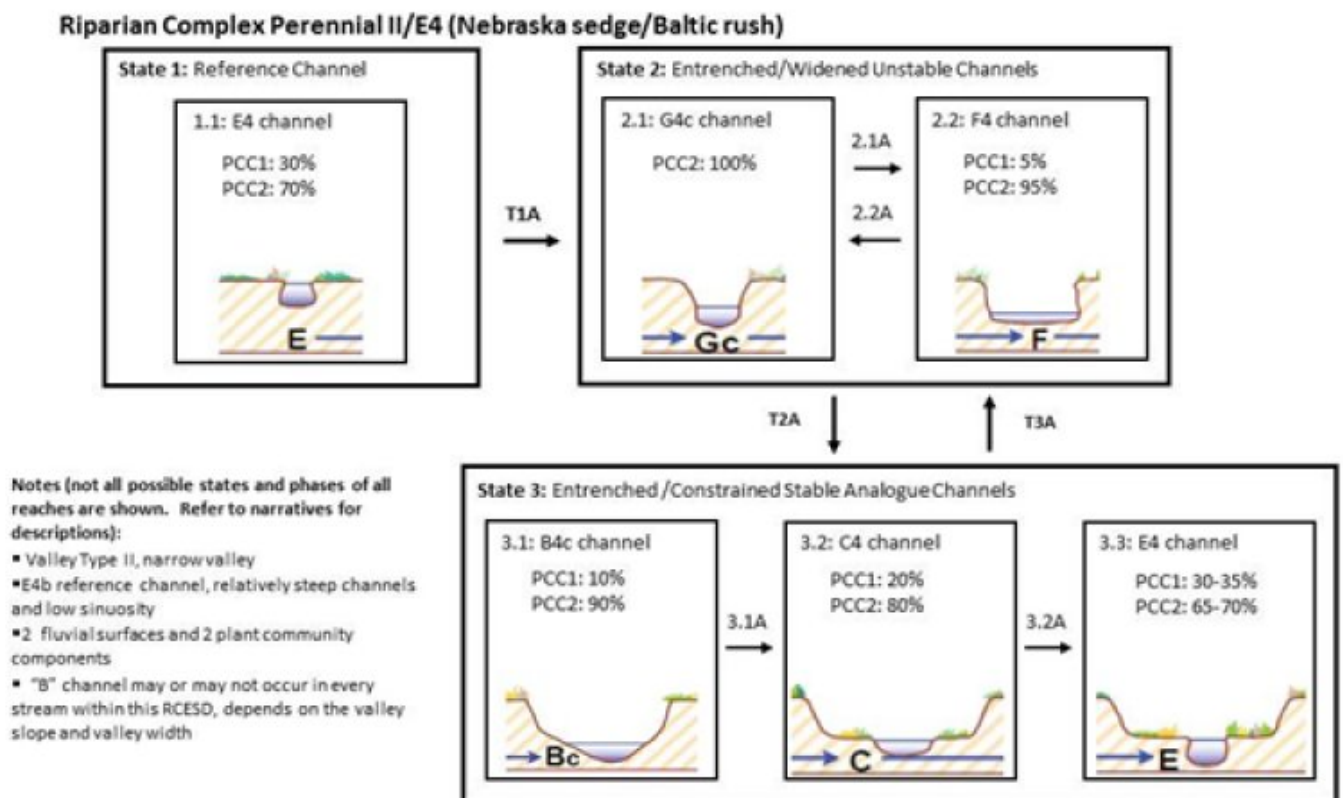
I.D.	Plant Association	Fluvial Surface/Landform
1	Northwest Territory sedge (<i>Carex utriculata</i>) / Nebraska sedge (<i>C. nebrascensis</i>)	Floodplain
2	Baltic rush (<i>Juncus arcticus</i> ssp. <i>littoralis</i>) / mesic forbs	Floodplain Step

Transition 1A

State 1 to 2

Change in vegetation on the banks to shallow rooted species, decrease in bank stability and bank sloughing causing a change in channel geometry to a wider shallower channel

Transition 2A

State 2 to 3

Vegetation re-establishment on streambanks and floodplain, rest from grazing pressure

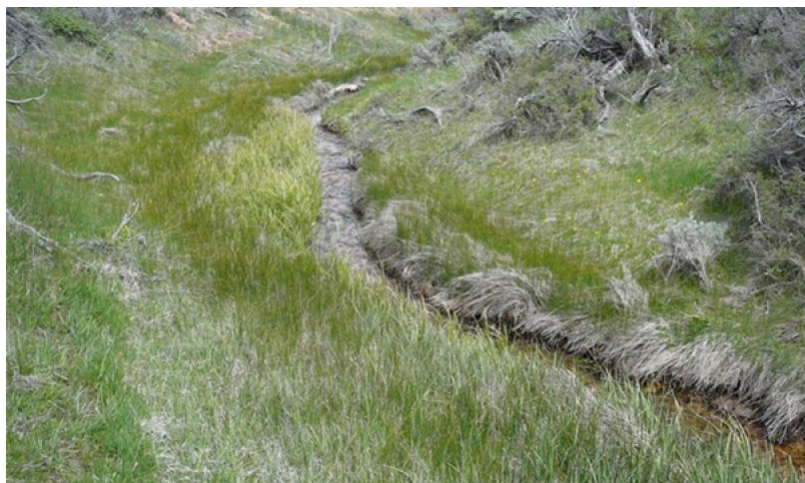
Figure 4. Narrow flood plain with streambank (PCC1)

Community Phase 1.1 has a narrow and deep channel with well-developed vegetation on the streambanks, predominantly composed of sedges and rushes. The flood plain receives regular flooding from snowmelt in the spring. All plant community components may be present in this phase.

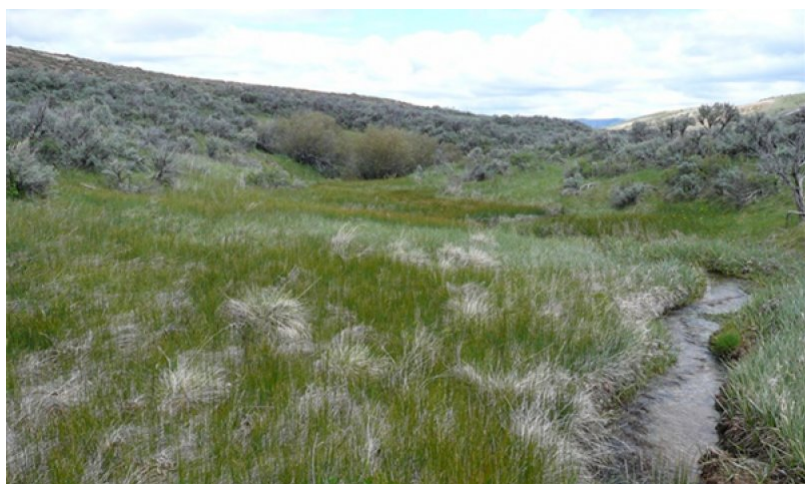
Figure 5. Flood plain plant community (PCC2)

Plant community component 2 is drier than plant community component 1 and is further from the stream and has a deeper water table. The community is composed of various graminoids and forbs, particularly Baltic rush.

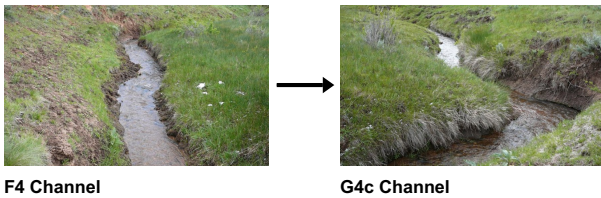
Vertical erosion from bed instability
