# Ecological site R035XY020UT

## Colorado Plateau Riparian Complex Perennial (Valley Type IV - B4C Stream Type)

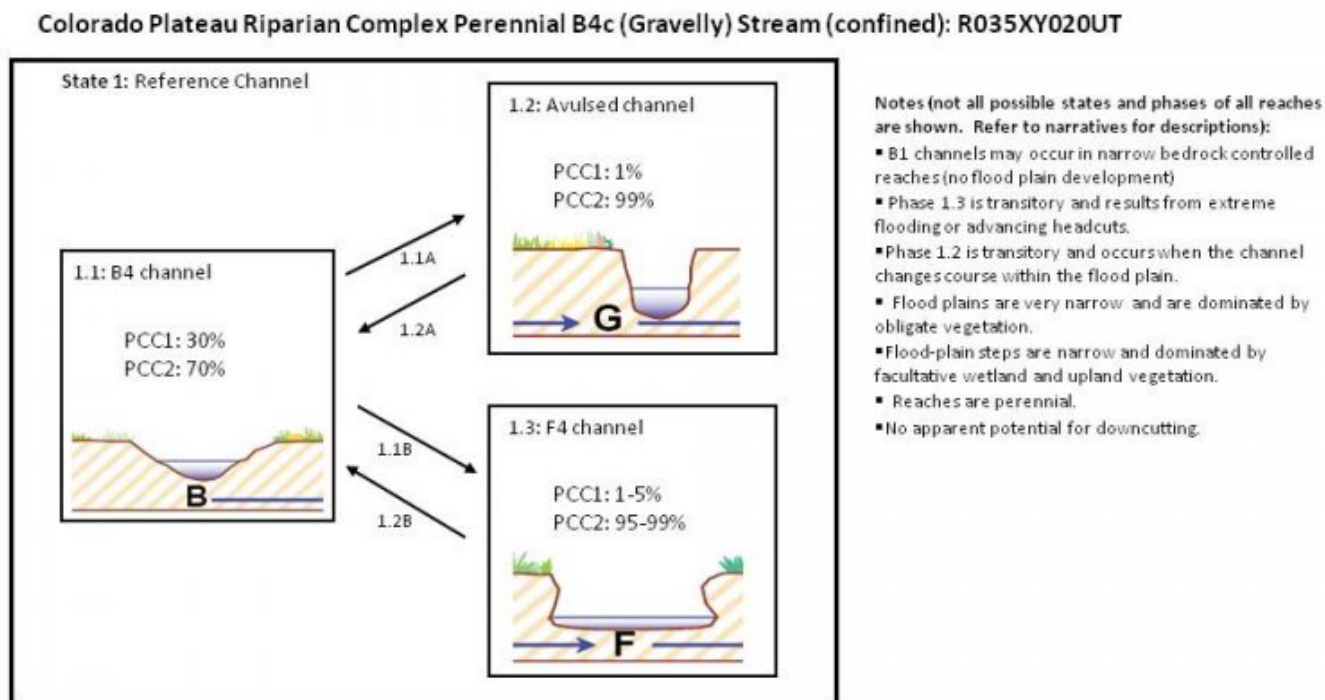
Figure 6. State and Transition Model

I.D.	Plant Association	Fluvial Surface/Landform
1	Baltic rush/common three square – Coyote willow	Bank zone/Floodplain
2	Fremont cottonwood	Over bank zone/Flood-plain step

The state and transition model is based on a customized (derived from documented scenarios) stream succession scenario of B4c > G4/F4. This may be due to bedrock controlling the stream grade; instead of the stream channel down cutting, the stream moves within the flood plain, creating a new channel.

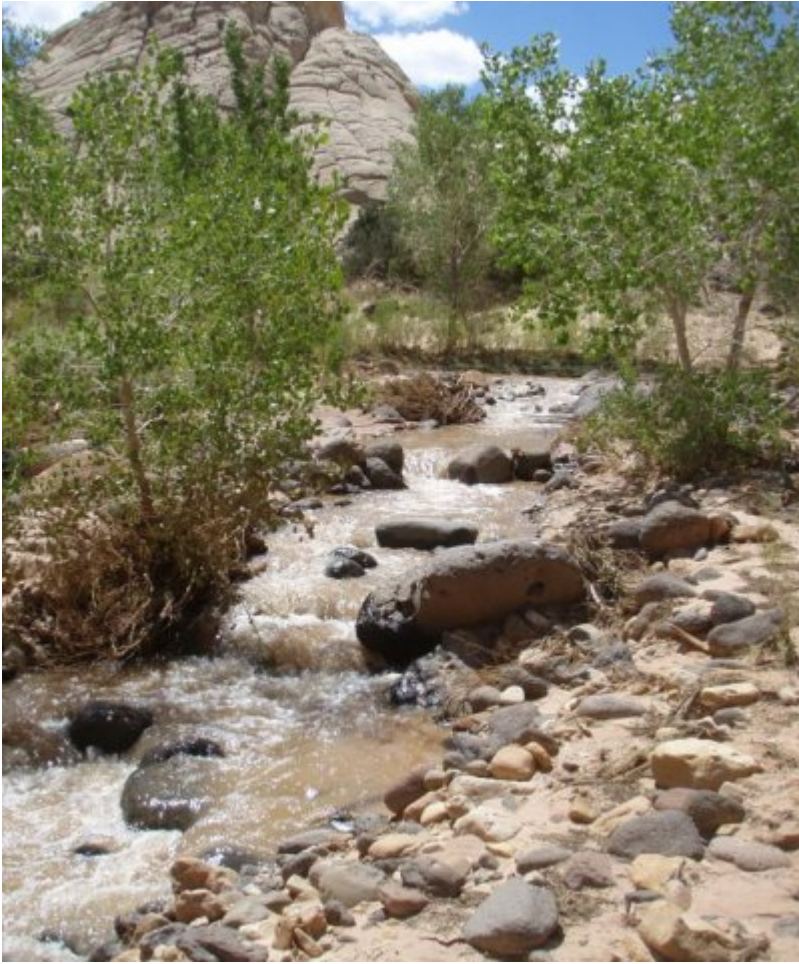
**Figure 11. G3 Channel**

This state occurs when disturbances remove bank stabilizing vegetation which leads to destabilization of banks and bed. The F4 channel evolves from the B4c channel by scouring bank sediments and widening the channel. This channel can also evolve from the “G” avulsed channel from lateral erosion on the stream banks that create a wider channel. Disturbances that could cause this include large floods that scour vegetation below flood prone area. Increased erosion of banks and bed result in some vertical instability and especially lateral instability. This site also has sections that are bedrock controlled that will not deepen vertically. In this situation the stream channel will erode laterally. In this state the stream becomes disconnected from the floodplains. Stream bank vegetation (PCC1) is removed and some floodplain vegetation is also removed (PCC2). This channel morphology may also be the result of a large sediment pulse that is deposited in the channel and that the intermittent flow is unable to carry downstream. Channel avulsion may also occur in this site where the channel abruptly changes course and cuts off a meander bend. The resulting channel is shorter and has a steeper slope. PCC1 is virtually absent from this phase because the new channel cut through the flood-plain step. Stream side vegetation may develop over time, or the channel may erode laterally before it begins rebuilding banks and PCC1. PCC1 - Baltic rush/coyote willow - bank zone/flood plain - 1% composition PCC2 - Fremont cottonwood - overbank zone/flood-plain step - 99% composition

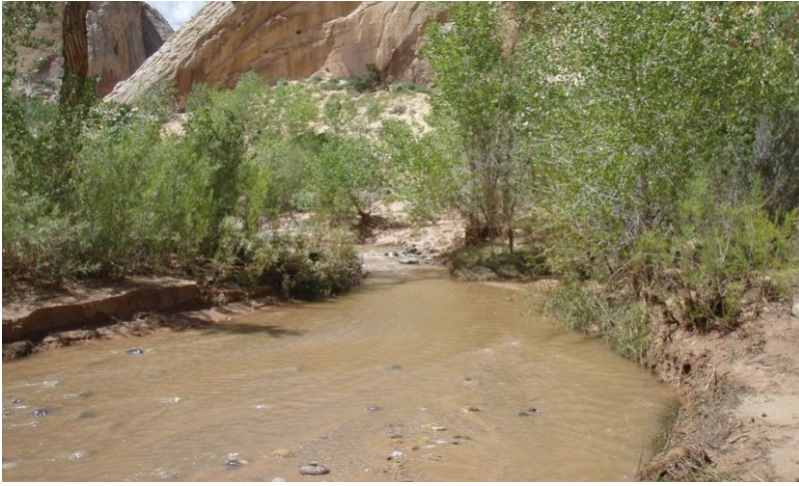
Figure 12. Typical F4 channel

This phase represents the channel after sediment has been scoured from banks, creating a wider, shallower channel. The flood-plain step (PCC2) is the predominant fluvial surface in this state; however PCC1 may be present in narrow and/or short sections where the banks have slumped. Stream banks/floodplains have some herbaceous and shrubby vegetation, but generally not enough for stabilizing fine sediment soils on the stream banks. Above the flood prone area are wider, flatter terraces with scattered cottonwood and shrubs with few grasses (PCC2). PCC1 - Baltic rush/coyote willow - bank zone/flood plain - 1-5% composition PCC2 - Fremont cottonwood - overbank zone/flood-plain step - 95-99% composition

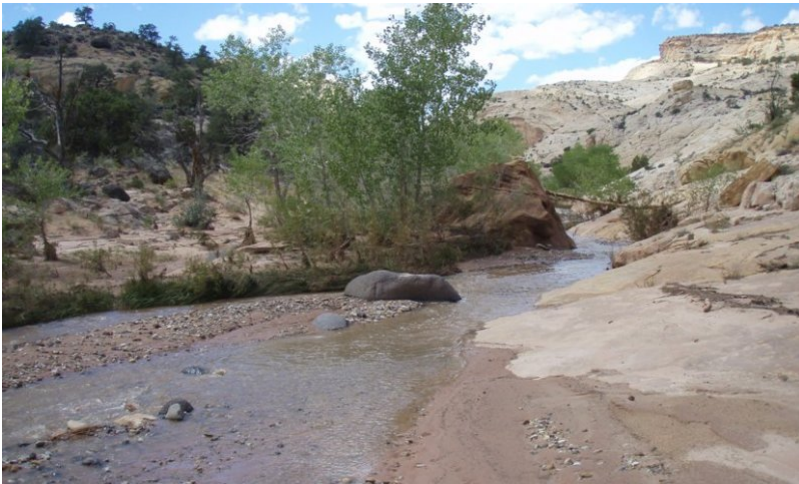
Figure 13. F4 channel with bedrock control on left bank
