Ecological site R036XC013UT

Southwestern Plateau Riparian Complex Intermittent (Valley Type IV - F4/B4C Stream Type)

Last updated: 9/07/2023
Accessed: 11/21/2024

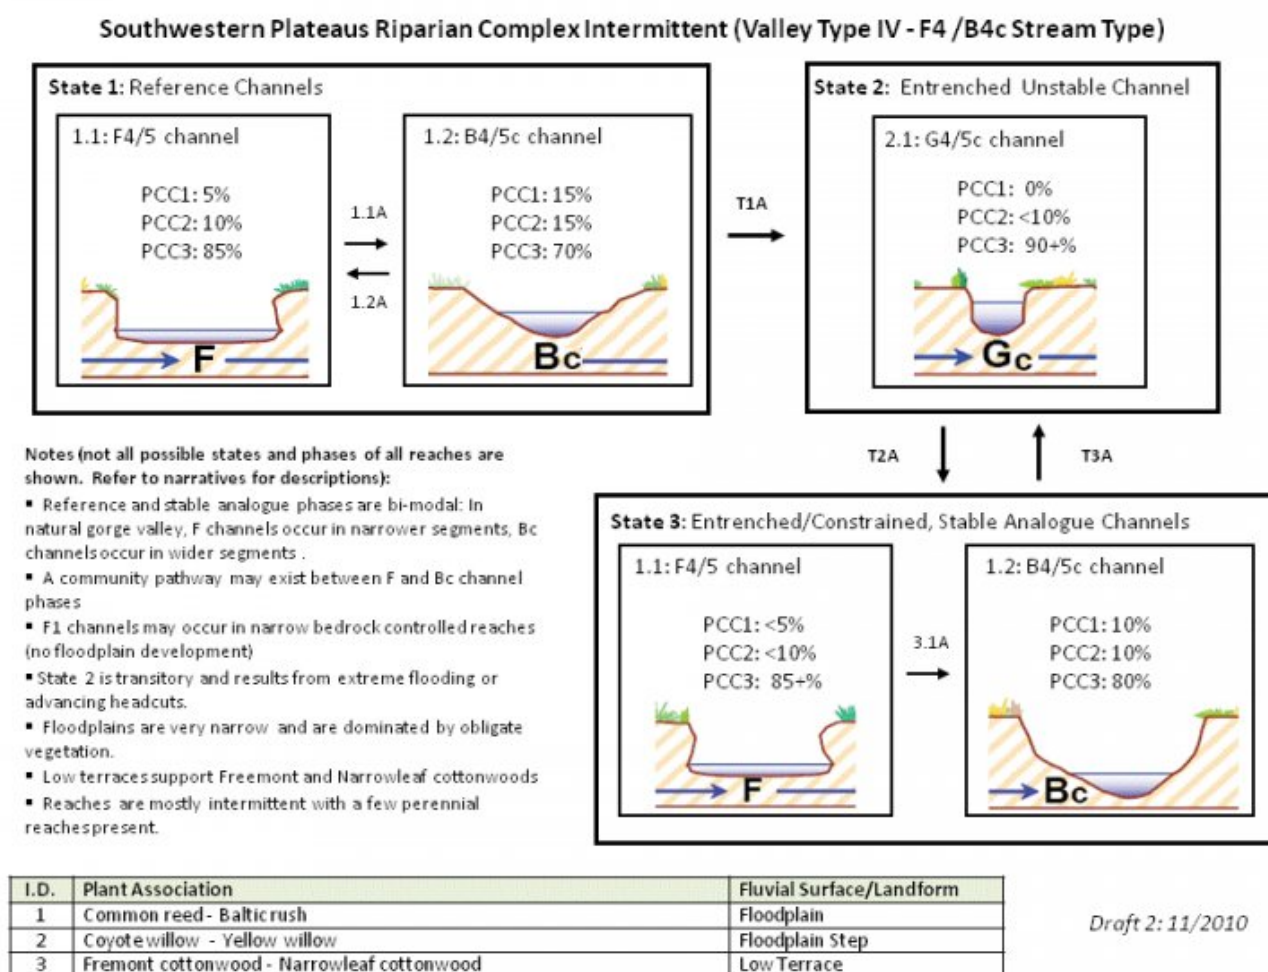
Figure 3. State and Transition Model

State 1 Reference Channels

The Reference Channels State is characterized as a B4c/F4 channel. There are two phases identified in this state, F4 and B4c channel. The F4 channel may evolve into a B4c channel through sediment deposition in the channel. This is believed to occur when there is enough valley fill to create an expanded floodplain and a low terrace. This occurs through a community pathway where no transition is crossed. Both channels are considered stable. The freshly deposited sediment is colonized by plants either through seed or rhizomes. The material on the stream banks is fine material (sand) that is more susceptible to erosion when not held together by roots, especially from rhizomatous plants and shrubs. Movement to any other channel type indicates a threshold has been crossed and

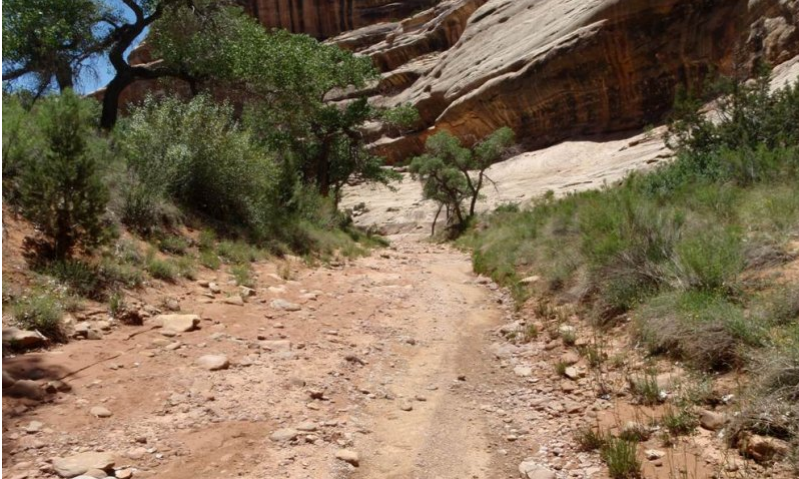
Figure 4. F4 channel, note flat channel bottom.

This phase represents the channel after a flood has removed deposition and PC1. There are generally three major fluvial surfaces with distinct plant communities (PC1, PC2, and PC3) on each surface. Stream banks/floodplains have herbaceous and shrubby vegetation for stabilizing fine sediment soils on the stream banks and are below the flood prone area. Above the flood prone area are wider, flatter terraces with scattered cottonwood and shrubs with few grasses (PC3).

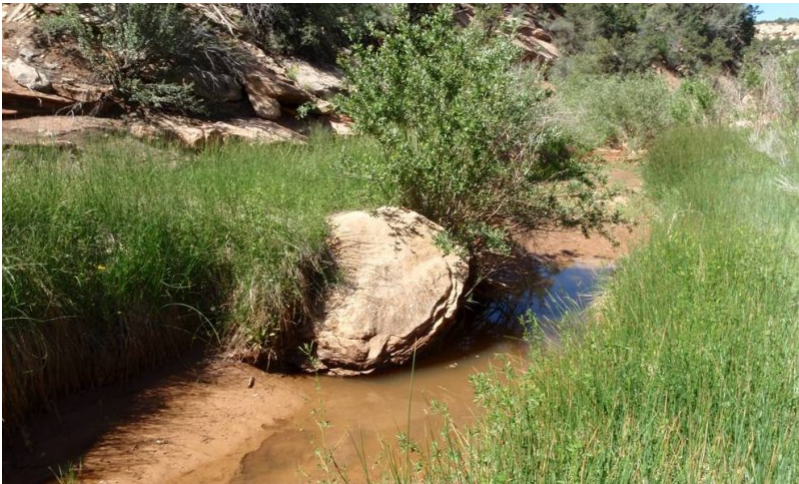
Figure 5. Example of PCC1 (bank zone/floodplain)

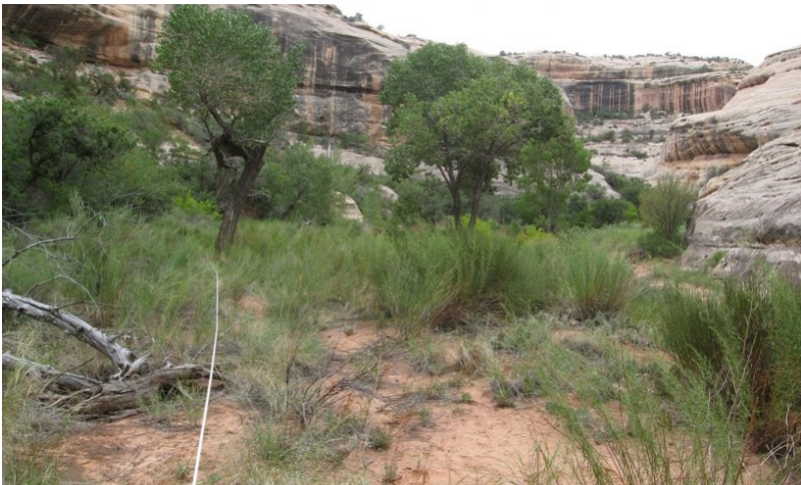
Figure 7. Scattered old Fremont cottonwood in PCC3 located o

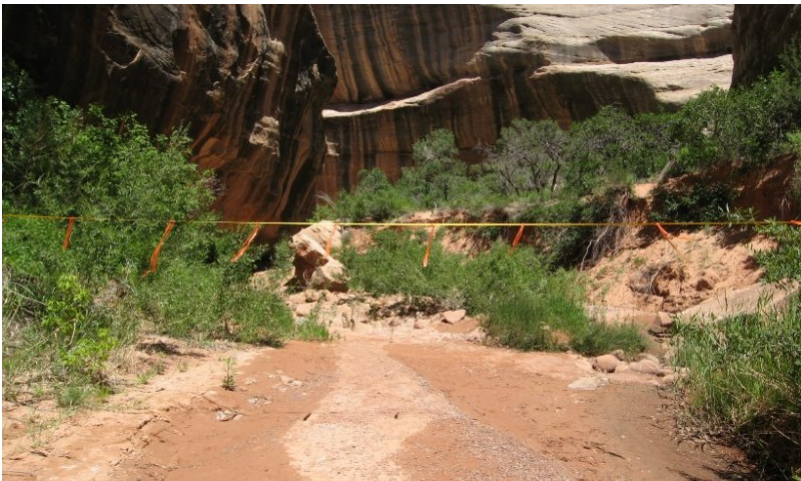
Figure 8. F4 channel with high terrace.

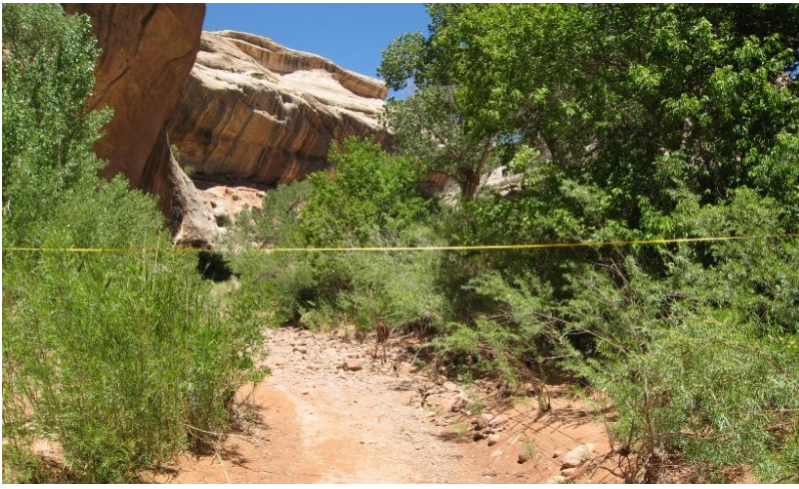
Figure 11. B4c intermittent channel.

This phase represents a relatively stable combination of stream morphology and potential natural vegetation. This phase provides better in stream habitat for aquatic species because it has more pools than phase 1.1. There are generally three major fluvial surfaces with distinct plant communities (PC1, PC2, and PC3) on each surface. Stream banks/floodplains have herbaceous and shrubby vegetation for stabilizing fine sediment soils on the stream banks and are below the flood prone area and have greater composition than phase 1.1. Above the flood prone area are wider, flatter terraces with scattered cottonwood and shrubs with few grasses (PC3).

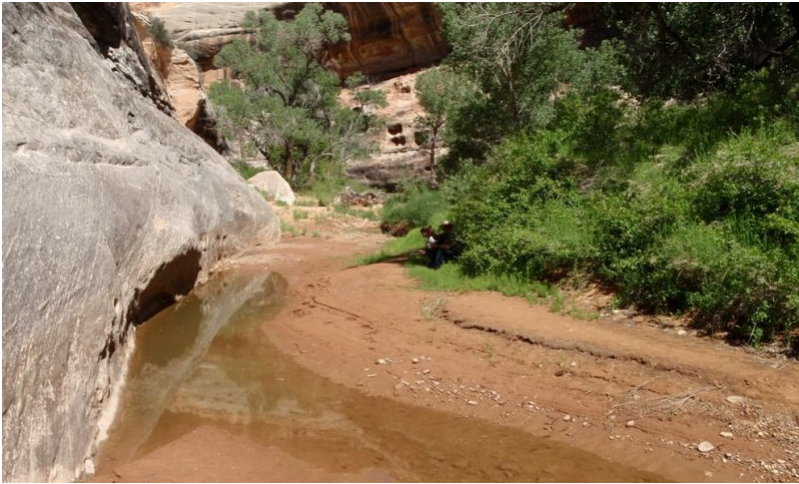
Figure 12. B4c channel with bedrock control, bankfull elevati
