Ecological site R036XC013UT

Southwestern Plateau Riparian Complex Intermittent (Valley Type IV - F4/B4C Stream Type)

Last updated: 9/07/2023
Accessed: 11/21/2024

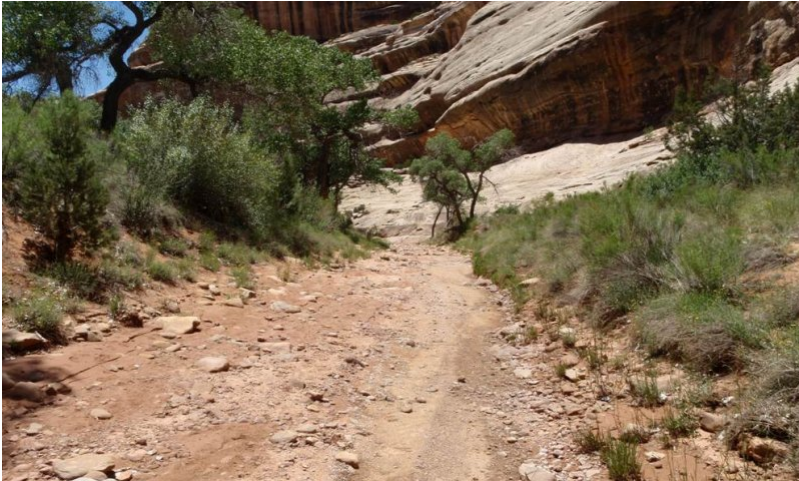
Figure 4. F4 channel, note flat channel bottom.

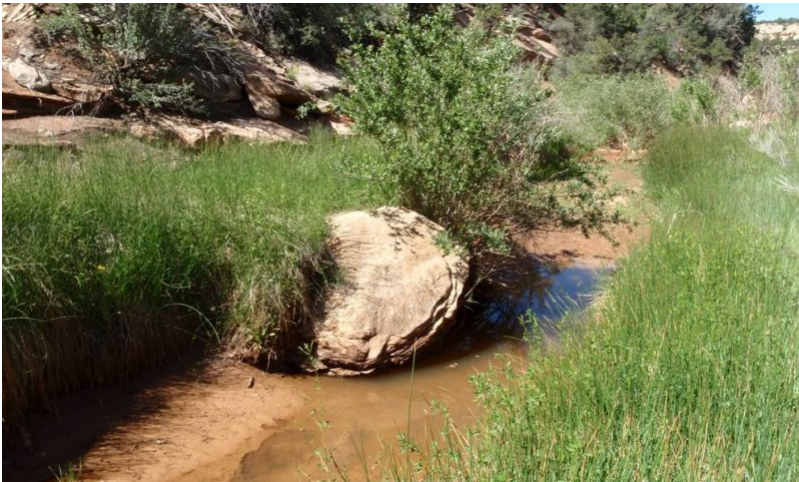
Figure 5. Example of PCC1 (bank zone/floodplain)

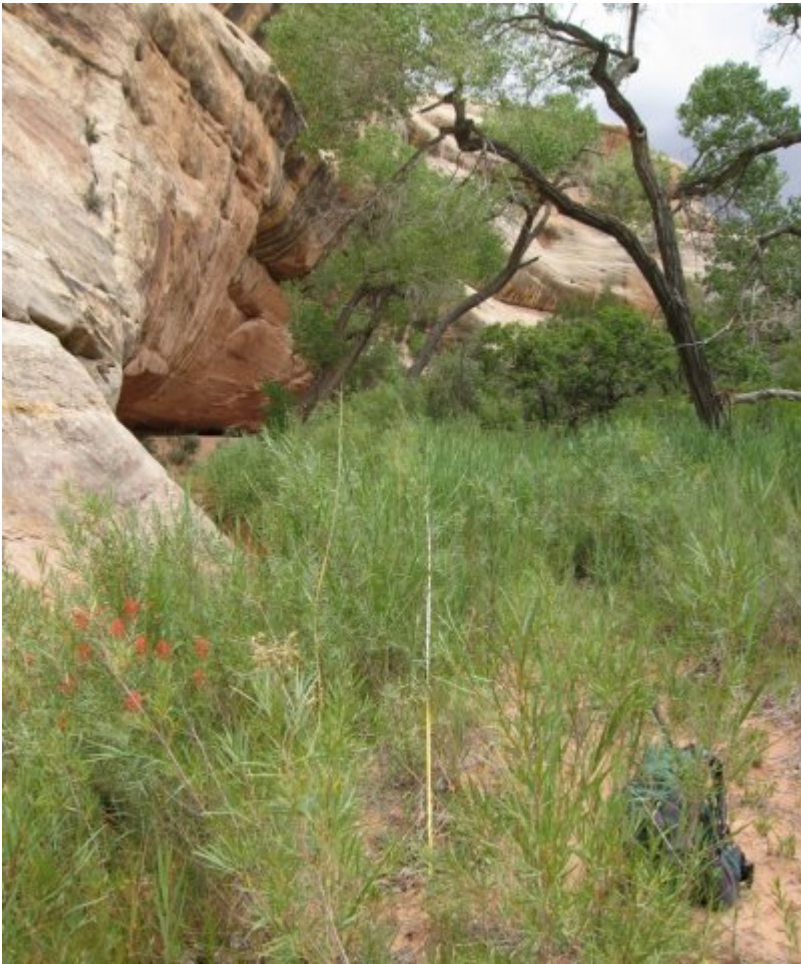
Figure 6. Coyote willow in PCC2 within floodprone elevation.

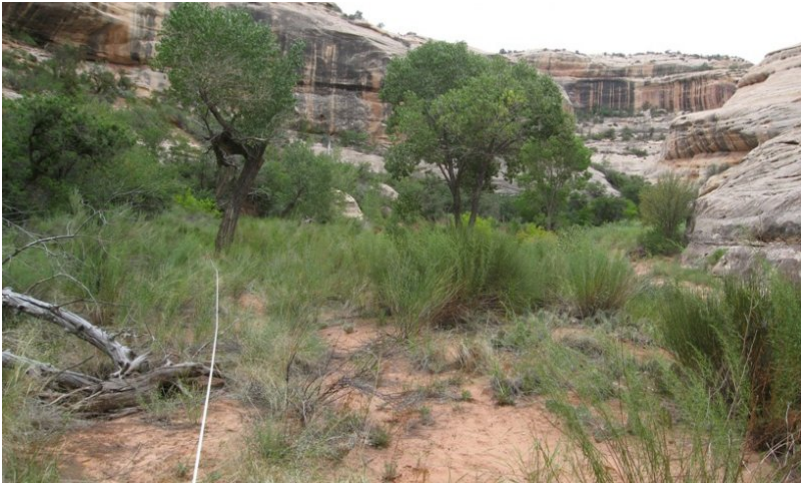
Figure 7. Scattered old Fremont cottonwood in PCC3 located o

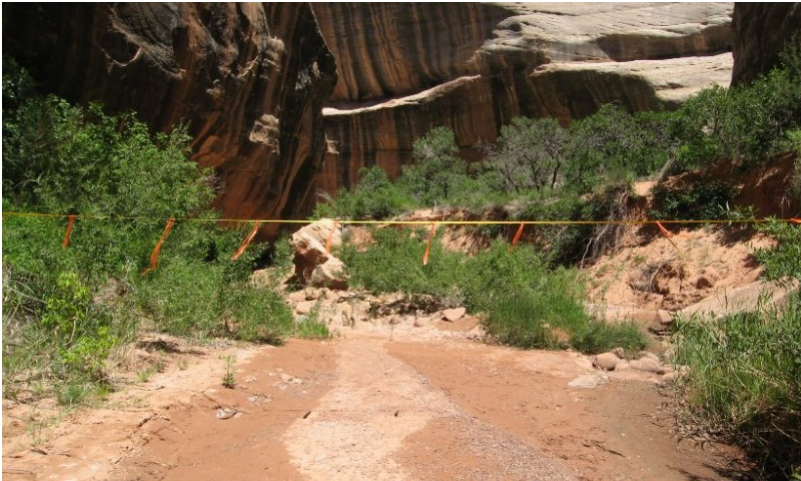
Figure 8. F4 channel with high terrace.

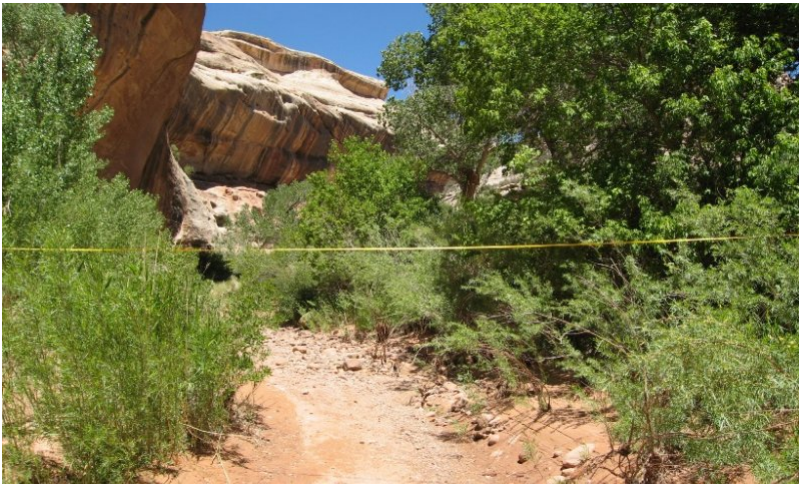
Figure 11. B4c intermittent channel.

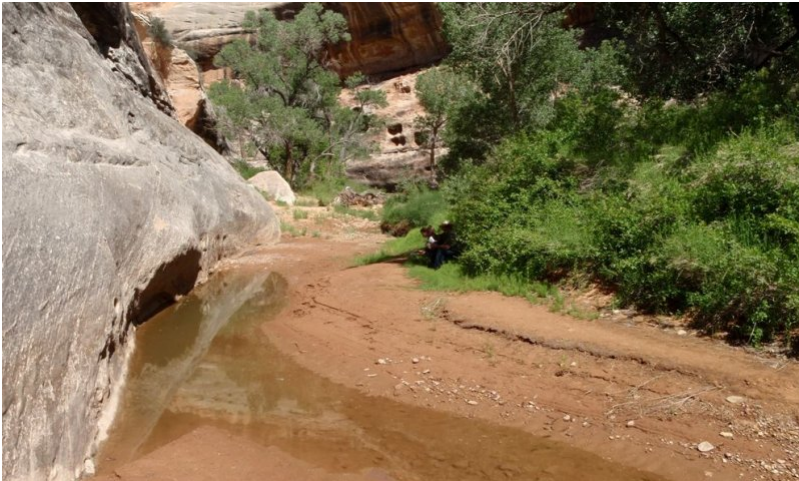
Figure 12. B4c channel with bedrock control, bankfull elevati

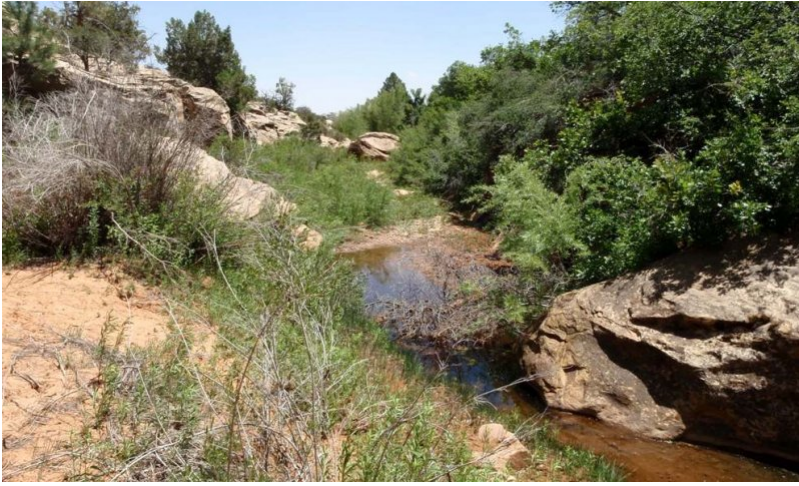
Figure 13. Entrenched F4 channel.
