Ecological site R036XC013UT

Southwestern Plateau Riparian Complex Intermittent (Valley Type IV - F4/B4C Stream Type)

General information

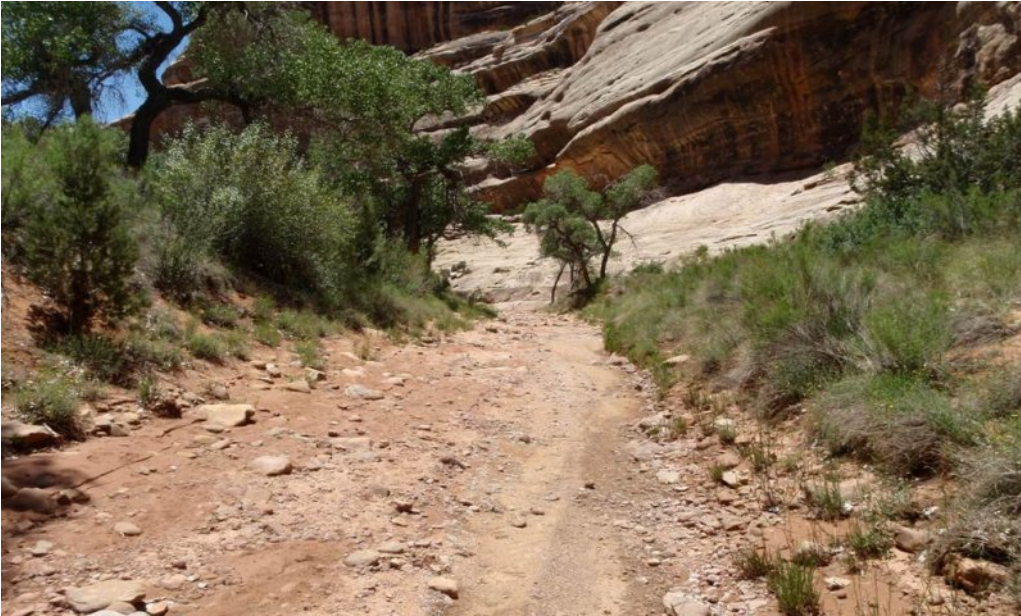
Figure 4. F4 channel, note flat channel bottom.

This phase represents the channel after a flood has removed deposition and PC1. There are generally three major fluvial surfaces with distinct plant communities (PC1, PC2, and PC3) on each surface. Stream banks/floodplains have herbaceous and shrubby vegetation for stabilizing fine sediment soils on the stream banks and are below the flood prone area. Above the flood prone area are wider, flatter terraces with scattered cottonwood and shrubs with few grasses (PC3).

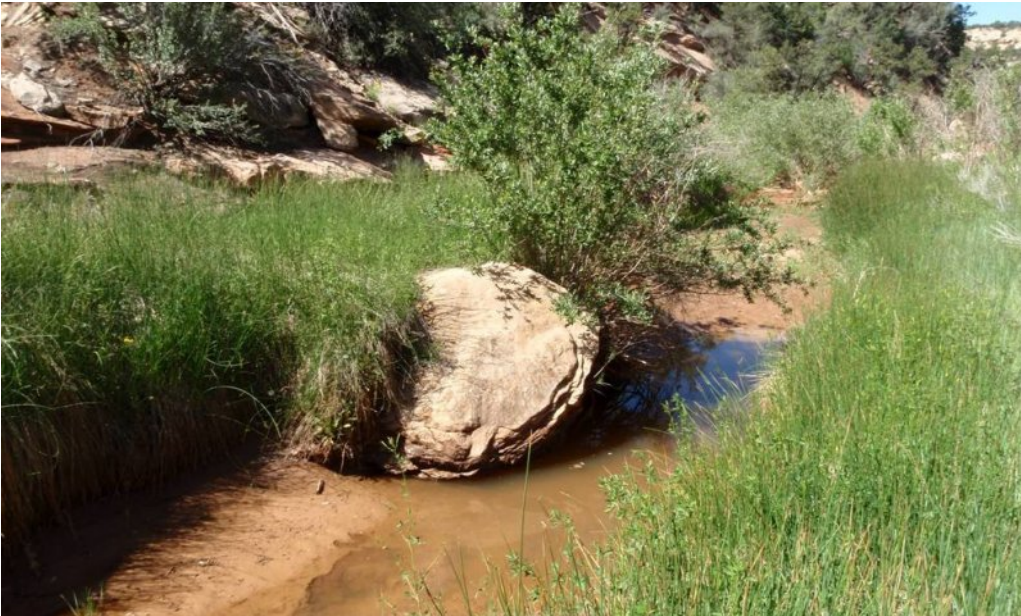
Figure 5. Example of PCC1 (bank zone/floodplain)

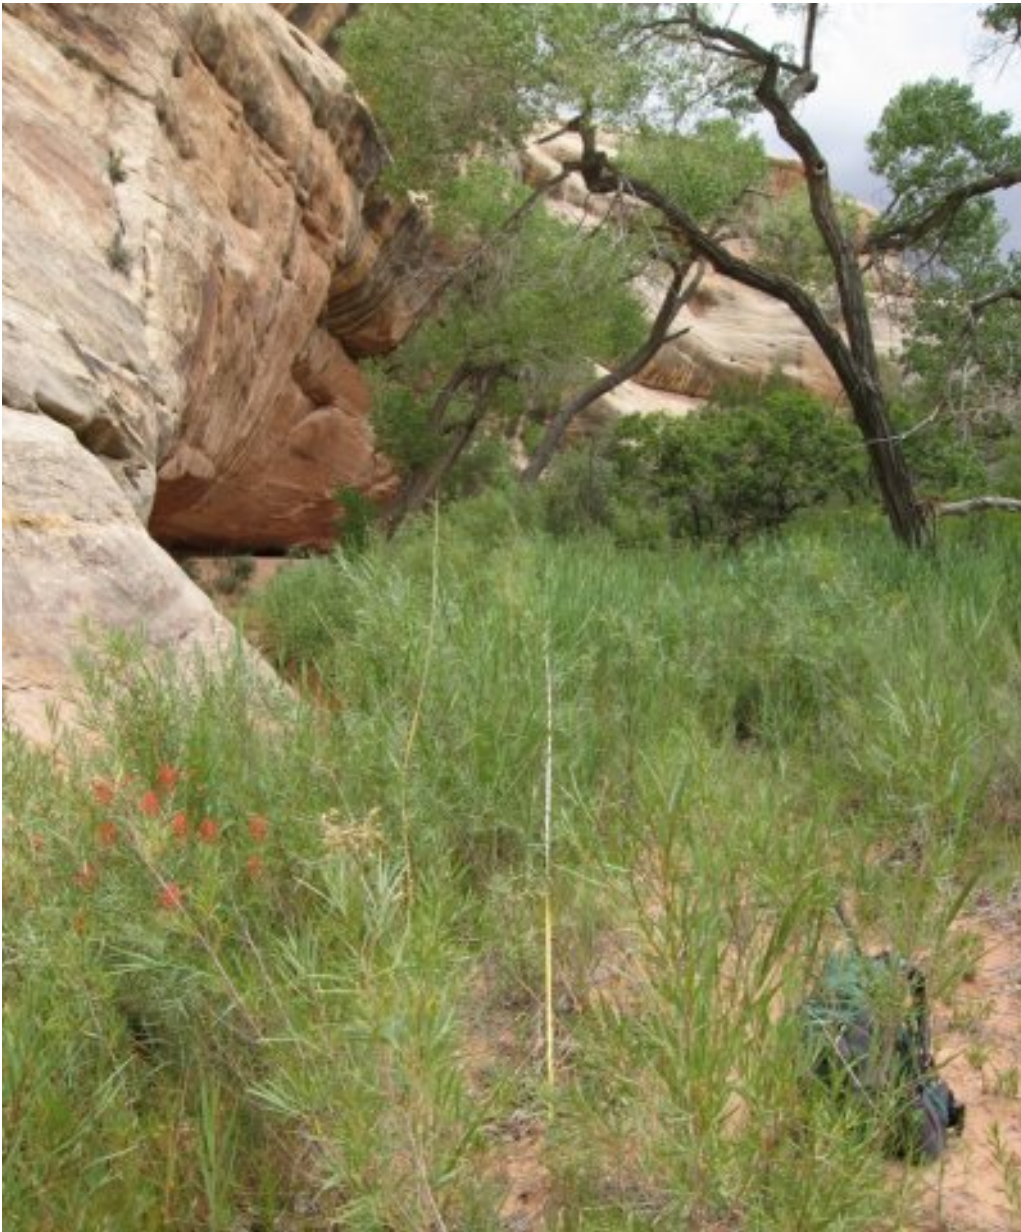
Figure 6. Coyote willow in PCC2 within floodprone elevation.

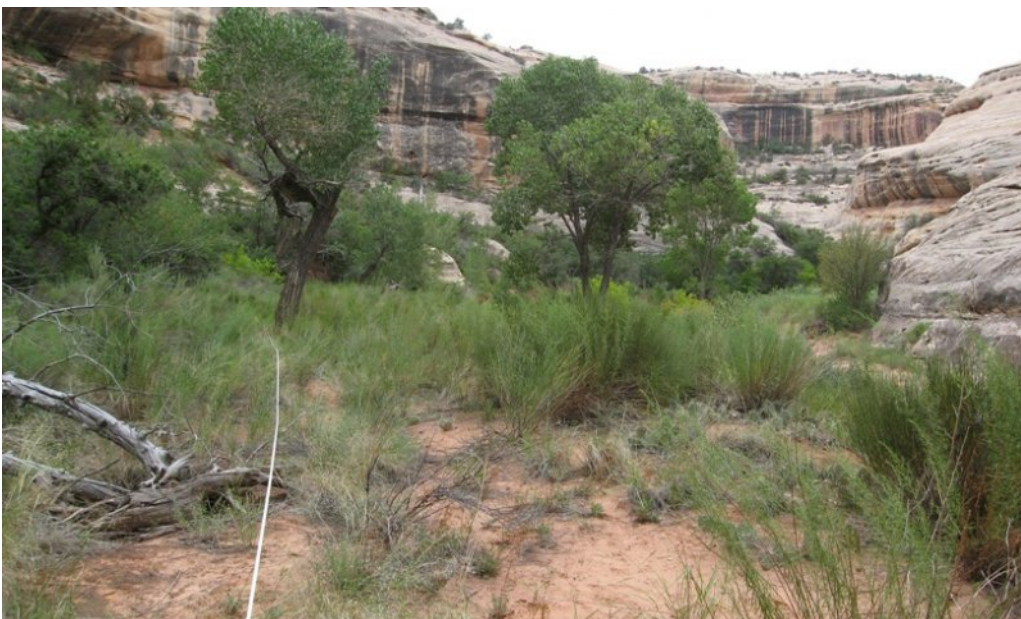
Figure 7. Scattered old Fremont cottonwood in PCC3 located o

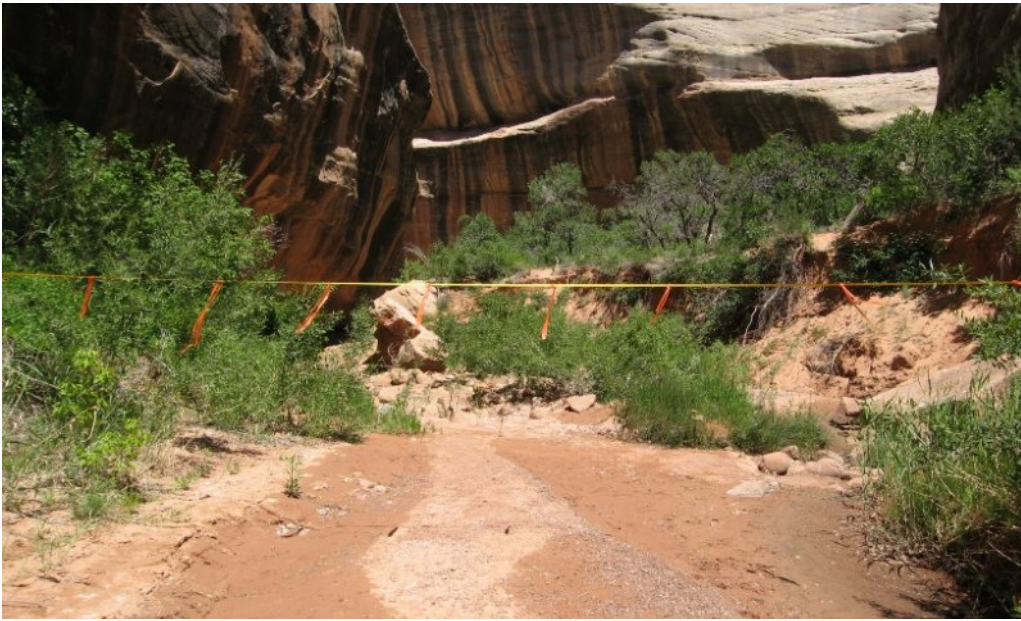
Figure 8. F4 channel with high terrace.

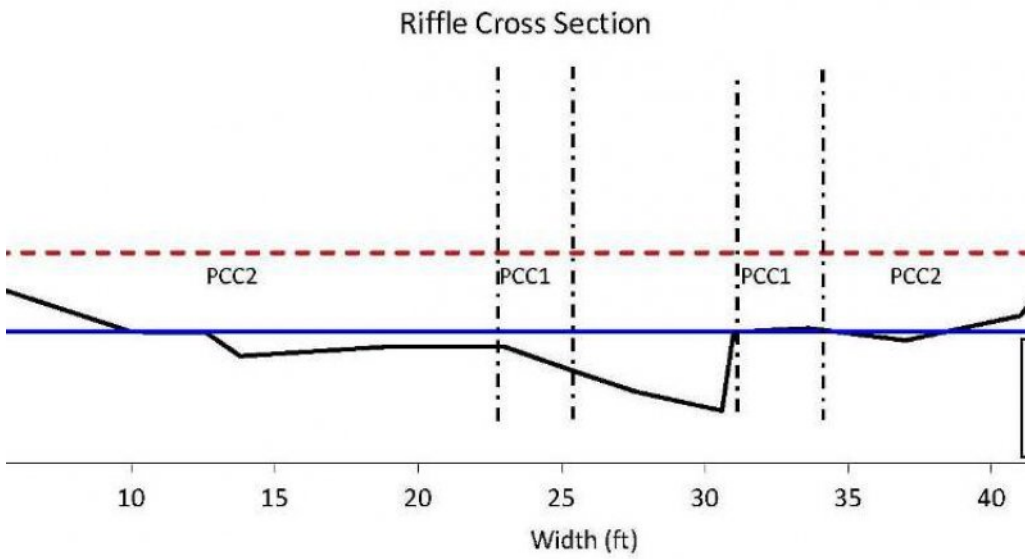
Figure 10. Stream channel cross section with PCC delineated.

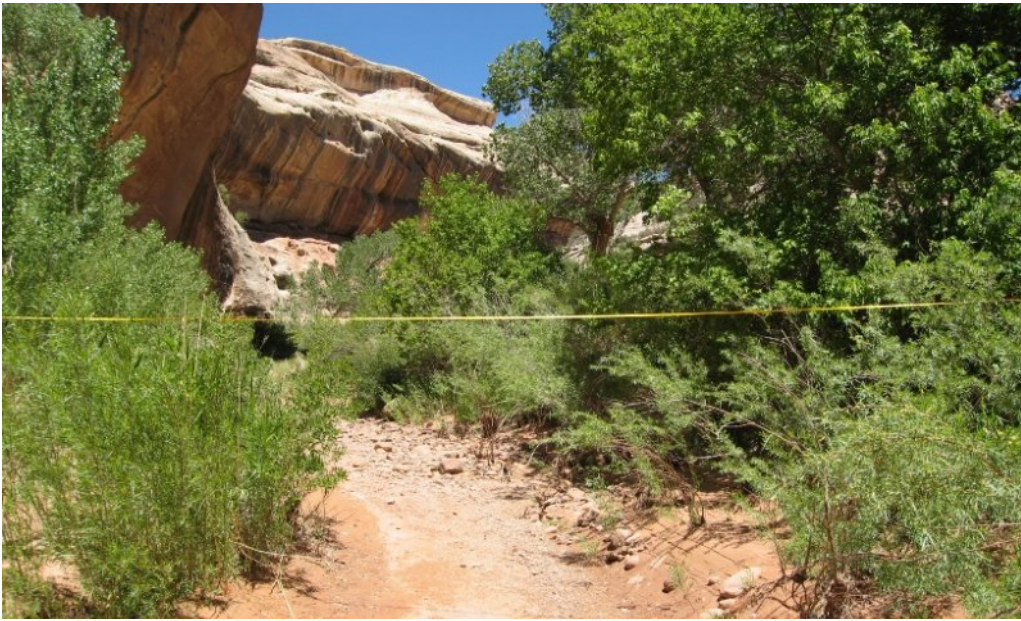
Figure 11. B4c intermittent channel.

This phase represents a relatively stable combination of stream morphology and potential natural vegetation. This phase provides better in stream habitat for aquatic species because it has more pools than phase 1.1. There are generally three major fluvial surfaces with distinct plant communities (PC1, PC2, and PC3) on each surface. Stream banks/floodplains have herbaceous and shrubby vegetation for stabilizing fine sediment soils on the stream banks and are below the flood prone area and have greater composition than phase 1.1. Above the flood prone area are wider, flatter terraces with scattered cottonwood and shrubs with few grasses (PC3).

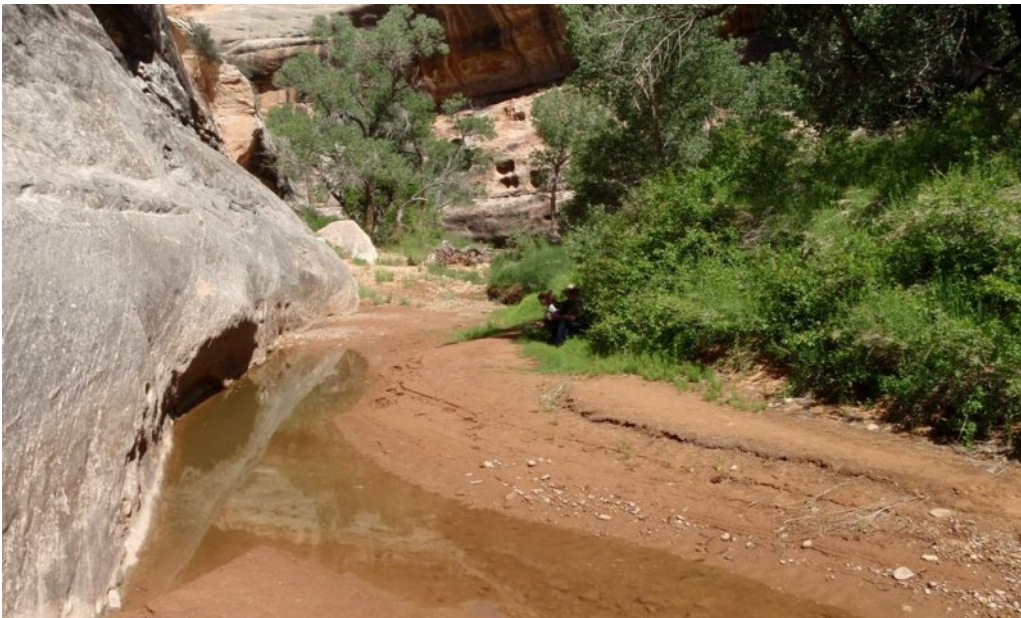
Figure 12. B4c channel with bedrock control, bankfull elevation

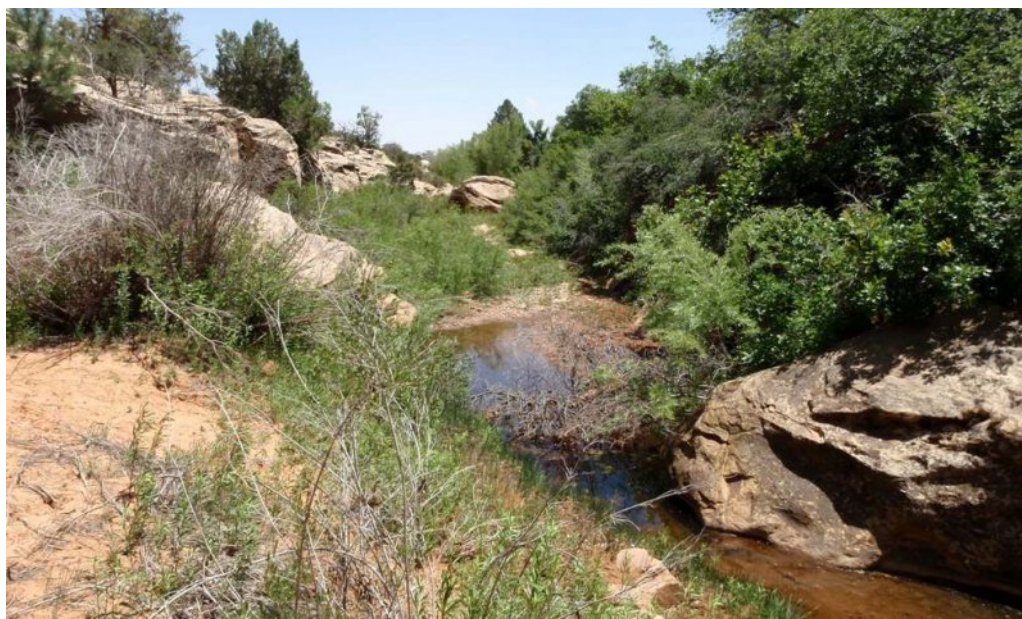
Figure 13. Entrenched F4 channel.

This phase represents the initial re-establishment of stream connectivity to its floodplain. Narrow floodplains are established where desirable bank stabilizing vegetation can establish. Local water tables may be raised, creating better conditions for terrace vegetation as well. All three plant community components are present in this phase, although PC1 and PC2 are reduced because the fluvial surfaces are narrower than in State 1 Phase 1.1. The potential natural plant communities may occur on their correlated fluvial surfaces (as in State 1 Phase 1.1). In some cases, previous invasion by tamarisk will continue in the willow community (PC2), restricting the extent of native vegetation. This state can become a stable analogue and can persist if flows, energy and sediments are
