Ecological site R040XD034CA

Gravelly, Braided, Ephemeral Stream

Provisional. A provisional ecological site description has undergone quality control and quality assurance review. It contains a working state and transition model and enough information to identify the ecological site.

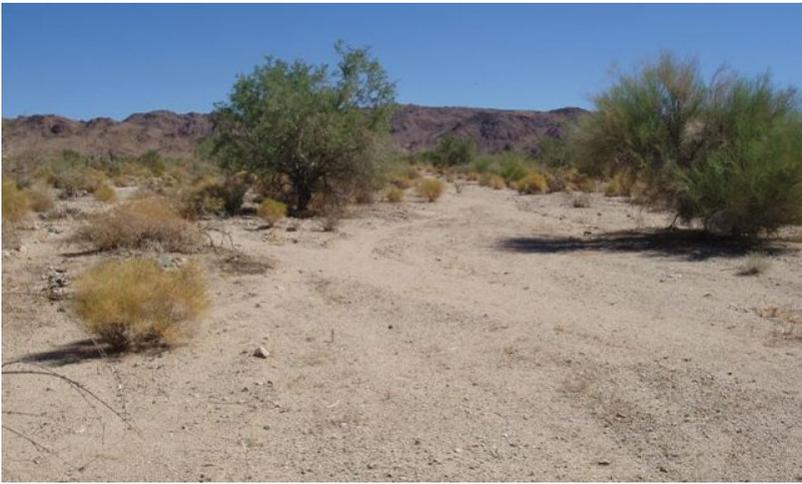
Figure 8. CC2 with Desert Ironwood
